# **Ordinary Meeting of Council**

**26 June 2024**

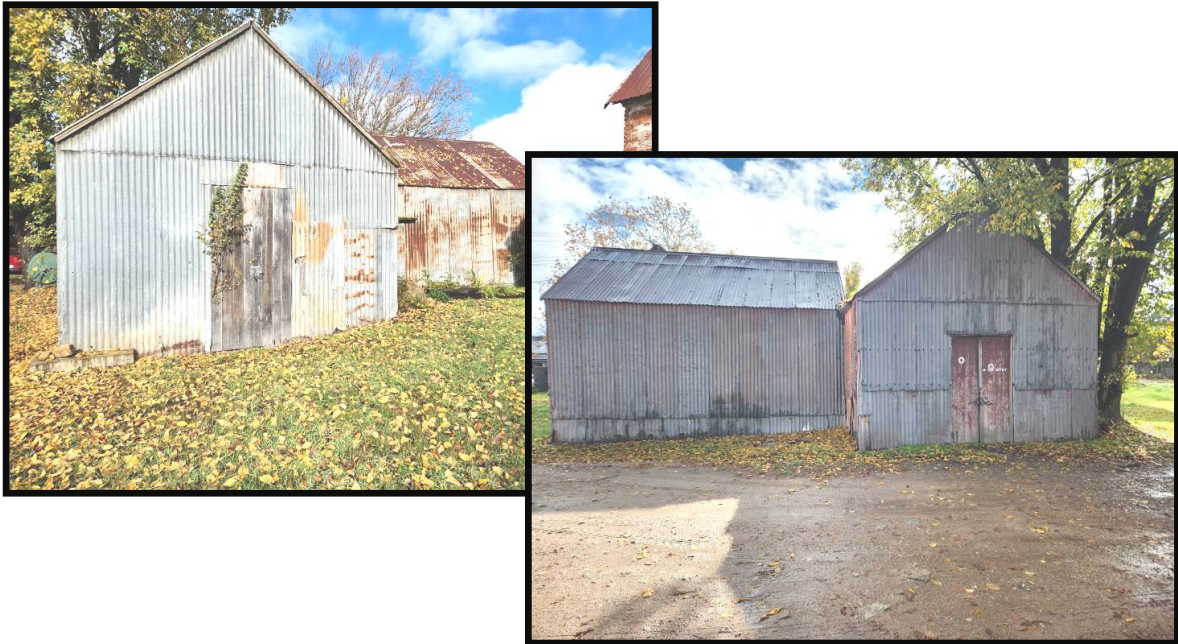
**Front and rear of the sheds at rear of  
119 Wallace Street Braidwood NSW**

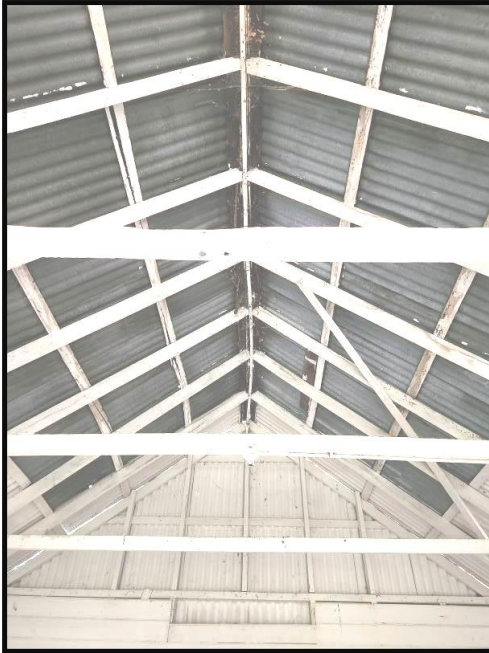
**Photograph 5**  
Decay and sagging to the ridge at the East Wing  
Roof batten split  
**Roof framing is a major structural component**

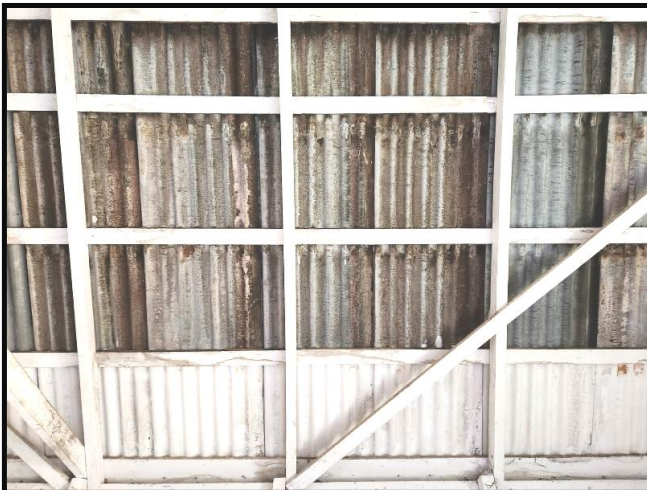
**Photograph 6**  
Roof battens are 25mm thick & the span between rafters are approximately 920mm.  
**Roof framing is a major structural component**

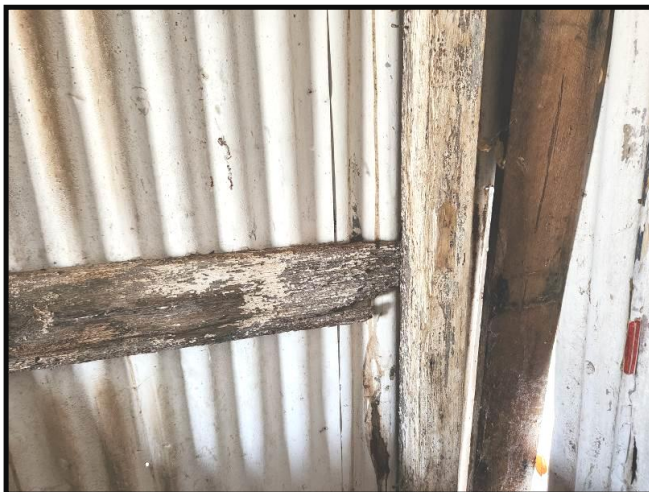
**Photograph 13**  
Wood decay at wall batten

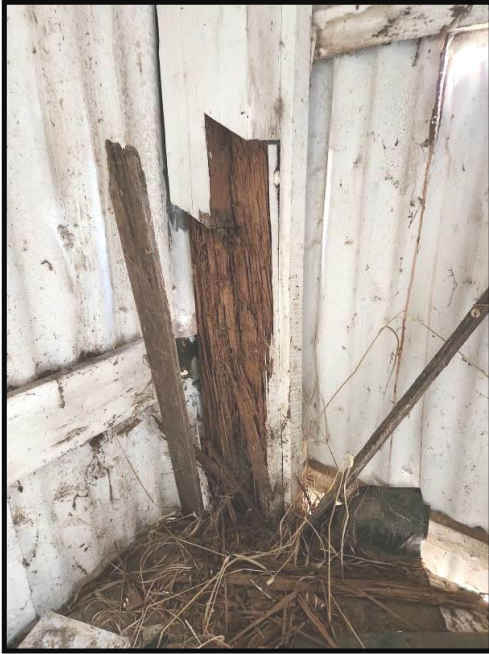
**Photograph 14**  
Termite damage to timber post at south west corner of the West Wing. This post is in two pieces.  
**Wall framing is a major structural component**

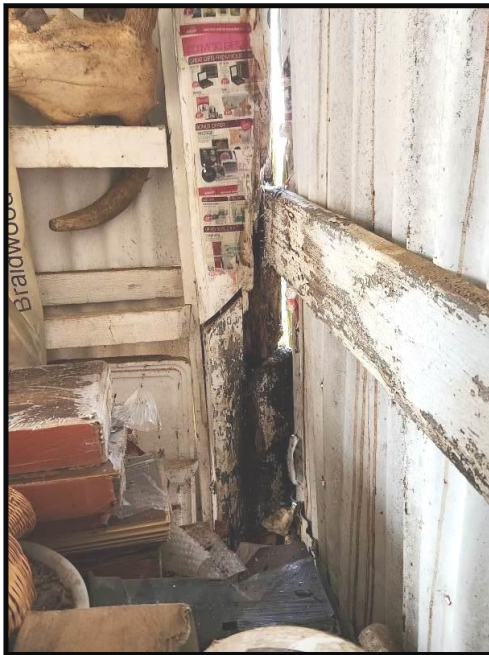
**Photograph 15**  
Wood decay to post at north west corner of the West Wing.  
**Wall framing is a major structural component**

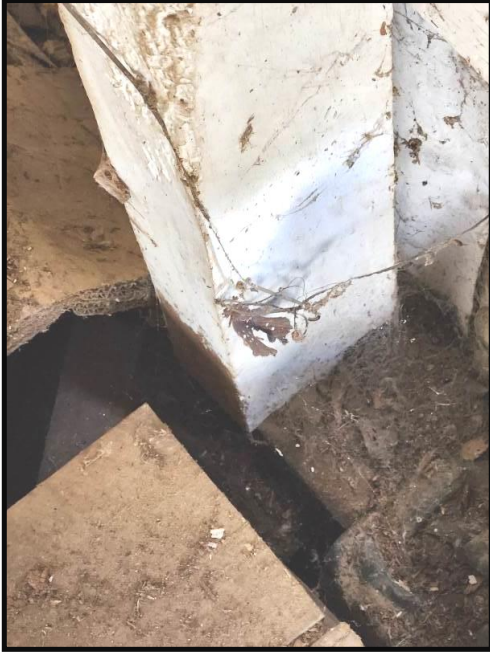
**Photograph 16**  
Wood decay to bottom plate at north east corner of  
the West Wing  
**Wall framing is a major structural component**

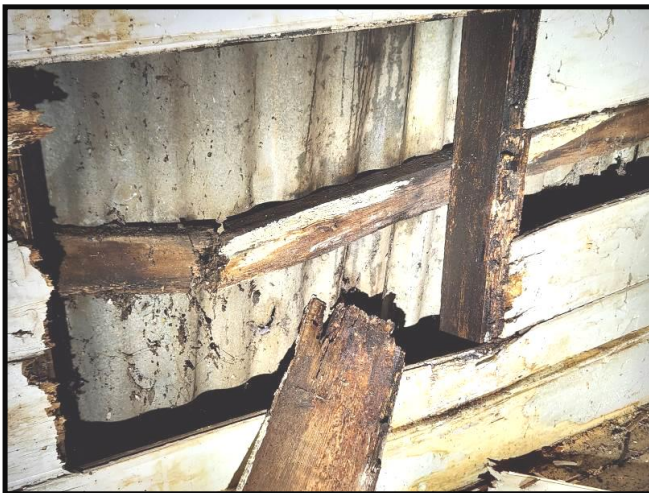
**Photograph 17**  
Damage & wood decay at south east  
corner of the East Wing, due to  
heave from tree

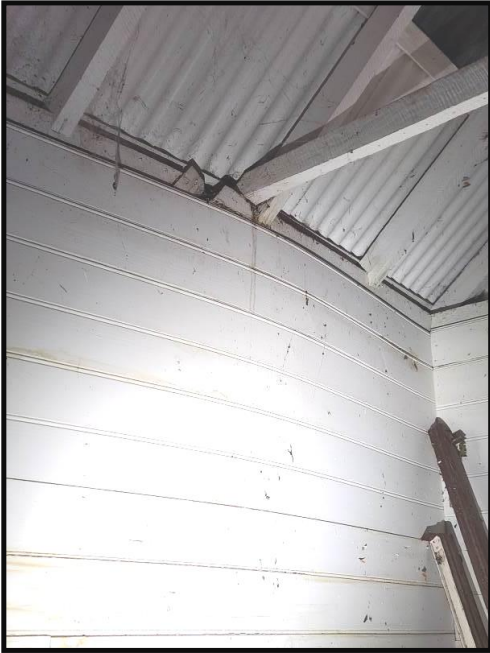
**Photograph 18**  
Bowed wall at south east side of East Wing, due to  
heave from tree  
**Wall framing is a major structural component**

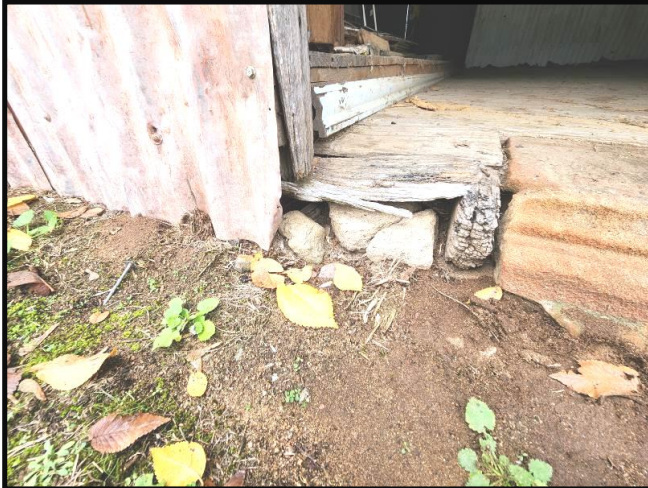
**Photograph 21**  
Timber floor framing in contact with the ground/soil & no sub-floor ventilation to West Wing, Note wood decay.  
**Floor framing is a major structural component**

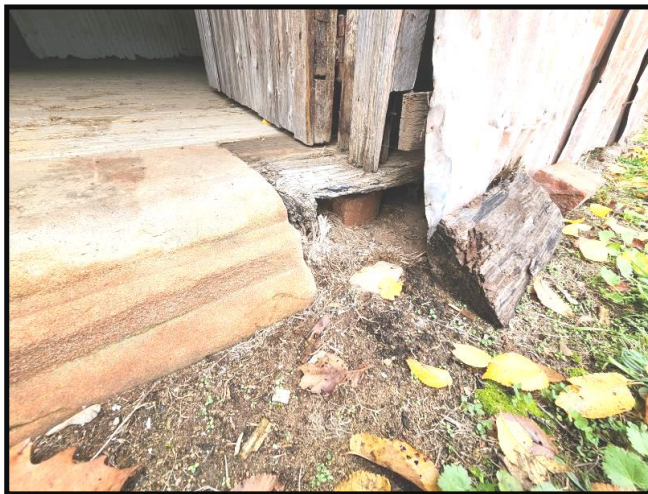
**Photograph 22**  
Timber floor framing in contact with the ground/soil & no sub-floor ventilation to West Wing, Note wood decay.  
**Floor framing is a major structural component**

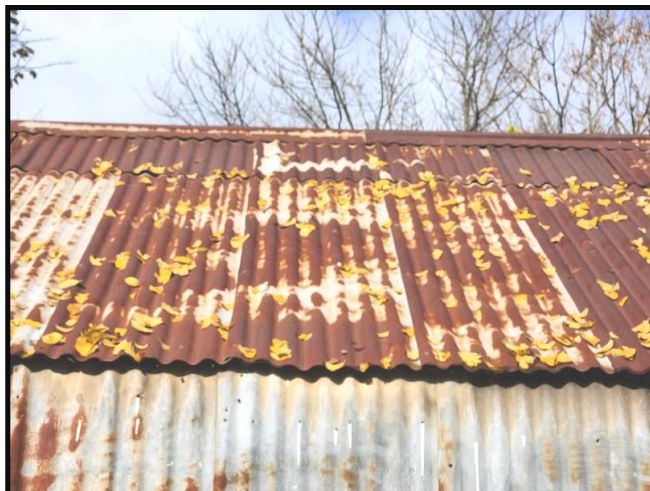
**Photograph 23**  
Roofing to West Wing corroded, holed and not in continuous lengths

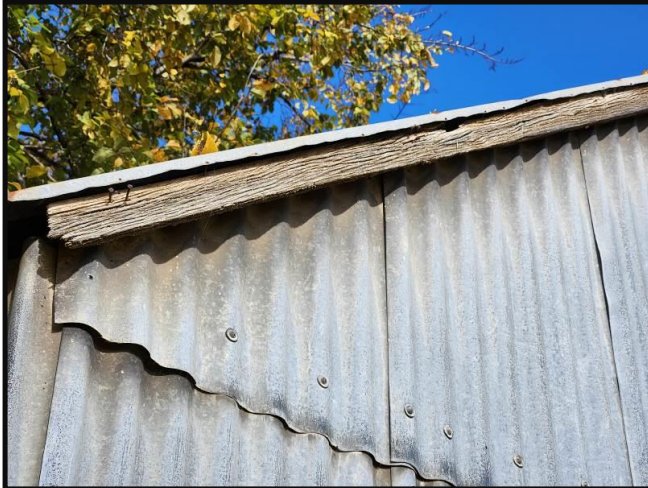
**Photograph 24**  
Decay to fascia, indicative  
throughout

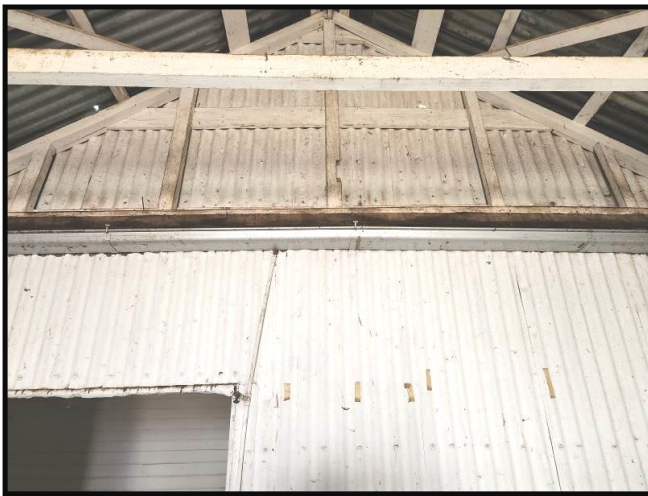
**Photograph 25**  
Eave gutter to the East Wing,  
finished inside the West Wing

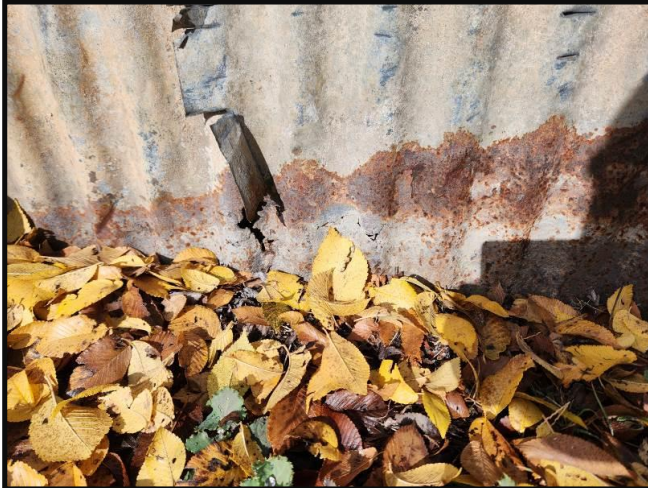
**Photograph 29**  
Holes & corrosion in wall cladding  
allows water entry

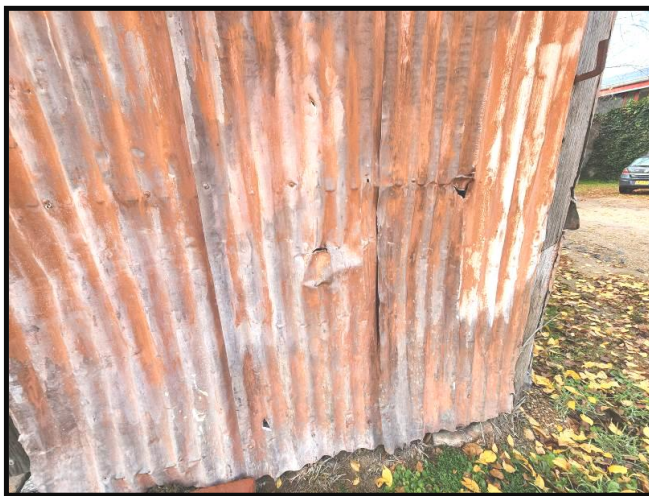
**Photograph 30**  
Holes & corrosion in wall cladding  
allows water entry. No cladding at  
corner

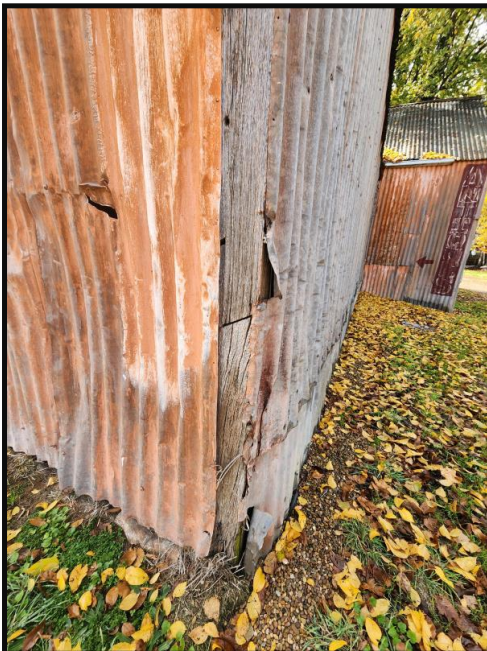
**Photograph 31**  
Holes & corrosion in wall cladding allows water  
entry. No cladding at corner

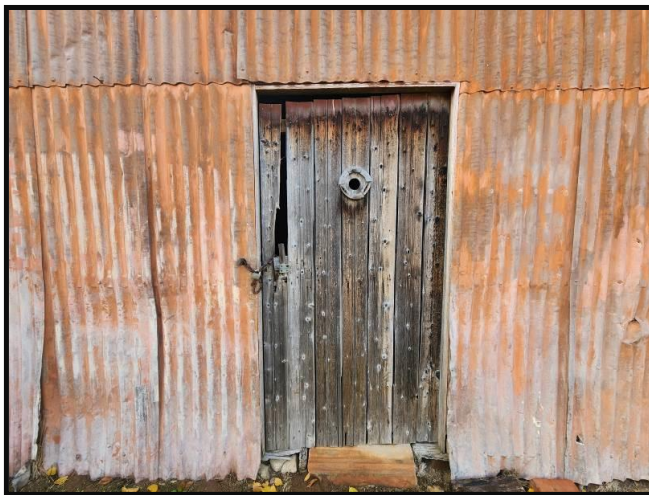
Holes & corrosion in wall cladding allows water entry. Heave from tree at south east corner of the East Wing.
