Ordinary Meeting of Council

12 February 2025

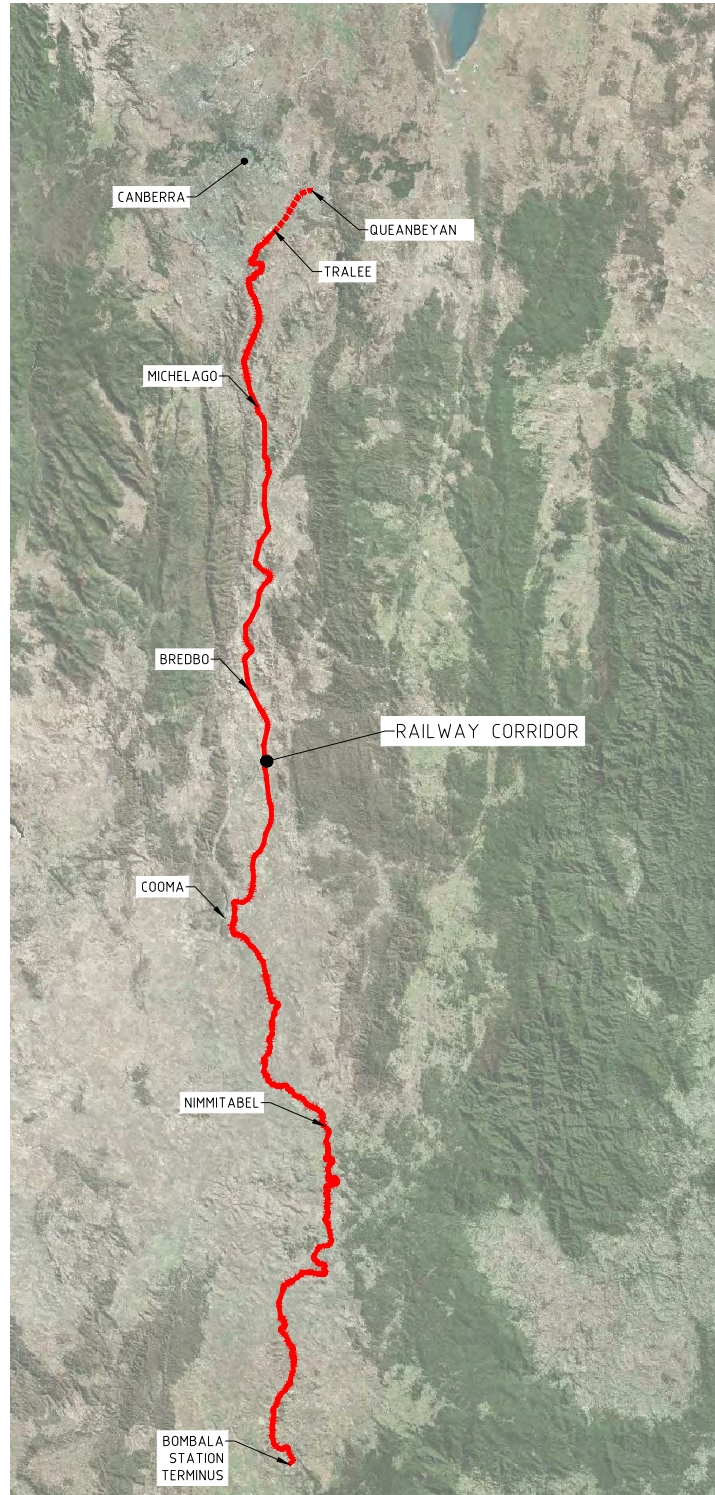
Monaro Rail Trail Development Plans Stage 1a – final report

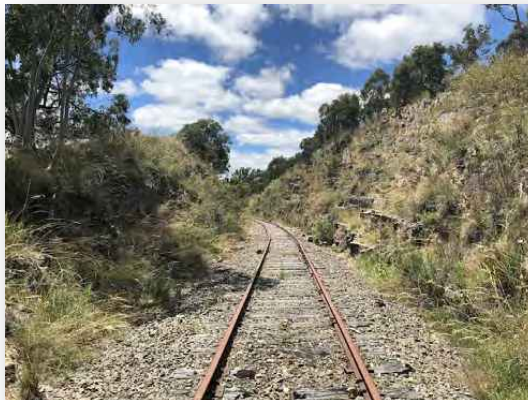
The old drains of the many cuttings along the proposed rail trail will require attention to ensure they still perform the task of clearing water from the cuttings.

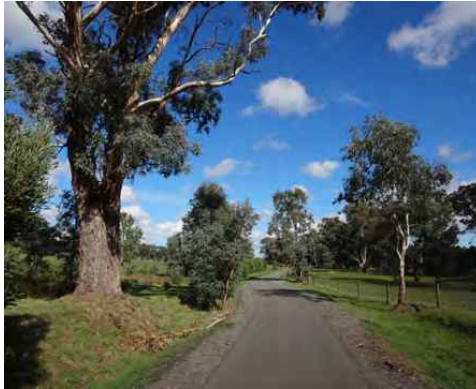
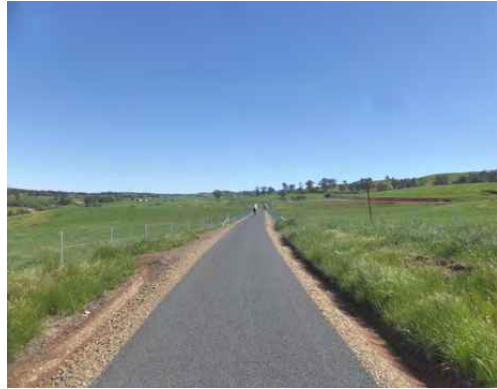
Above left: The Amy Gillette Rail Trail (SA) – an asphalt trail. Above right: The Tumbarumba Rosewood Rail Trail (NSW) – a chip seal rail trail.

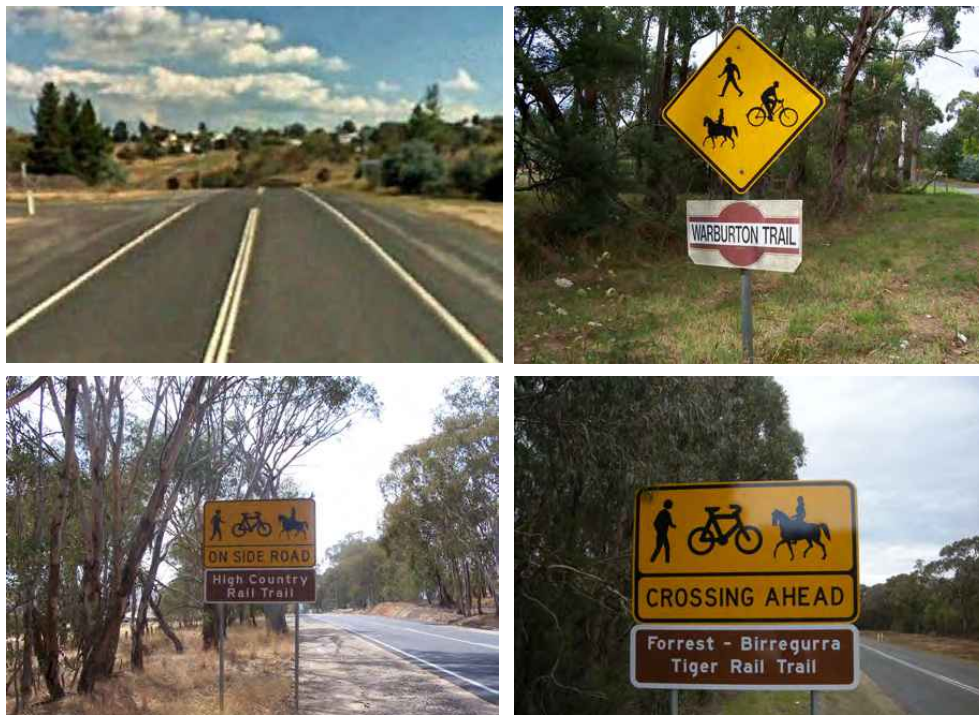
Road crossings often present a challenge. Crossing the Monaro Highway twice at Bombala presents a particular challenge (top left). The suggested solution is to include a large trail name sign at the bottom of the standard trail sign crossing sign (as shown above on three Victorian rail trails).

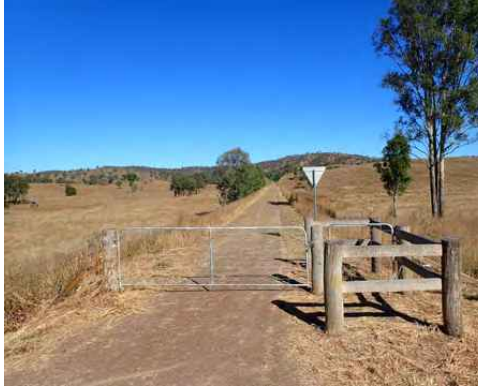
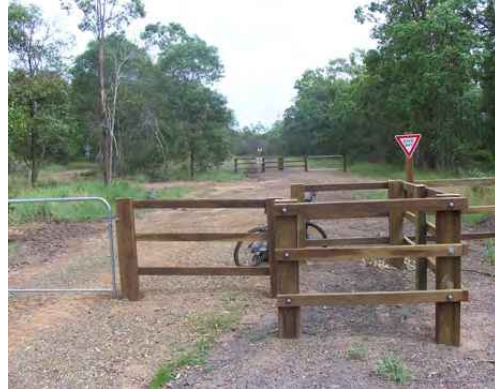
The preferred chicane gating system at road crossings shown on the Kilkivan Kingaroy Rail Trail in Queensland (above left) and the Brisbane Valley Rail Trail in Queensland (above right)

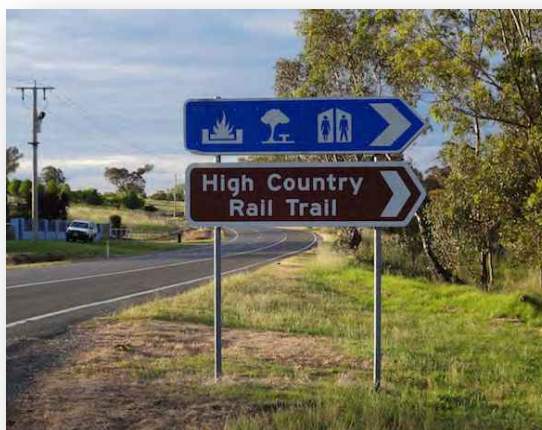
Signs pointing in to the "Trailhead", as used on the High Country Rail Trail in Victoria, are an excellent means of directing trail users to a Trailhead and serve to promote the existence of the rail trail to passing motorists, tourists and local people.

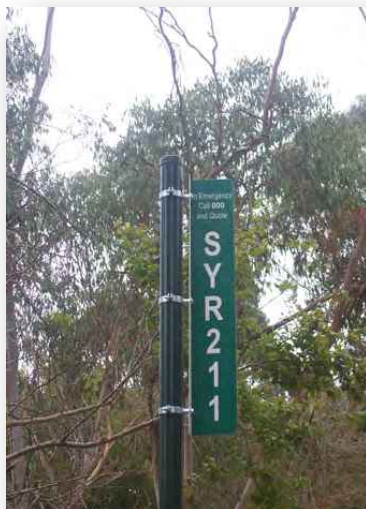
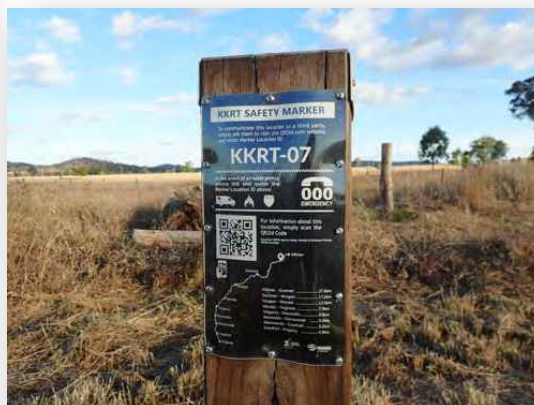
Above left: An Emergency Marker sign on the Lilydale Warburton Rail Trail in Victoria. Above right: An Emergency Marker on the Kilkivan Kingaroy Rail Trail in Queensland.

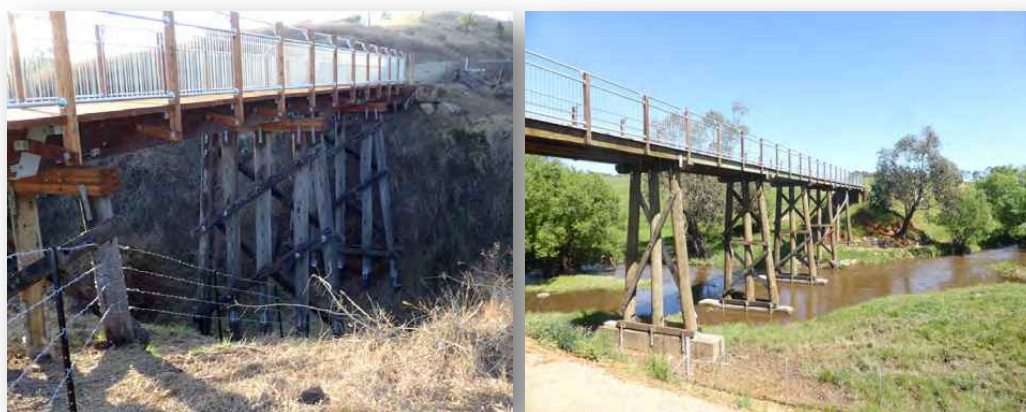
Renovating original railway bridges adds significantly to the trail user's experience. The bridge on the left is on the Brisbane Valley Rail Trail while the bridge on the right is on Tumbarumba-Rosewood Rail Trail. Both are restored in accordance with designs by WRD and both are good examples of restored railway bridges. Both use a combination of old (existing) and new timbers.

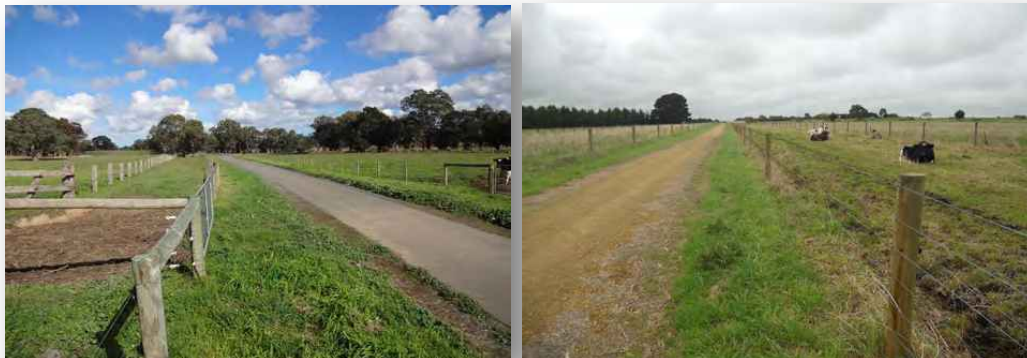
An option for managing the corridor beyond the trail is to fence a narrower trail corridor and allow adjoining landholders to graze the “excess” corridor. In both examples above, the original railway corridor boundary fence has also been retained (on the left hand side) on the Amy Gillett Rail Trail (above left) and on the right side on the Port Fairy Rail Trail (above right).

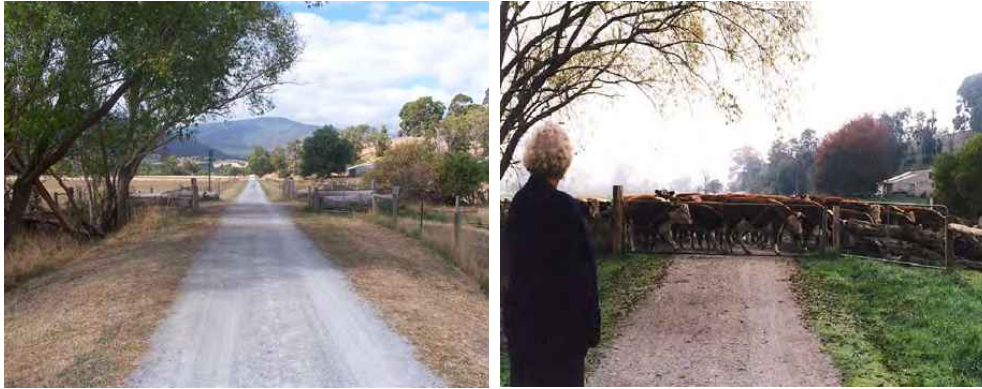
On the Lilydale Warburton Rail Trail (Vic), gates are open to the trail user (above left) and are only closed to the trail when stock are moved across in a mob. Other trails (Otago Central Rail Trail (NZ) – bottom left and Port Fairy Warrnambool Rail Trail (Vic) – bottom right) use similar systems.

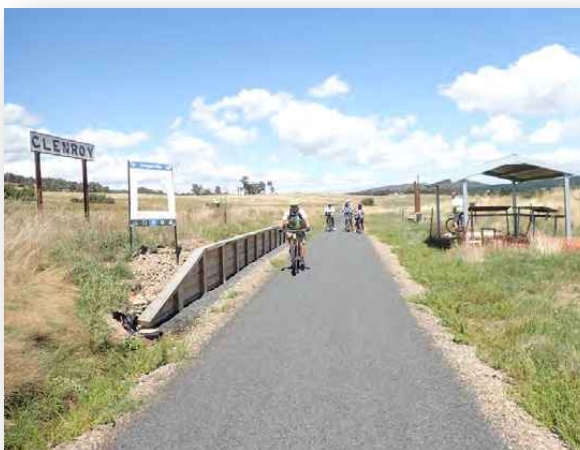
*Above: Glenroy Siding on the Tumbarumba Rosewood Rail Trail.
Siding platform rebuilt by the Tumbarumba Men's Shed.*

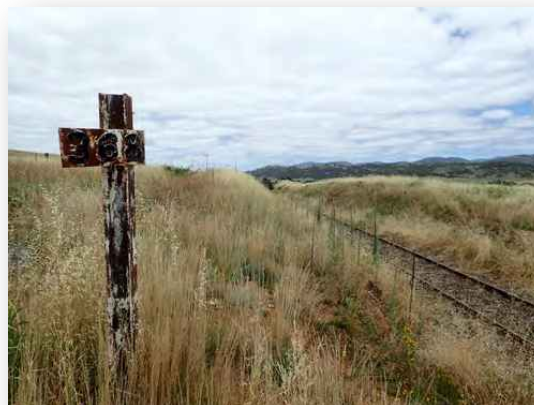
Retention of all old distance pegs, and other signage, is strongly recommended.

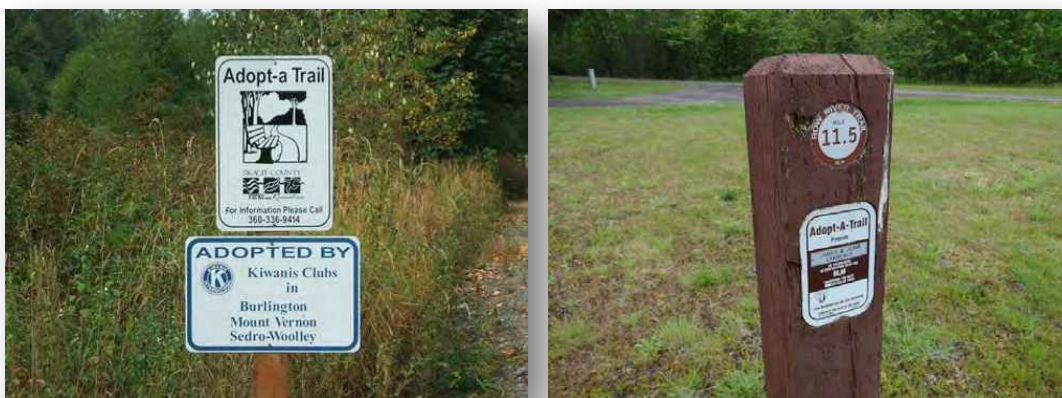
Trail managers and “Friends of...” groups often arrange ‘Adopt-a-Trail’ programs to ensure the rail trail is well maintained – by volunteers. The majority of some trails, such as the Bibbulmun Track, are maintained by volunteers.

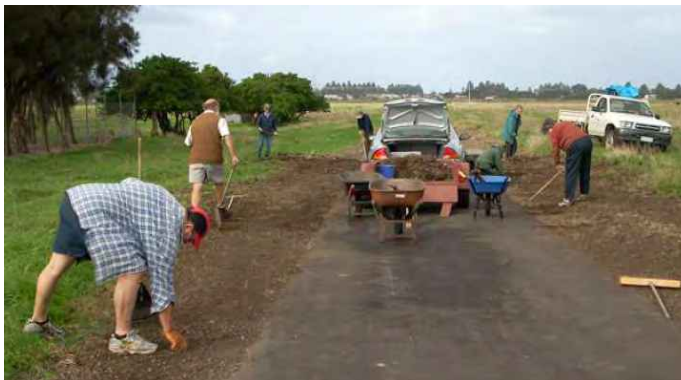
Volunteers organised by the Committee of Management at a busy bee to undertake maintenance work along the rail trail near Port Fairy in Victoria.

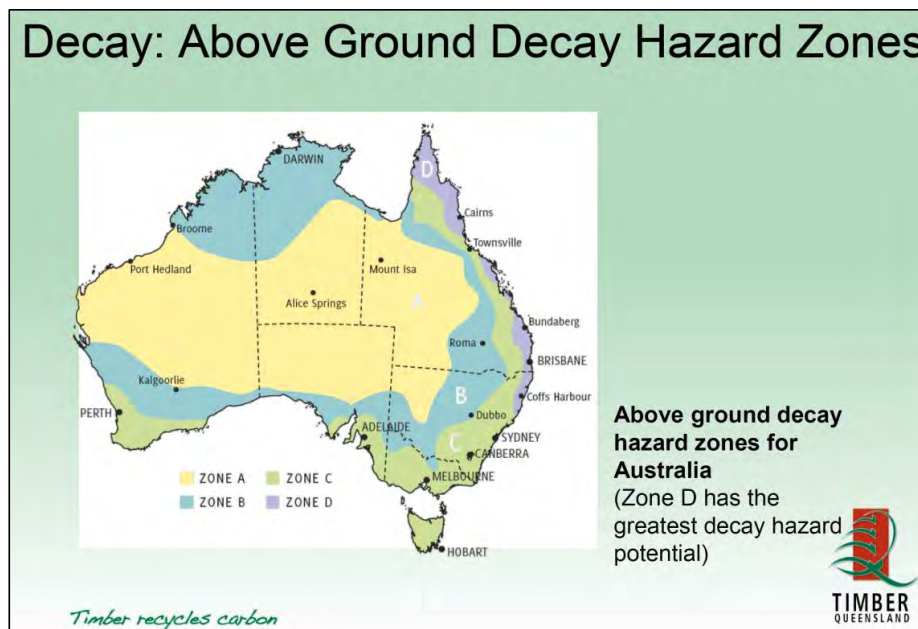
Figure 3-1: Decay Hazard Map for Australia showing that the proposed Monaro Rail Trail bridges are in Zone C of the decay hazard zones in Australia. The typical moisture contents in these timber bridges are 16.4% for open deck bridges and 14.2% for closed deck bridges. Decay doesn't begin in wood till the moisture content reaches 22%. The majority of decay in timber elements is due to vertical fasteners and design details that allow moisture to accumulate in and around timber elements.

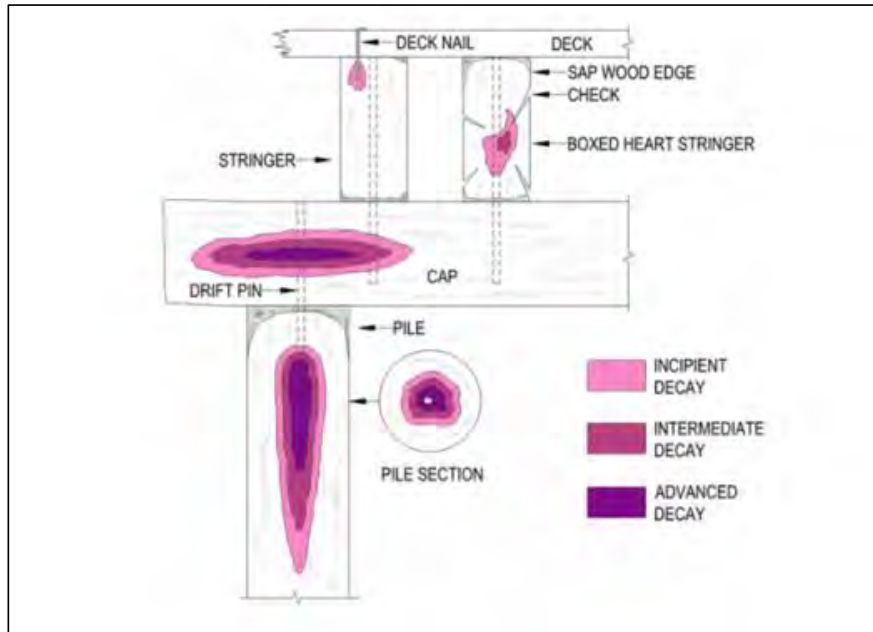
Figure 3-2: Shows the level of decay that occurs in timber due to the use of vertical fasteners. Vertical fasteners increase the rate of decay in timber as they allow moisture to travel down the fastener into the heartwood of the headstock (cap), girders (stringers), corbels and piles, therefore increasing the moisture content in the middle of these elements. The heartwood of a log element is less capable of breathing and expelling moisture than the sapwood that surrounds it, so vertical connectors funnel the moisture directly into the heartwood accelerating decay. Once the moisture content exceeds 22%, timber consuming fungi are activated, and the decay process begins.

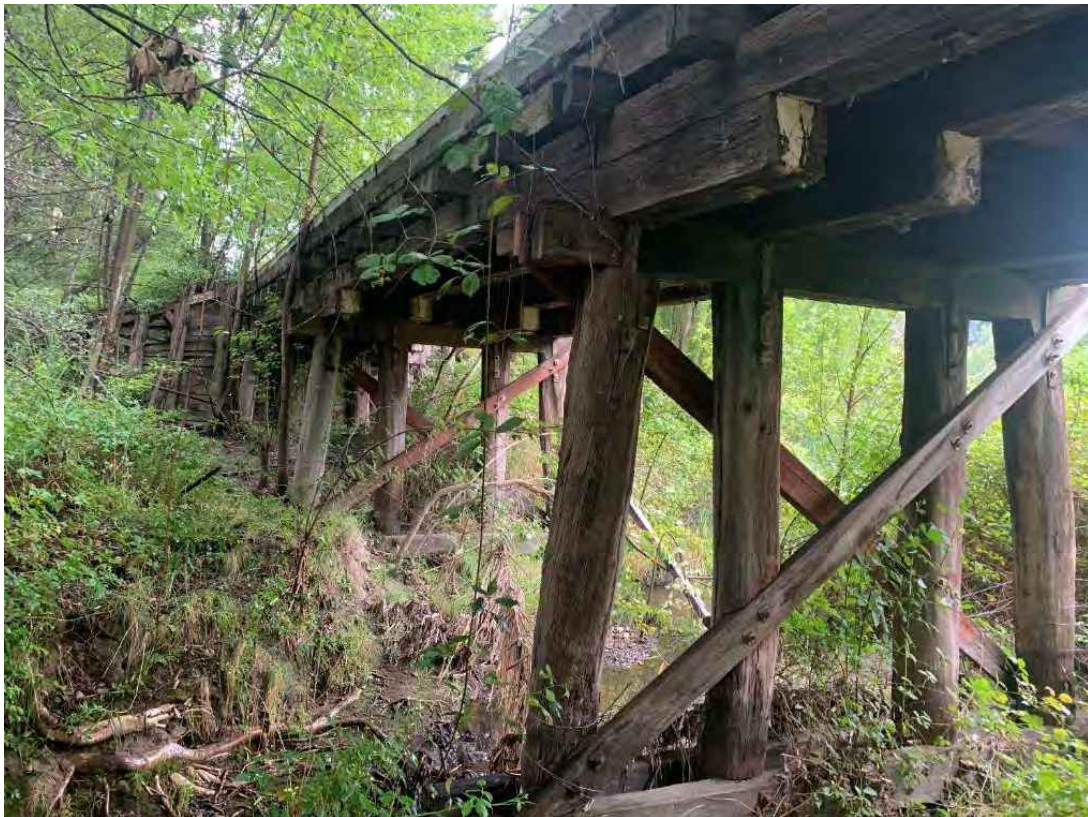
An essential step in evaluating the condition of a structure is undertaking a visual inspection. The visual aspect of the investigation is used to pick up missing or failed elements, cracks and splits, cavitation, connection details, abutment condition, undermining and debris build-up, among other important information. Gathering this information is essential for completing a comprehensive investigation and considering the surroundings in addition to the main structural elements. See **Figure 4-1** through **Figure 4-9** below for a summary of findings as well as the description of each bridge.

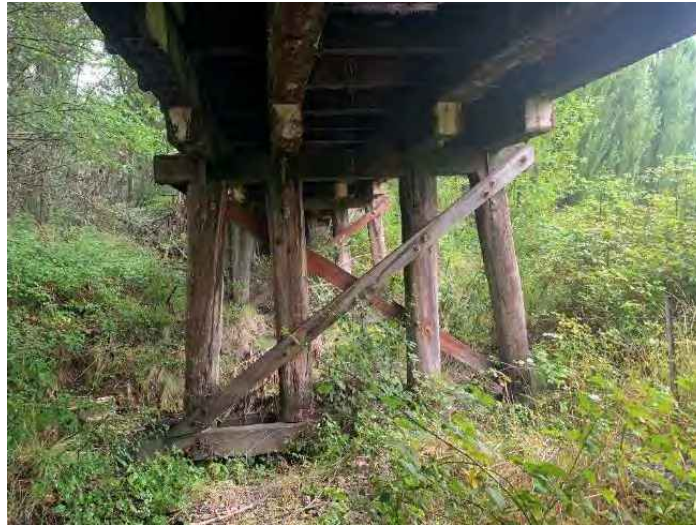
Figure 4-2: View of the typical timber pile bent configuration. The bent is comprised of 4 driven piles, single timber head stocks and corbels. The bent is also supported by a double cross bracing system with sashes at halfway and timber wales at the bottom. Overall, the timber bents were found to be in a poor to very poor condition. Note the surface brown rot fruiting bodies on the faces of some of the cross braces -orange brown colour.

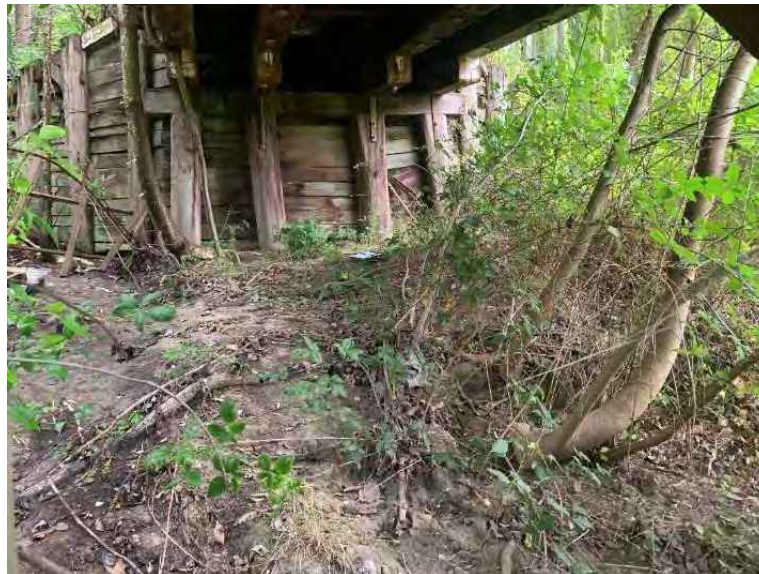
Figure 4-3: Both abutments consist of 4 timber piles, timber headstock, timber corbels and timber sheeting. It was noted that the bottom section of several piles has started to undergo decay. Note abutment sheeting is rotted and failing. Timber pile and sheeting wing walls present on both sides of each abutment. Once the moisture content in the timber elements reaches 22%, decay causing fungi are activated and the decay process begins. Large trees need to be cleared as their root systems apply lateral pressure on the substructure elements as will the branches and trunks on super structure elements.

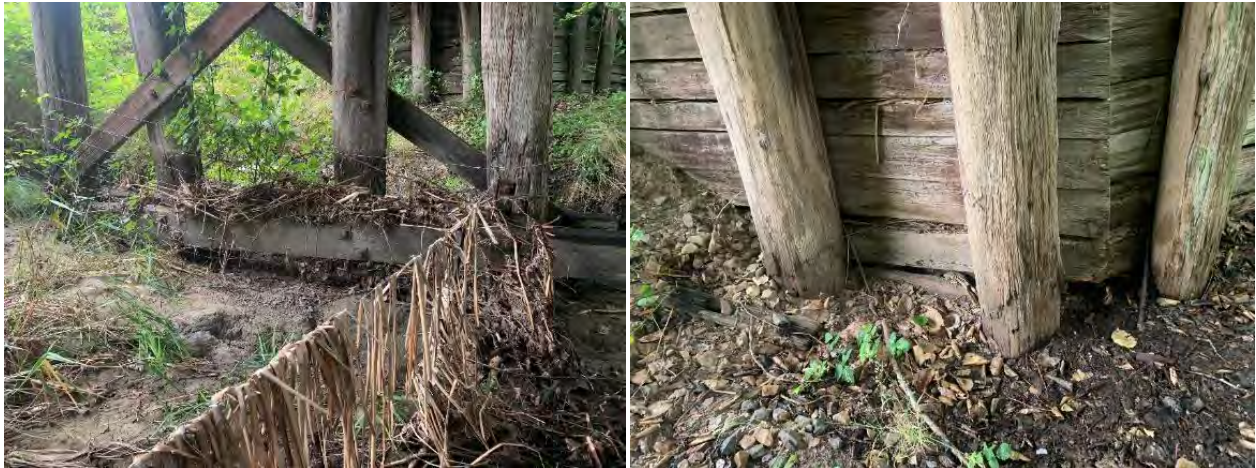
Figure 4-4: The bottom sections of the timber piles were determined to be a ‘hotspot’ for decay, this is caused by the moisture retained by debris increasing the moisture content in timber members. Sapwood decay in the timber piles is photographed on the right-hand side. Refer to Section 4.1 below for a full list of recommended repair options for refurbishment to a pedestrian/cycle bridge.

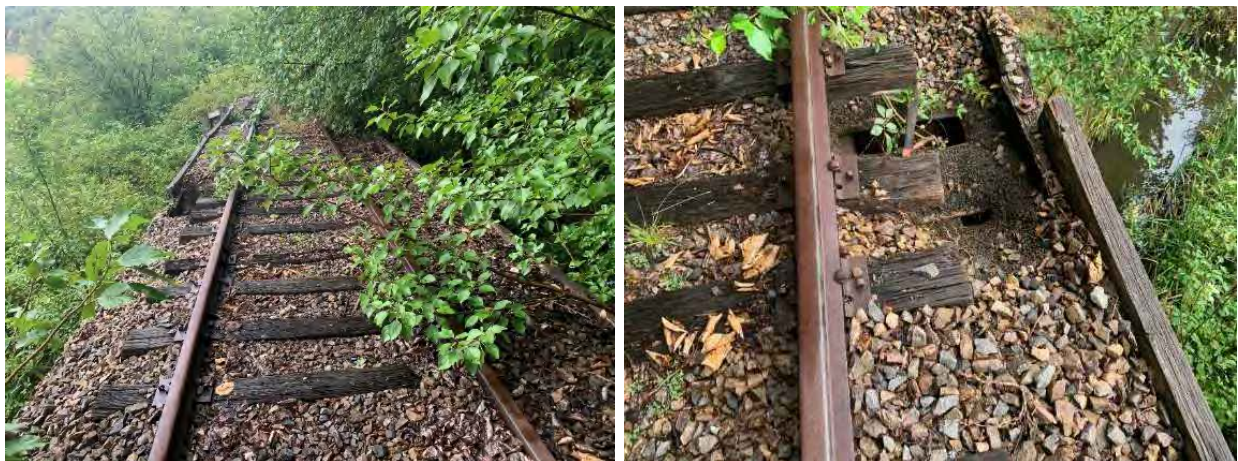
Figure 4-5: The timber transoms were found to be in a very poor (unsafe) condition. The timber ballast tray side walls and rock ballast were in poor condition with erosion of material found in several locations. If the bridge was to be repurposed for pedestrian and cycle use the timber transoms, railway line and rock ballast would need to be removed. Depending on the condition the existing ballast tray side boards they can left in place to act as a kerb/kick rail in the re-purposed bridge. To meet the current standards and Australian codes; vertical balustrade panels and a 1.4m high cycle rail will need to be installed. Note: Significant vegetation growth. The ballast tray will provide a great subgrade for the walking track.

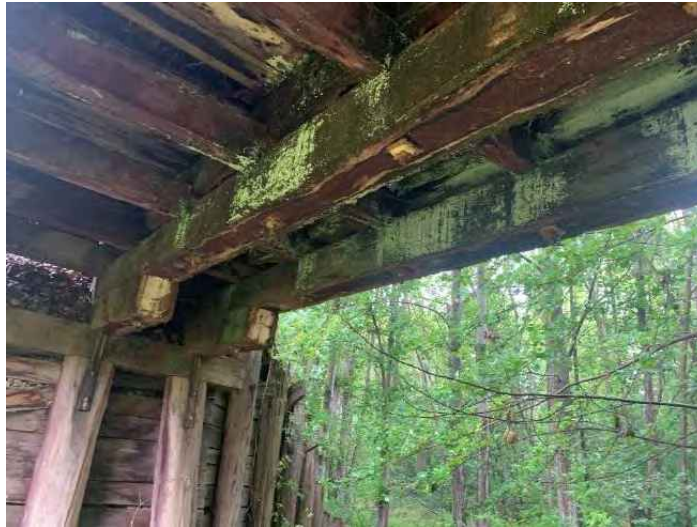
Figure 4-6: View of 2/4 girders. Consists of 4 girder lines which are double stacked with the top girder serving as a lateral bearer beam end stabilizer as well increasing the elevation of the ballast tray floor. All girders exhibited major water stains and decaying fungal growth. Girders were found to be in poor to very poor condition.

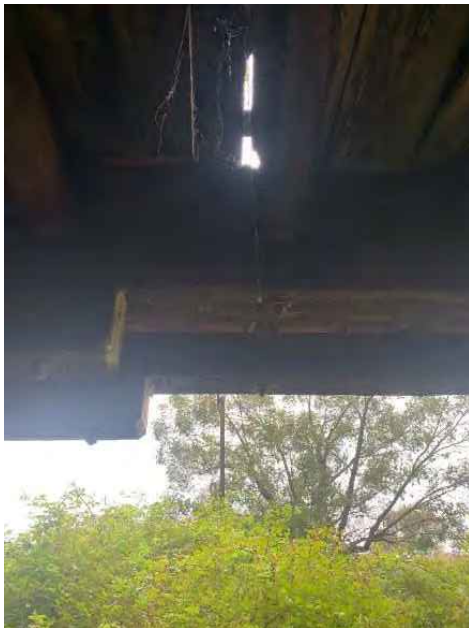
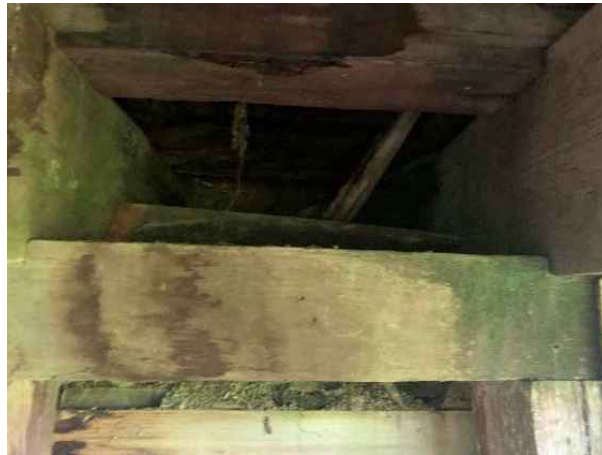
Figure 4-7: The photo on the left shows a failed deck plank from below. The photo on the right shows another failed deck plank located above the abutment. Decking failure causes the above rock ballast to erode and elements below experience excess weathering and load. These planks will require replacement before the bridge can be reopened for pedestrian and cycle use.

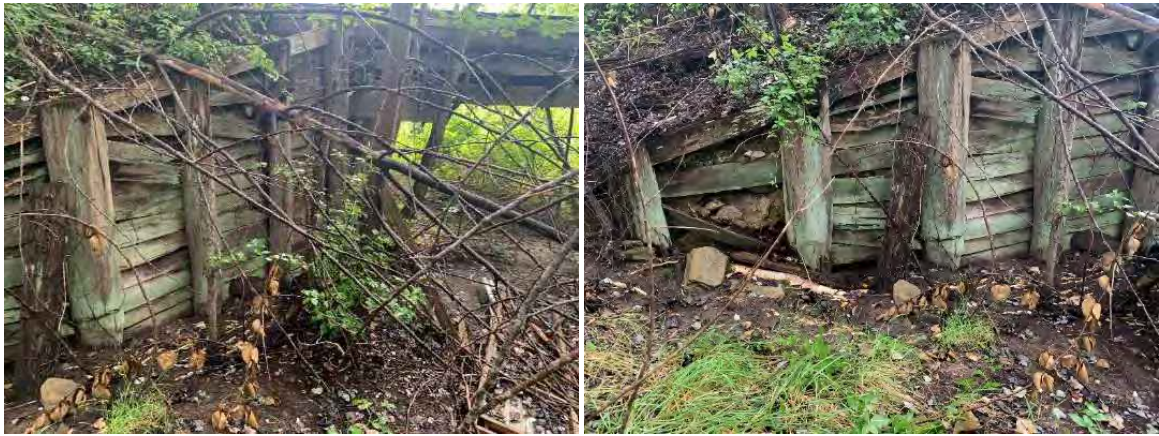
Figure 4-8: The timber wingwalls have undergone significant deterioration with timber sheeting completely rotted and failing in several locations. Due to this the walls' ability retain the approach fill material is poor leading to erosion and excessive loading.

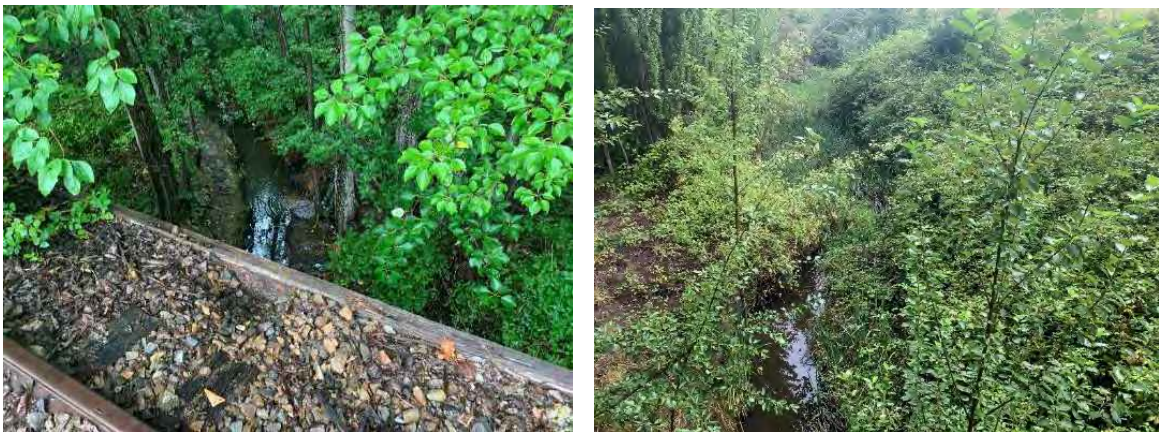
Figure 4-9: Left photo is the general downstream view from bridge deck & photo on the right is the upstream view.

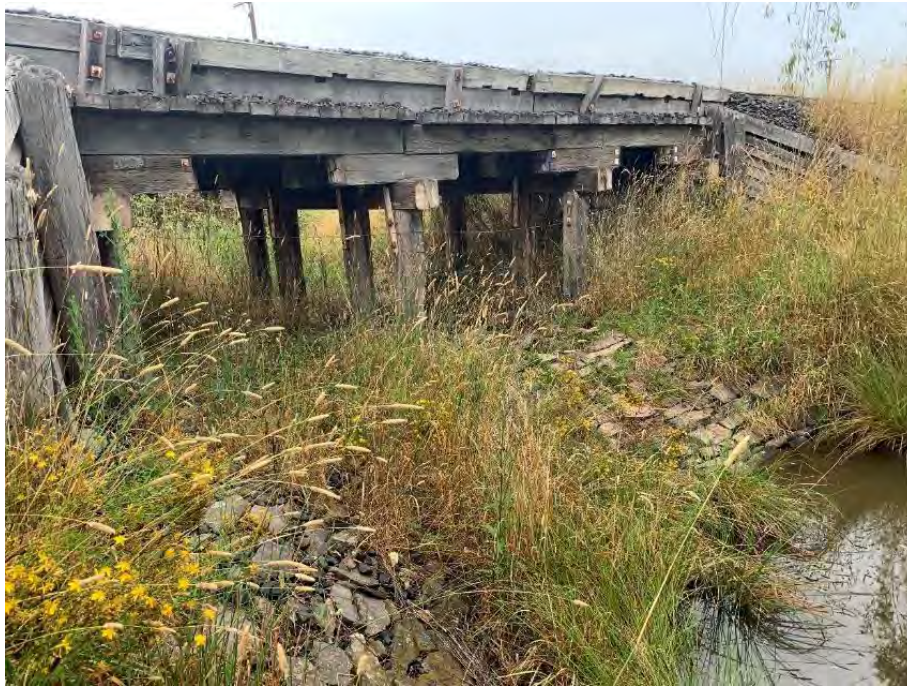
Figure 5-1: The top image shows a general view of the minor 10m Bridge from an abutment. The timber girder under bridge consists of 3 spans of 3.3m. Each bent consists of 4 driven timber piles and a single headstock. Headstocks are attached to the piles using a vertical steel bracket on either side. Note kerb support completely split vertically through middle.

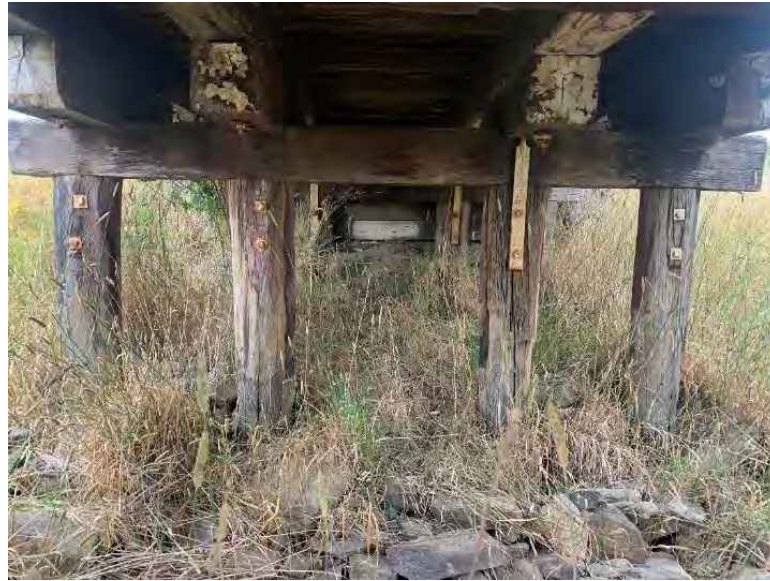
Figure 5-2: General configuration of each pile bent. Large vegetation growth and cobbles located around the base of piles. All piles were found to be in very poor condition with large splits and sapwood decay are present in majority of piles, predominately at ground level. Excess vegetation growth leads to an increase in moisture content within timber members resulting in accelerated decay.

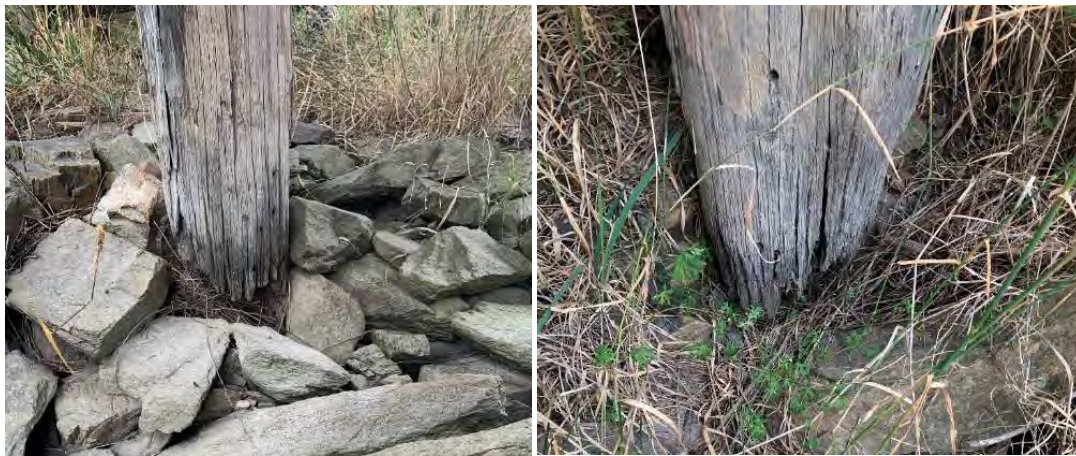
Figure 5-3: View of piles at PB1, pile 3 and PB2 pile 4, both are in very poor condition and were found to be completely decayed at ground level and hanging freely above ground.

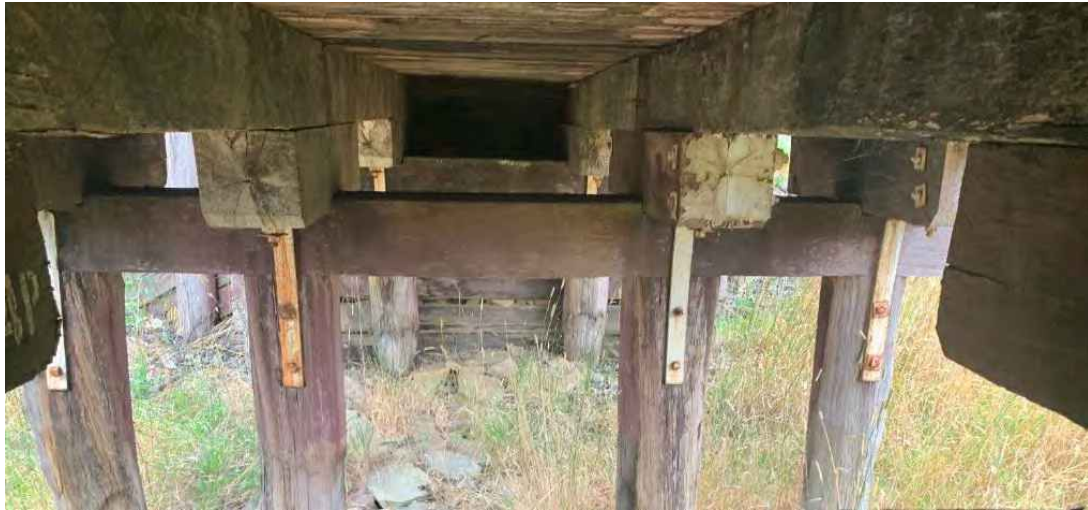
Figure 5-4: View from in between internal girders, all girders were found to be in fair condition with no major deterioration present. Corbels and bent caps were found to be in fair to poor condition throughout with evidence of minor decay present. Brief NDT testing was completed using non-destructive methods, such as EPHOD® Stress Wave Technology. Refer to Appendix A for more information of this type of testing method. Readings for girders were found to be between 300-500 μ s, Corbels – 400-100 μ s and caps 300-800 μ s. This is the time taken for the compression wave to travel across the section of the member tested. This was recorded on most elements and aids in verifying the condition of the elements. The pile tops are in better condition due to the use of horizontal connectors with side plates.

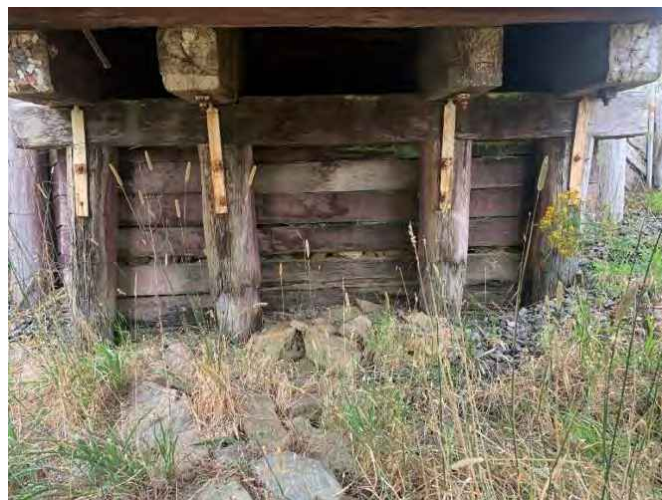
Figure 5-5: View of abutment shows the general formation. The timber sheeting was found to be in poor condition, with water stains and decaying fungi growth present. Significant sapwood deterioration was located on members near the ground. Gaps between lower planks show minor erosion of backfill material. The breast wall planks are spiked to the backside of the piles which has resulted in their shrinkage producing gaps and subsequent loss of fines. They should be stitched.

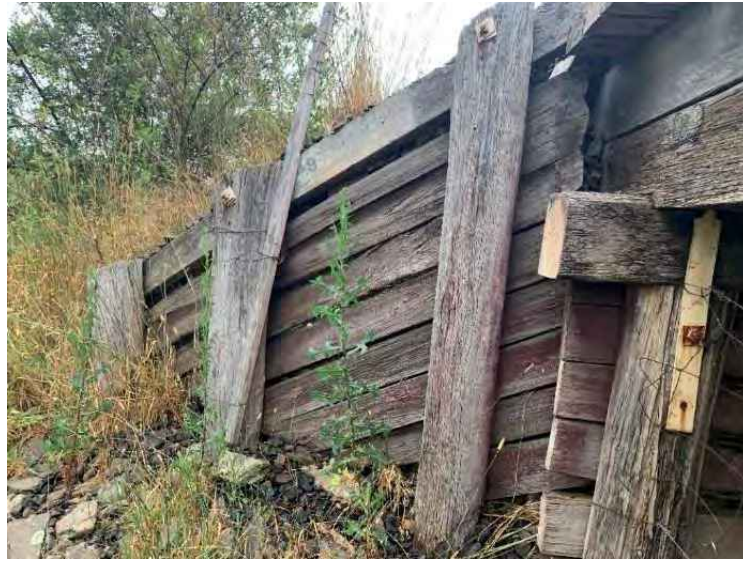
Figure 5-6: A view of abutment wingwall. The wingwall was found to be in fair to poor condition with minor deterioration present throughout all components. Minor deformation was present at top of wall due to bearing load of ballast.

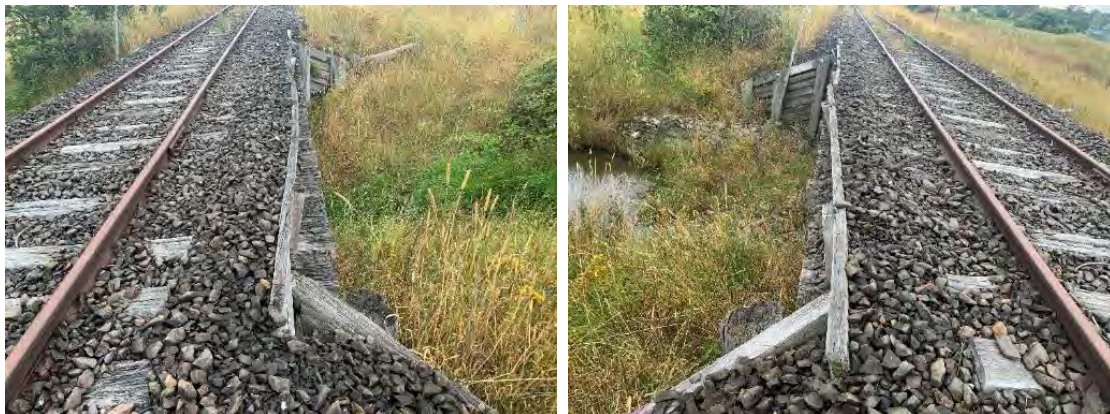
Figure 5-7: View of both ballast tray side walls. Both side walls were found to be in fair to poor condition, with minor deterioration of sapwood present at all lengths. Photo on the right shows the side walls support leaning backwards creating a deformation in side wall length. Photo on the left shows a significant bow in middle length due to bearing the load from the rock ballast.

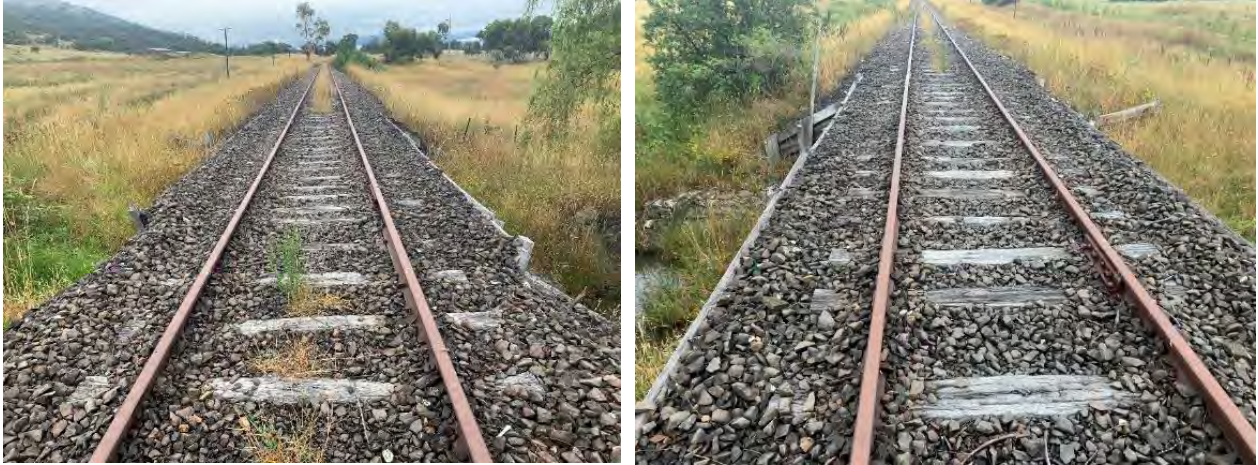
Figure 5-8: Top view of rock ballast looking in opposite directions. The rock ballast was found to be in fair condition with no major erosion present, no holes were found in bridge decking. Transoms were found to be in fair to poor condition with moderate deterioration and decay found.

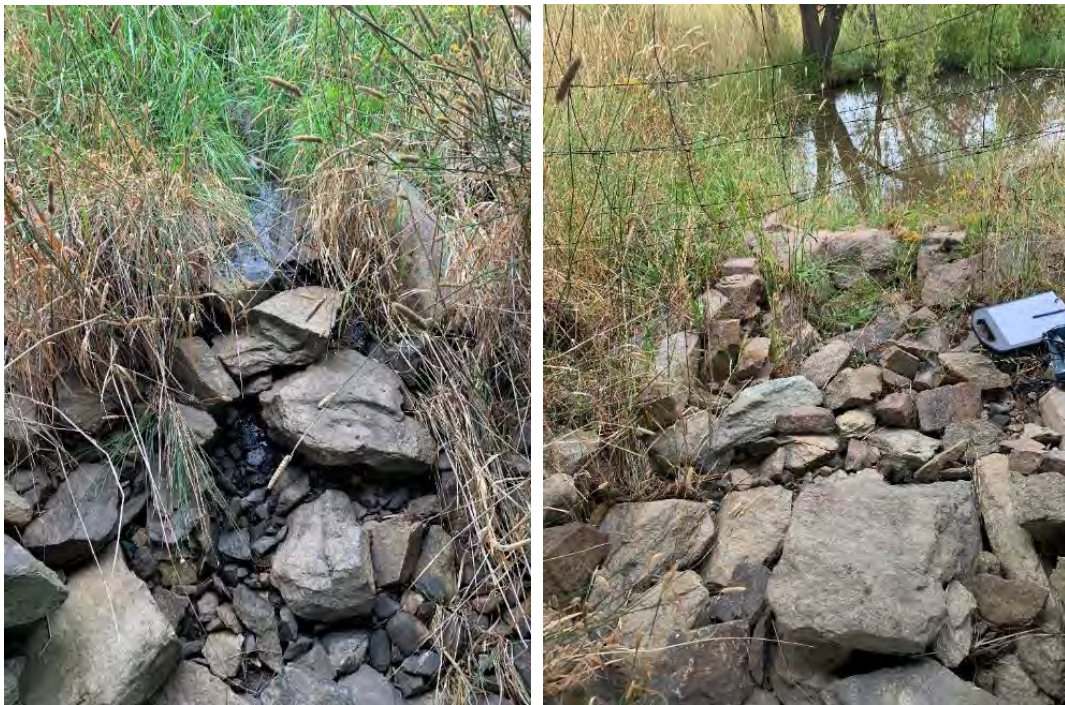
Figure 5-9: View of small inlet creek that trickles through rocks under the span 2 into a pool on the opposite side.

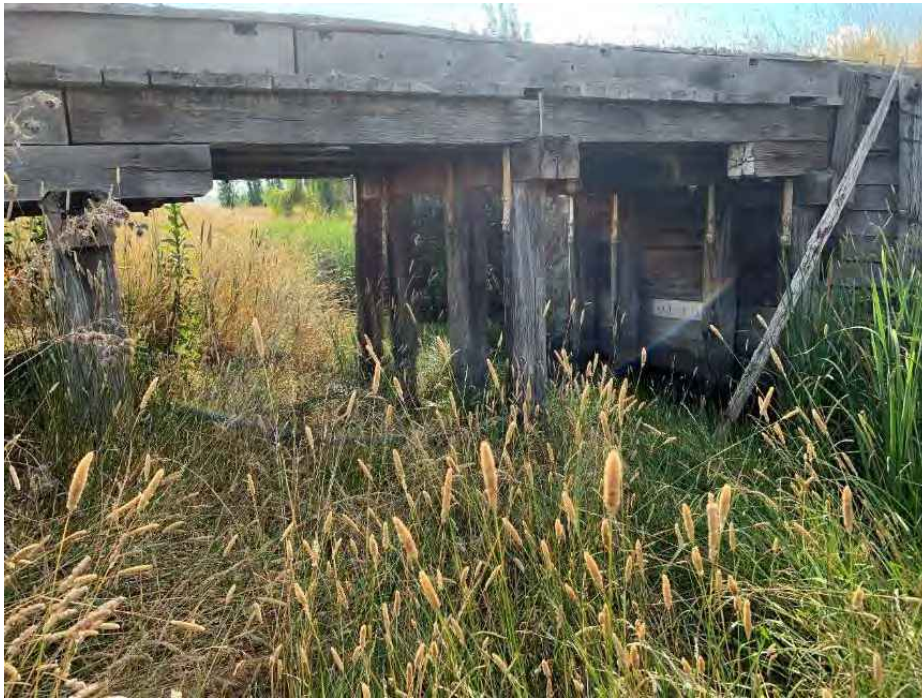
Figure 6-1: General view of Lobbs Hole Creek Bridge from the side of the bridge. The Creek that flows underneath span 1 at the time of inspection was flowing very slowly/still. The configuration of the bridge is a girder under and consists of 3 spans, 2 abutments and 2 pile bents. The span length is 3m equating to a total length of 12m. Note: abutment 1 and abutment corbels as does one of the bents.

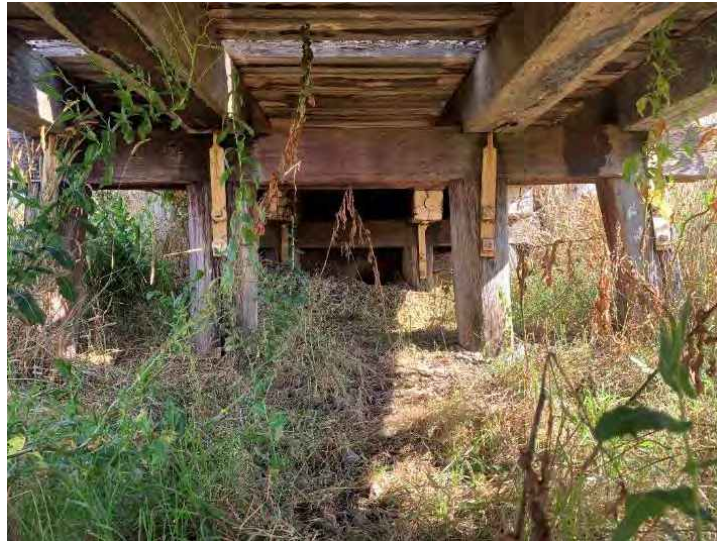
Figure 6-2: View of the typical timber pile bent configuration with each bent varying in height. The bent comprises of 4 driven piles a capsule (cap) and at bent 2 4 corbels located directly underneath girders. Overall, the timber bents were found to be in fair to poor condition. Note: large Wombat hole at abutment 2 between pile 2 and 3 and the significant amount of vegetation growth surrounding the substructure elements. Note that the use of horizontal bolts in the side plates have let to improved pile top condition. Also note the notches in the caps for the girders to drop into.

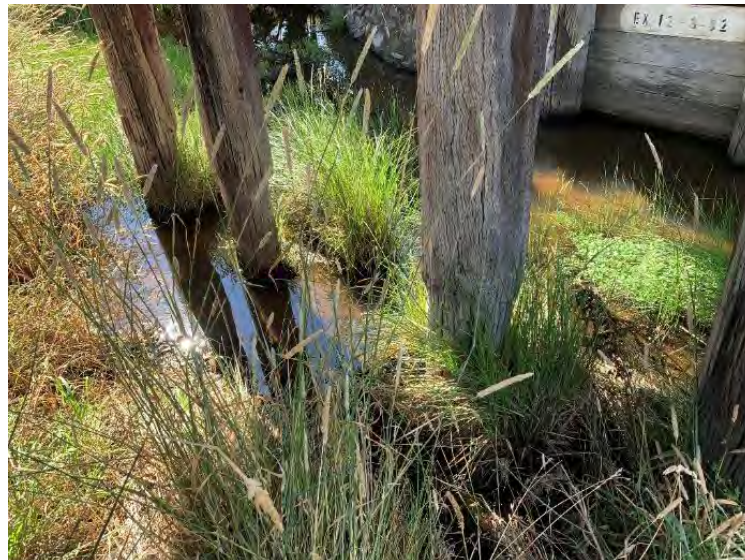
Figure 6-3: A view of Bent 2 shows the timber piles were driven into the creek. Significant sapwood decay is present in the lower length of each pile as seen by the noticeable change in cross section. This is seen as a length that is subject to temporary exposure to moisture which causes accelerated decay compared to constant saturation. Once the moisture content exceeds 22%, timber consuming fungi are activated, and the decay process begins. Refer to Figure 3-2 for a detailed description of how and where the decay occurs due to these vertical bolts.

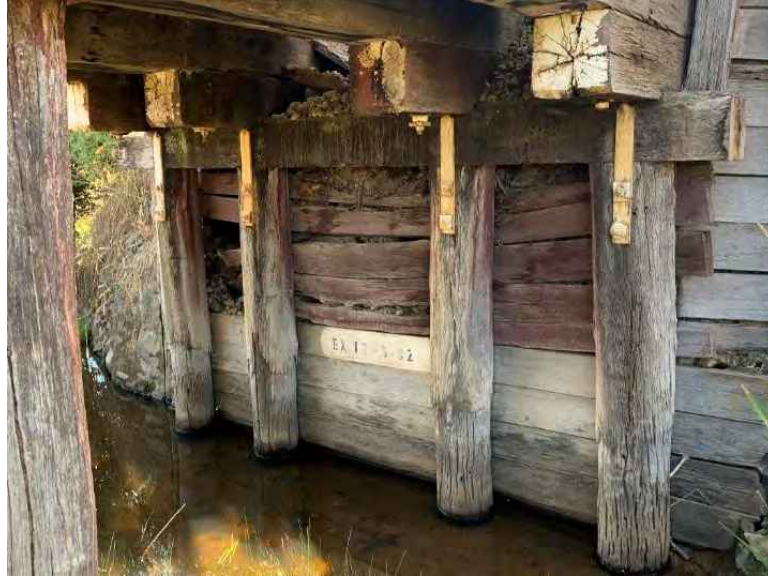
Figure 6-4: General view of Abutment 1 shows the timber sheeting in very poor condition as top half is failing and backfill material is eroding. Note: Hole in decking above abutment causing significant material loss from rock ballast above.

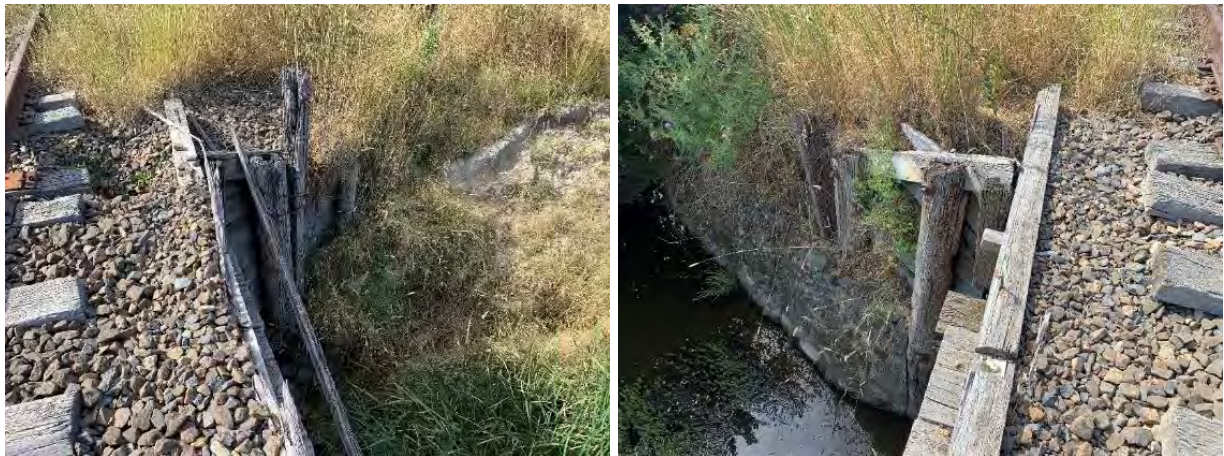
Figure 6-5: Above photos show the existing condition of the wingwalls. The wingwalls were found to be in a poor to very poor condition, multiple members had failed, and significant deterioration was present throughout.
