Ordinary Meeting of Council

12 February 2025

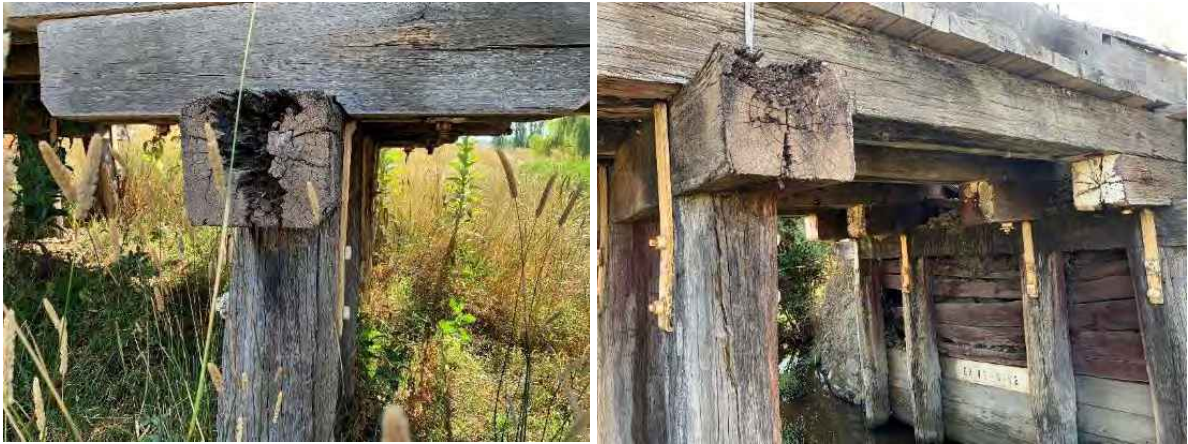
Figure 6-6: Above photos show the ends of the pile bent caps at PB1&2. Minor deterioration and cavities were found at all ends of caps. Overall, the caps were in poor condition. Brief NDT testing was completed at the mid length using non-destructive methods, such as EPHOD® Stress Wave Technology. Refer to Appendix A for more information of this type of testing method. Readings for bent caps were found to be between 200-1000 μ s. This is the time taken for the compression wave to travel across the section of the member tested. This aided in verifying the overall condition of the elements.

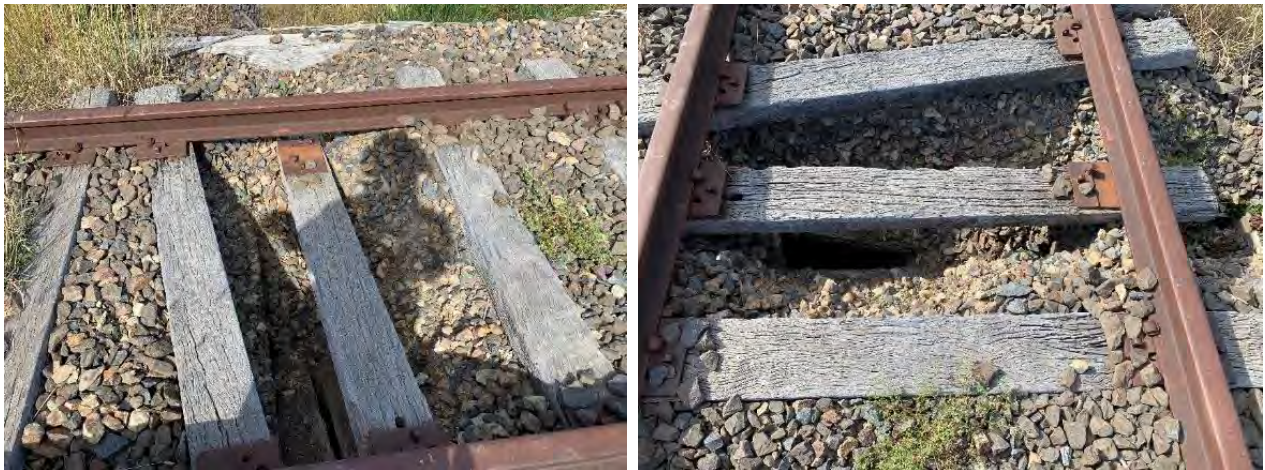
Figure 6-7: Above two photos show 2 of 3 deck collapses. The ballast tray floor boards are in very poor condition with major deterioration and rot present throughout.

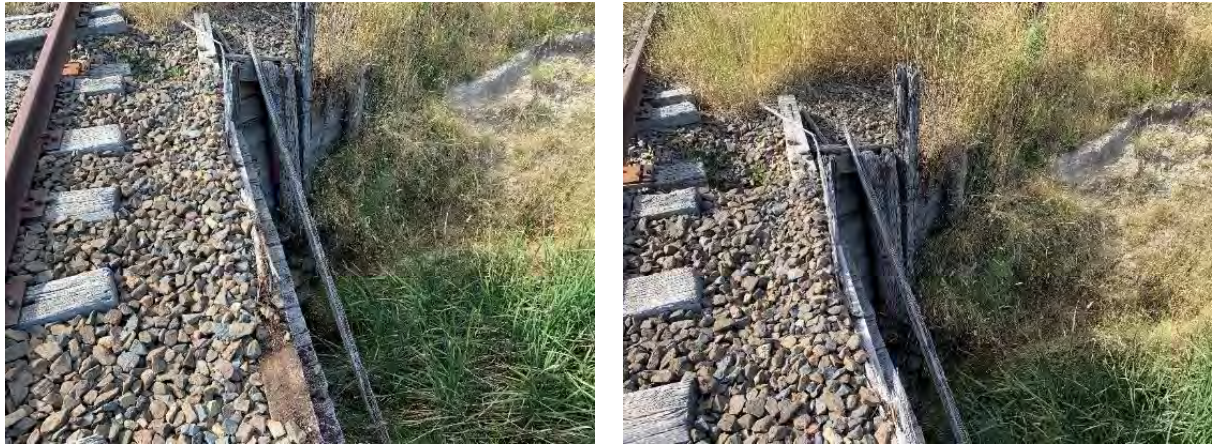
Figure 6-8: View of timber ballast tray side walls, spacing between side walls was 3.5m. Side walls were found to be in very poor condition with significant rot and decay present.

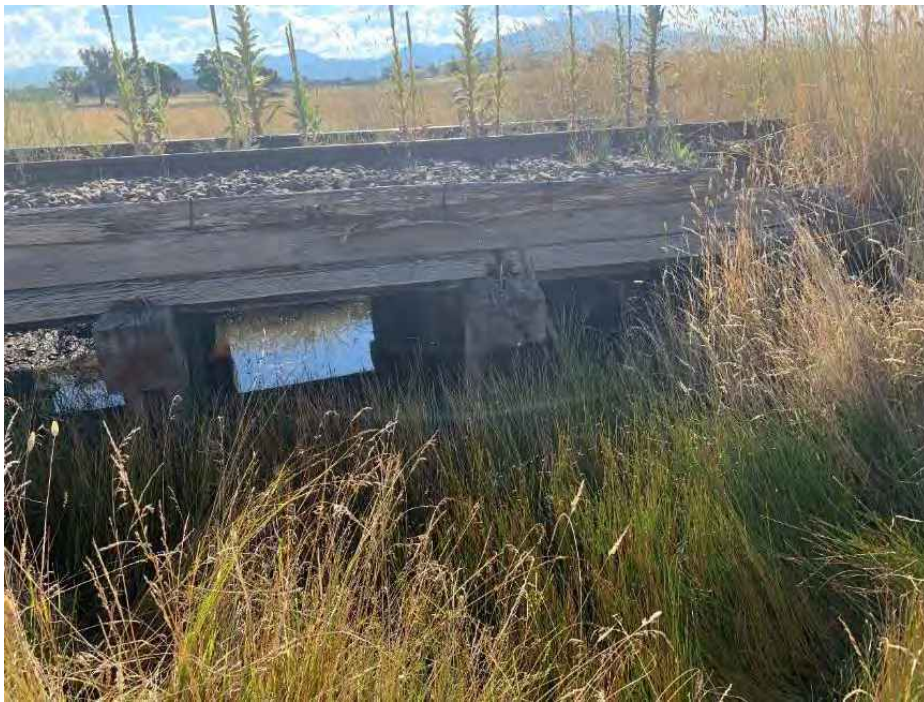
Figure 7-1: The image above shows a general view of the 7m minor bridge (Williamsdale Rd). The consists of 3 spans each span is 2m in length, substructure includes 2 pile bents and 2 abutments that each have 4 driven piles, a pile cap and 4 girders. At the time of inspection there was water approximately 0.5m deep in Spans 1-3. There is a large amount of vegetation growth around the substructure which keeps the moisture content high in the timber. When the moisture level in the timber is above 22%, decay-causing fungi can start to grow; when the moisture content drops below this level, the fungi become dormant, and decay will be arrested until the moisture content rises again.

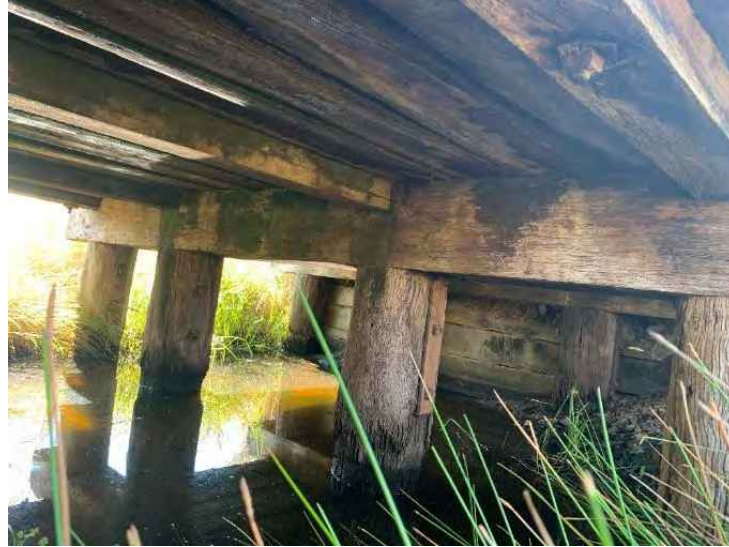
Figure 7-2: Shows the general configuration of the pile bents. Piles are approximately 1m high and in fair condition. Minor deterioration of sapwood is present at water level due to increased moisture content. Water stains and fungal growth present. Note: top plank in abutment sheeting has failed leading to erosion of backfill material.

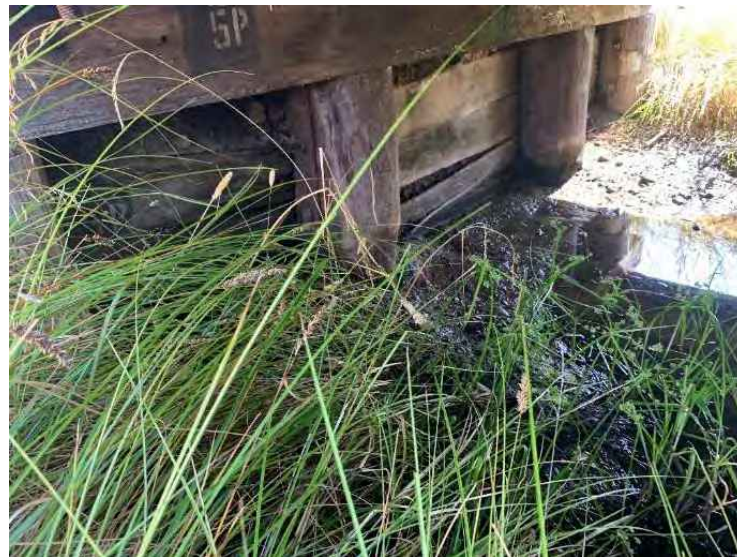
Figure 7-3: View of abutment 2, overall, in a poor condition. Sheeting planks have separated due to spiking to the pile backs in the breast wall, causing loss of fines in the approach fill material through gaps.

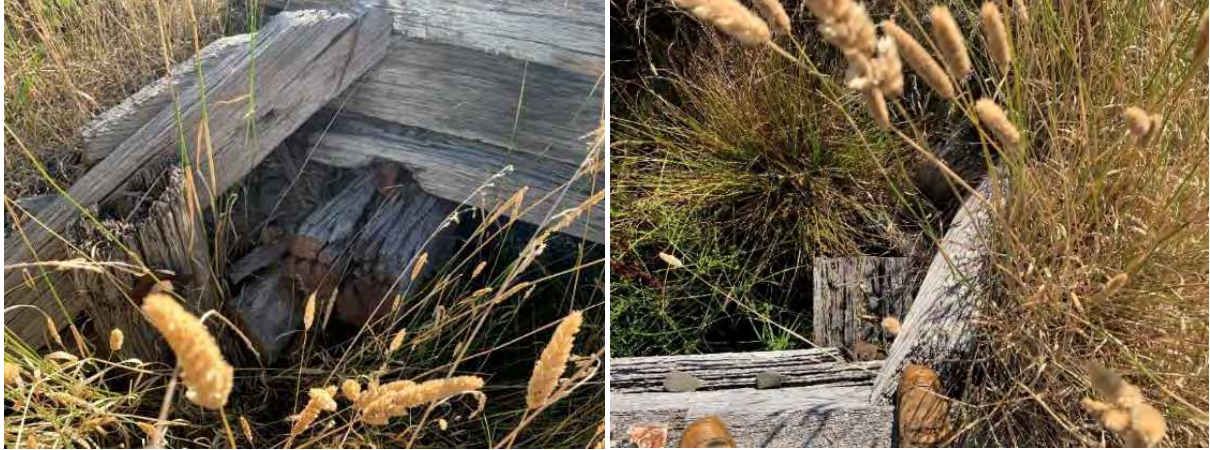
Figure 7-4: Top view of abutment cap connection. Cap is in very poor condition; severe deterioration is present in the ends and at the vertical connection. When a vertical connection is not sealed appropriately it exposes the heart wood to excess moisture accelerating decay. As seen in the photo a large crack is present at the end and a cavity is present at the top of the vertical connection.

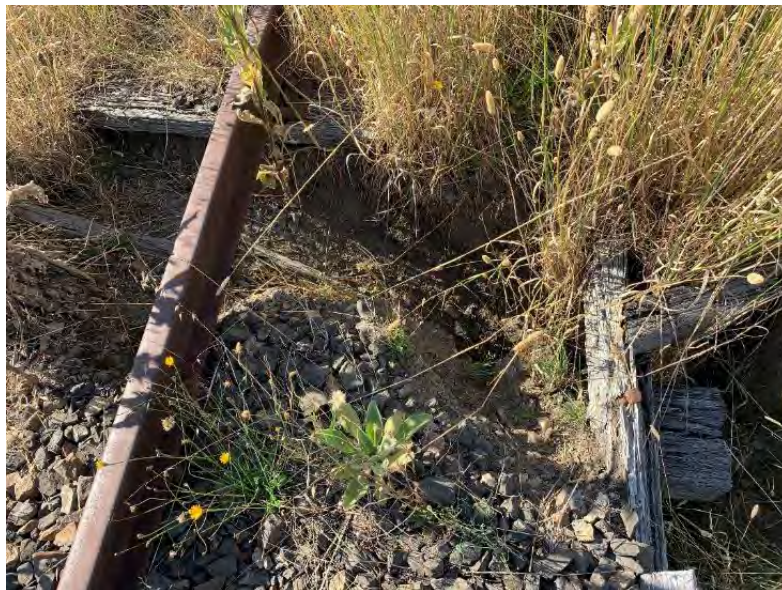
Figure 7-5: Top view of floorboards in the ballast tray at abutment. Large hole caused by abutment/ballast tray failure allowing significant erosion of ballast to occur.

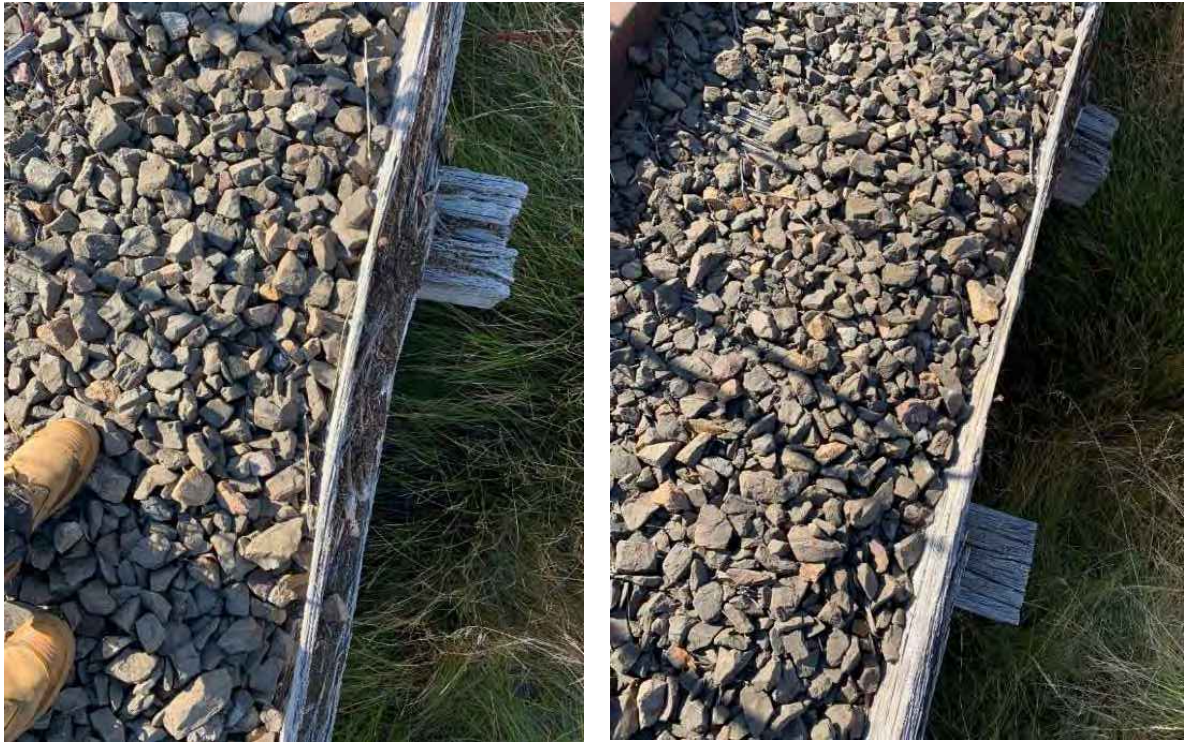
Figure 7-6: Above photos show a ballast tray side wall lengths that have completely rotted away, significantly reducing its ability to retain the ballast material.

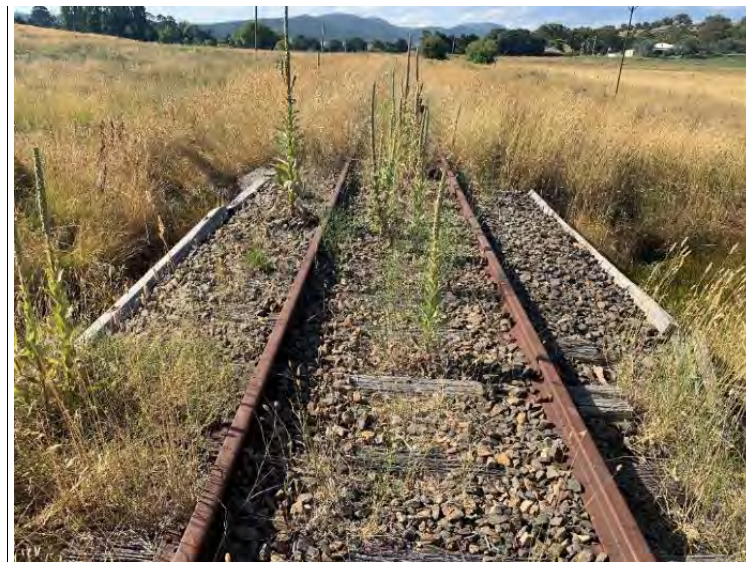
Figure 7-7: The photo above shows the general view down the rail line. Significant overgrown vegetation present through rock ballast and surrounding the substructure. Note: Ballast is 450mm thick.

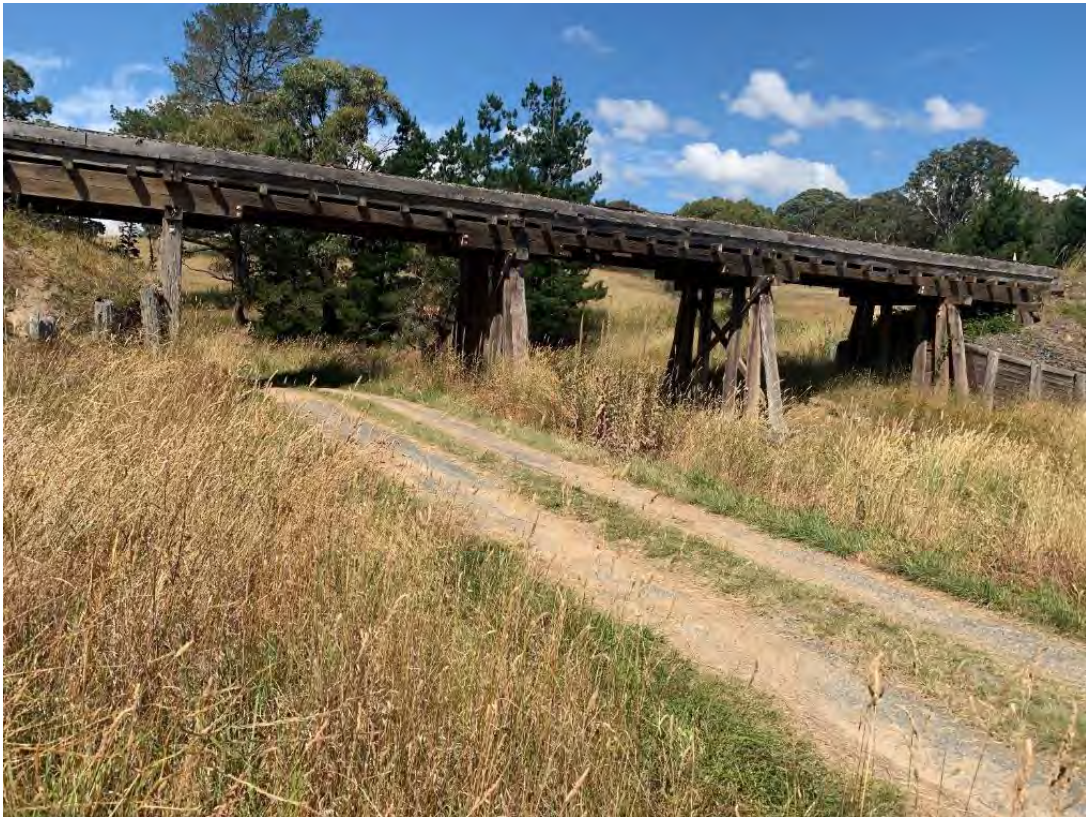
Figure 8-1: General view of Deep Creek Bridge from abutment 1 looking towards abutment 2. The timber bridge is 5 spans long and approximately 32 metres in length (Spans 1 & 5 – 4m and spans 2, 3 and 4 – 8m). Note span 2 passes over the road (4.2m Clearance) and span 3 passes over a creek 2m wide and 0.5m deep.

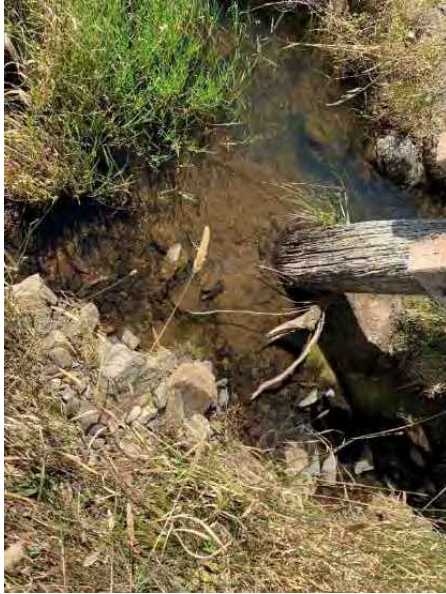
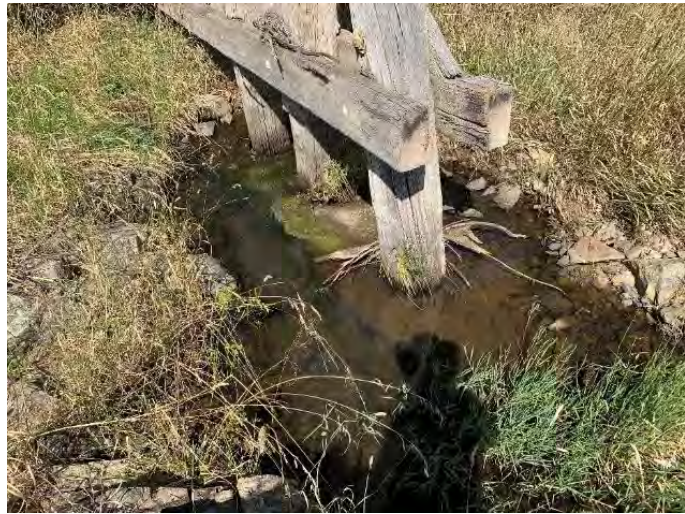
Figure 8-3: General view of pile bent 3 bearing on a concrete sill, piles were found to be in poor to very poor condition. The bottom sections of the timber piles were determined to be a ‘hotspot’ for decay and determined to be an ideal area to test using non-destructive methods, such as EPHOD® Stress Wave Technology. The timber piles were estimated to produce SWT data ranging between 300-1400 μ s. Readings above 700 μ s indicates that there is significant decay present and are required to be monitored. Reading of above 1000 μ s indicate severe decay is present resulting in the member being unable to support its own dead load.

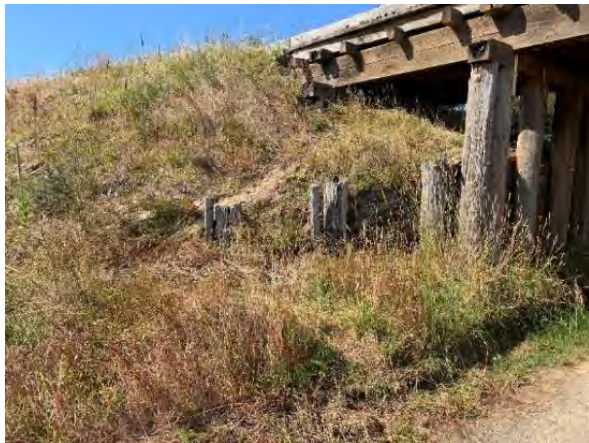
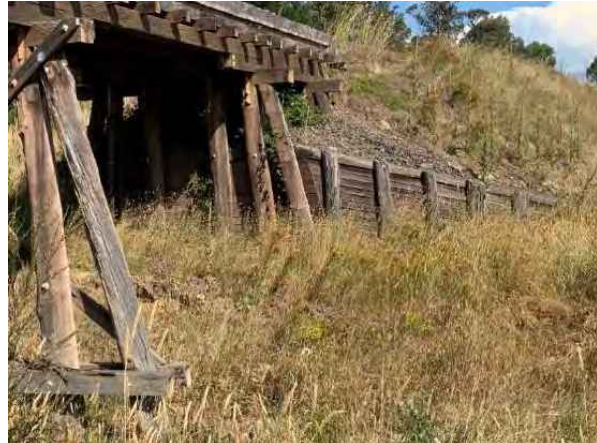
Figure 8-4: The images above show the condition of the breast wall at PB1 & 4. The left photo shows the breast wall at PB1 to be poor to very poor condition with significant decay in timber elements present, surrounding overgrown vegetation and erosion of back fill material. The right image shows the breast wall at PB4 to be in fair to poor condition, it was noted that the back fill material had forced the wall to “lean” forward. Note: Severely decayed batter pile at PB3.

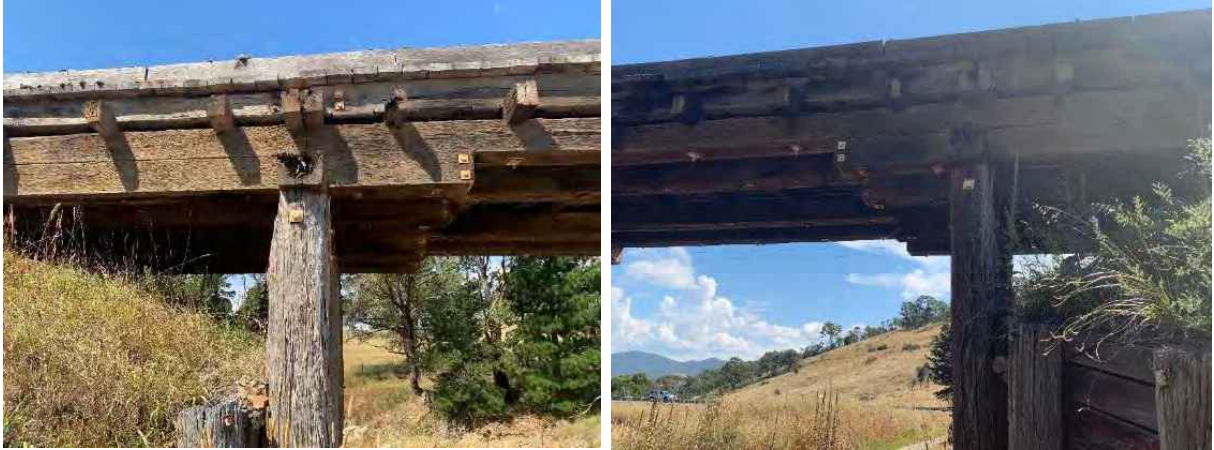
Figure 8-5: View of pile caps at PB1 & 4. Caps were found to be in very poor condition due to the significant cavities present in both ends of each cap. Note: The right photo also shows the backfill from PB4 pushing the breast wall forward.

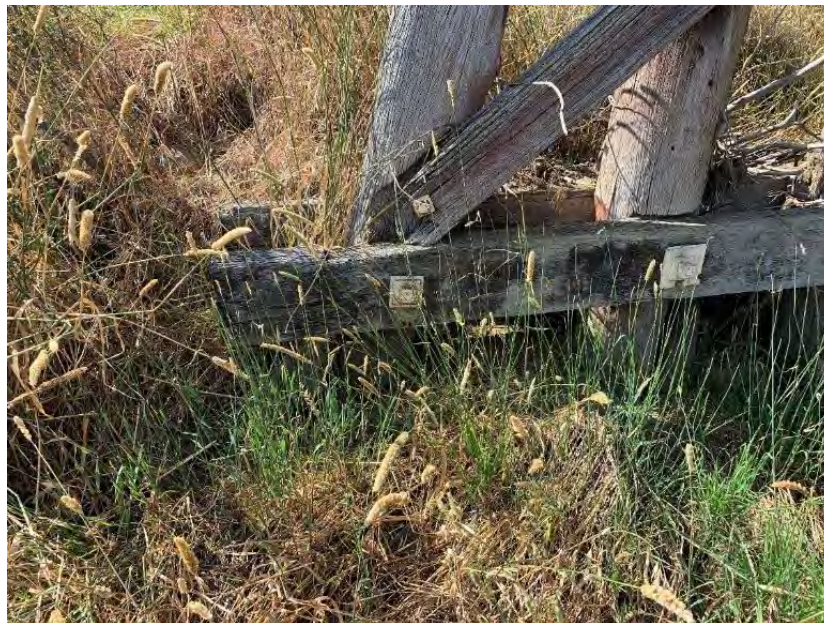
Figure 8-6: A view of a cross bracing plank connection. Plank was found to be in very poor condition as the end has completely decayed away to the connection point. Timber wales were found to be in poor condition with significant water stains and decay present throughout.

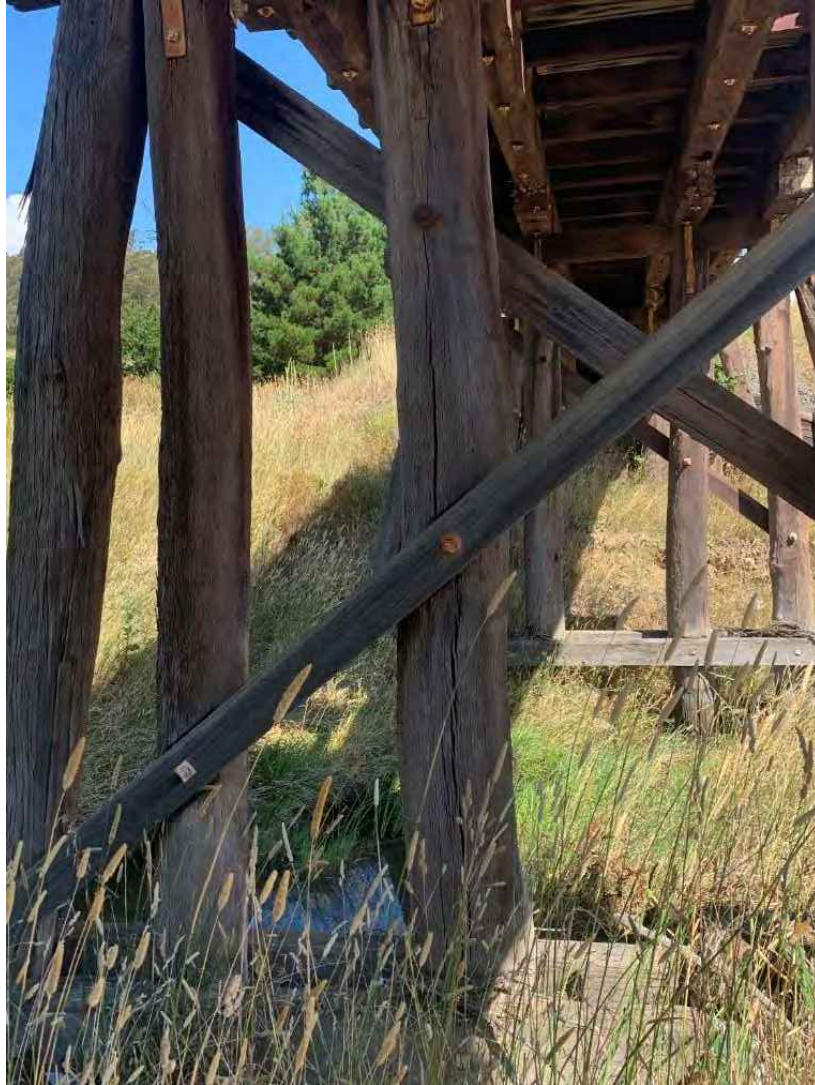
Figure 8-7: View of timber pile and cross bracing connection.

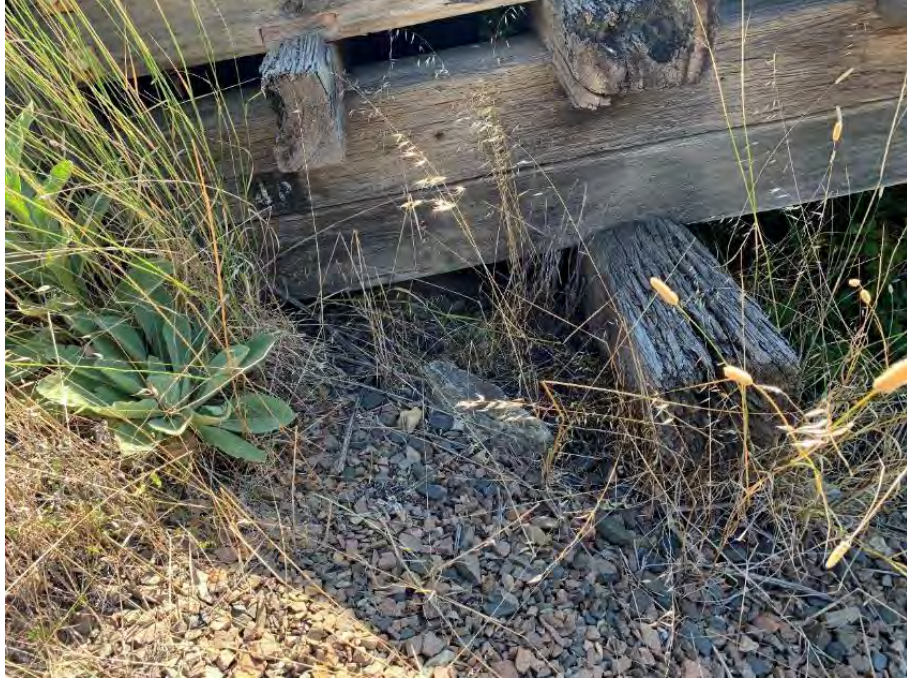
Figure 8-8: View of Abutment cap and spacing logs, cap is in very poor condition due to the large cavity and significant decay present at both ends. Spacing members were found to be in fair to poor condition with sapwood decay and cavities present.

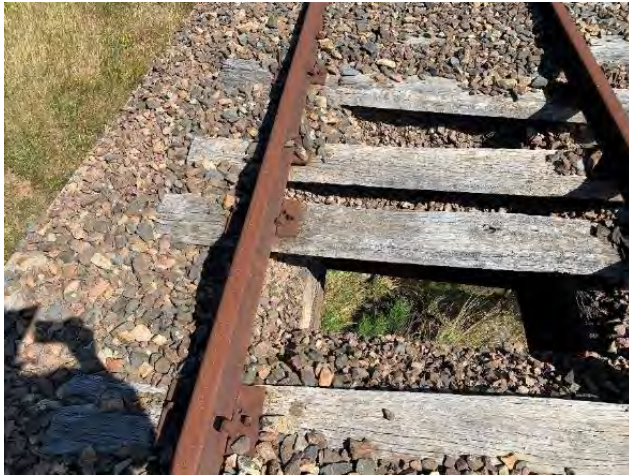
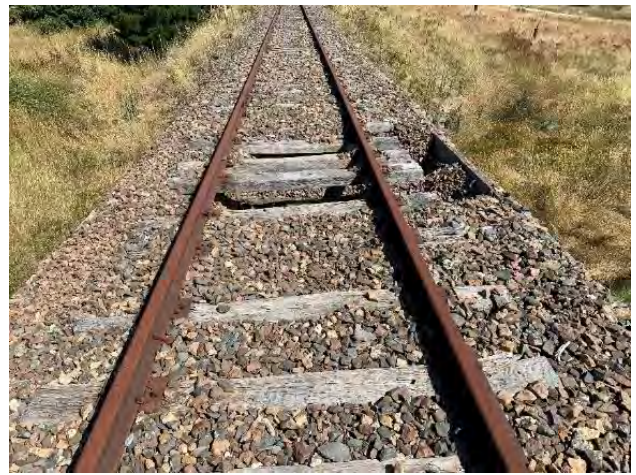
Figure 8-9: Top view of ballast, found to be in very poor condition due to bridge ballast tray floor board degradation and failure leading to a significant hole in the ballast. Transoms appear to be in fair to poor condition with no major decay or defects present.

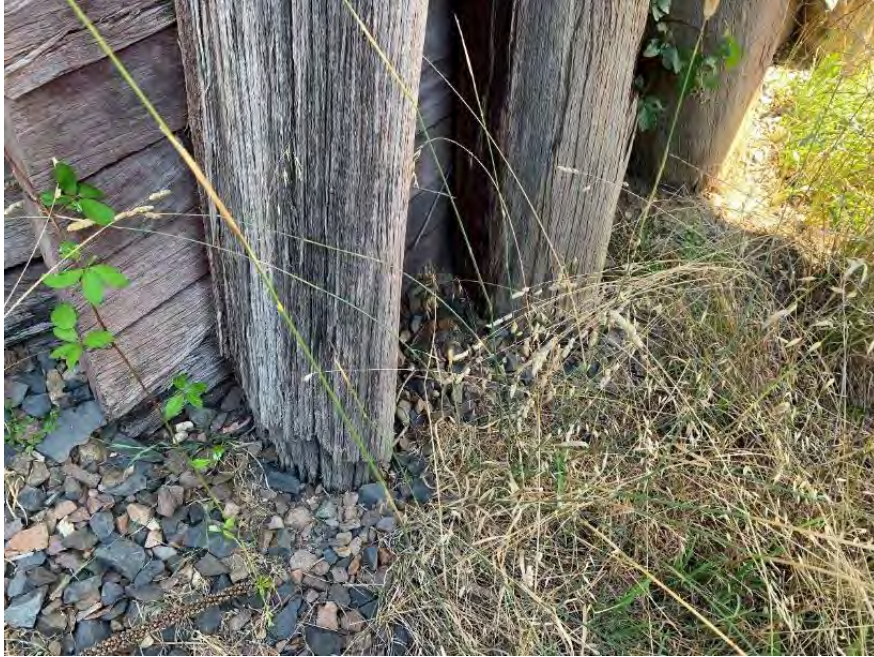
Figure 8-10: View of pile at PB4. Pile was found to be in very poor condition with significant decay present. Decay of approximately 50% of the cross section.

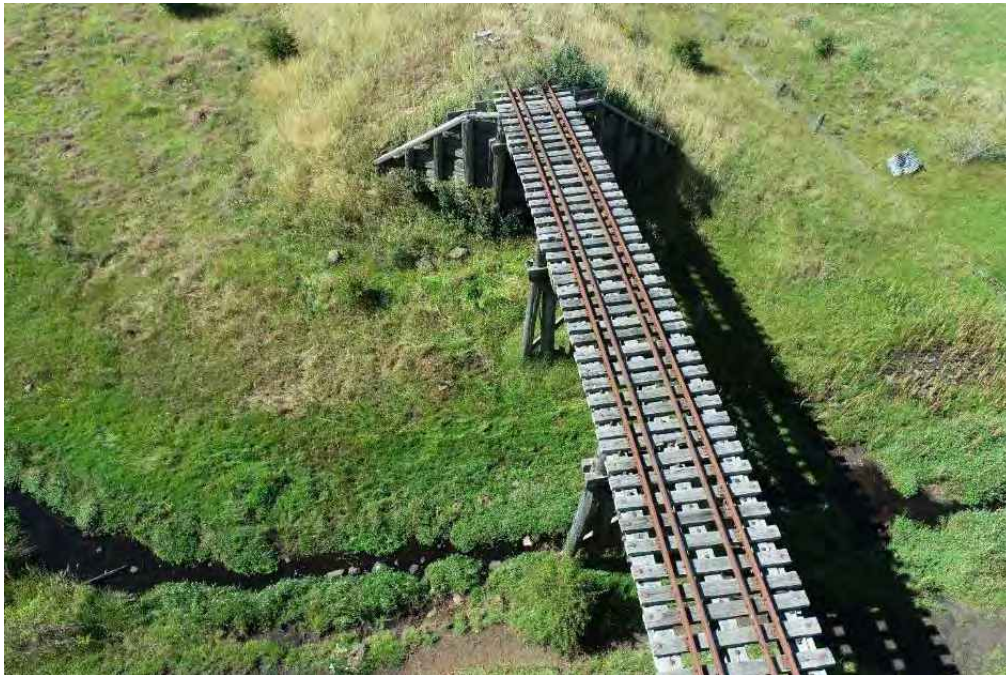
Figure 9-1: General view of Bobundara Creek Bridge from abutment 1 looking towards abutment 2. The timber bridge is 3 spans long and approximately 22.5 metres in length (7.5m spans). Note Bobundara creek runs underneath span 2 and is approximately 1m wide and 1ft deep. note the inner guard rail to prevent derailment leading to the train going off the bridge when train operations were occurring.

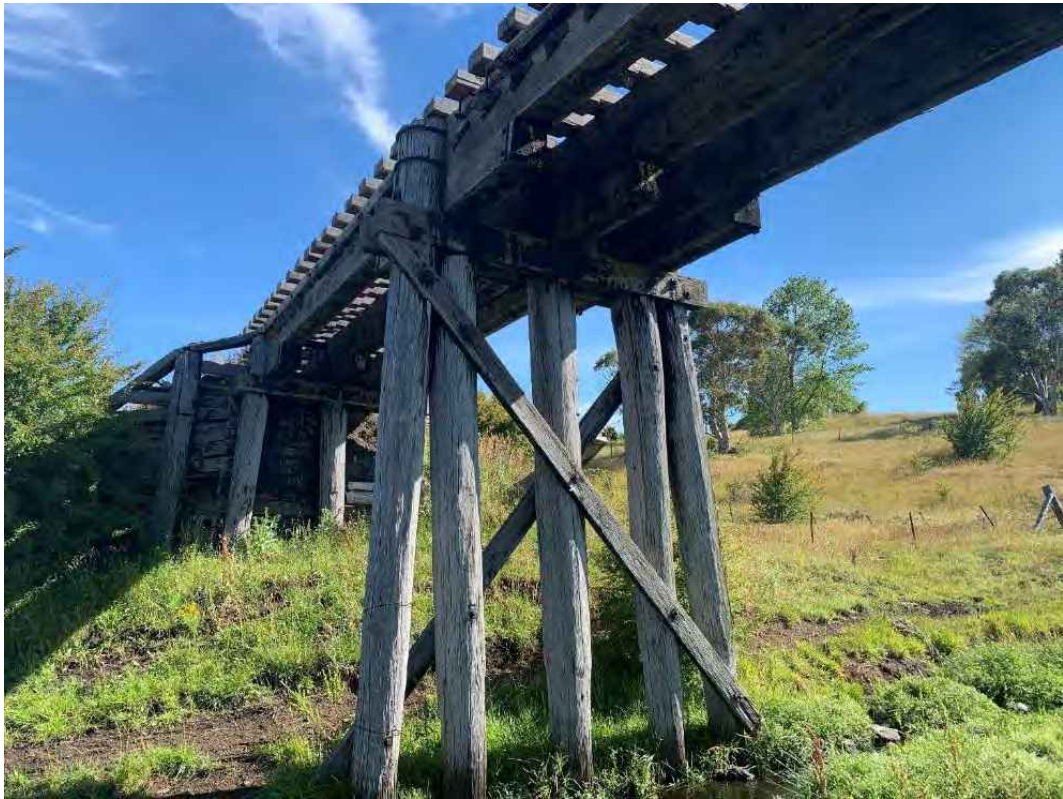
Figure 9-2: View of the timber pile bents configuration. PB 2 and 3 comprise of 5 driven piles (3 Plum piles directly under the girders and 2 batter piles on either side). Pile bent 2 and 3 are supported by cross bracing. The two abutments do not contain the cross bracing and are support by timber sheeting to retain backfill. It was noted that the bottom section of several posts has started to undergo decay. This can be expected due to the timber posts being exposed to increased moisture in overgrown vegetation, debris, and the nearby creek. Once the moisture content in the timber elements reaches 22%, decay causing fungi are activated and the decay process begins. Overall, the timber bents were found to range from poor to very poor condition.

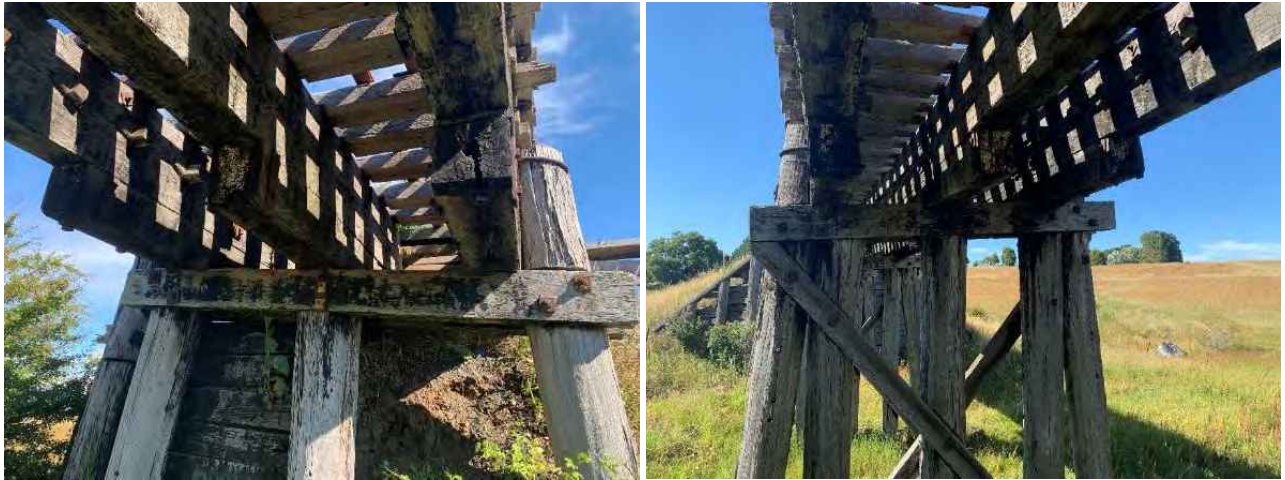
Figure 9-3: The images above show the substructure configuration. It is seen that double stacked girders have been used in addition to split headstocks and corbels. Both images show significant water stains and decaying of corbel ends. The left image identifies a large cavity present in the end of corbel 1 AB1. It was noted that AB1 sheeting has failed.

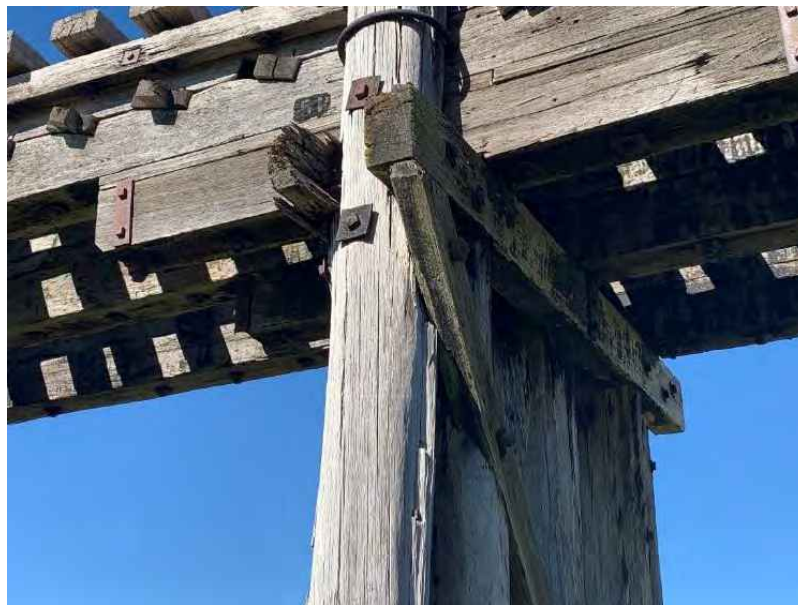
Figure 9-4: The images above show the condition of the split headstocks. The majority of headstocks were found to be in poor to very poor condition. The left member in the image above is completely decayed through the end and in very poor condition.

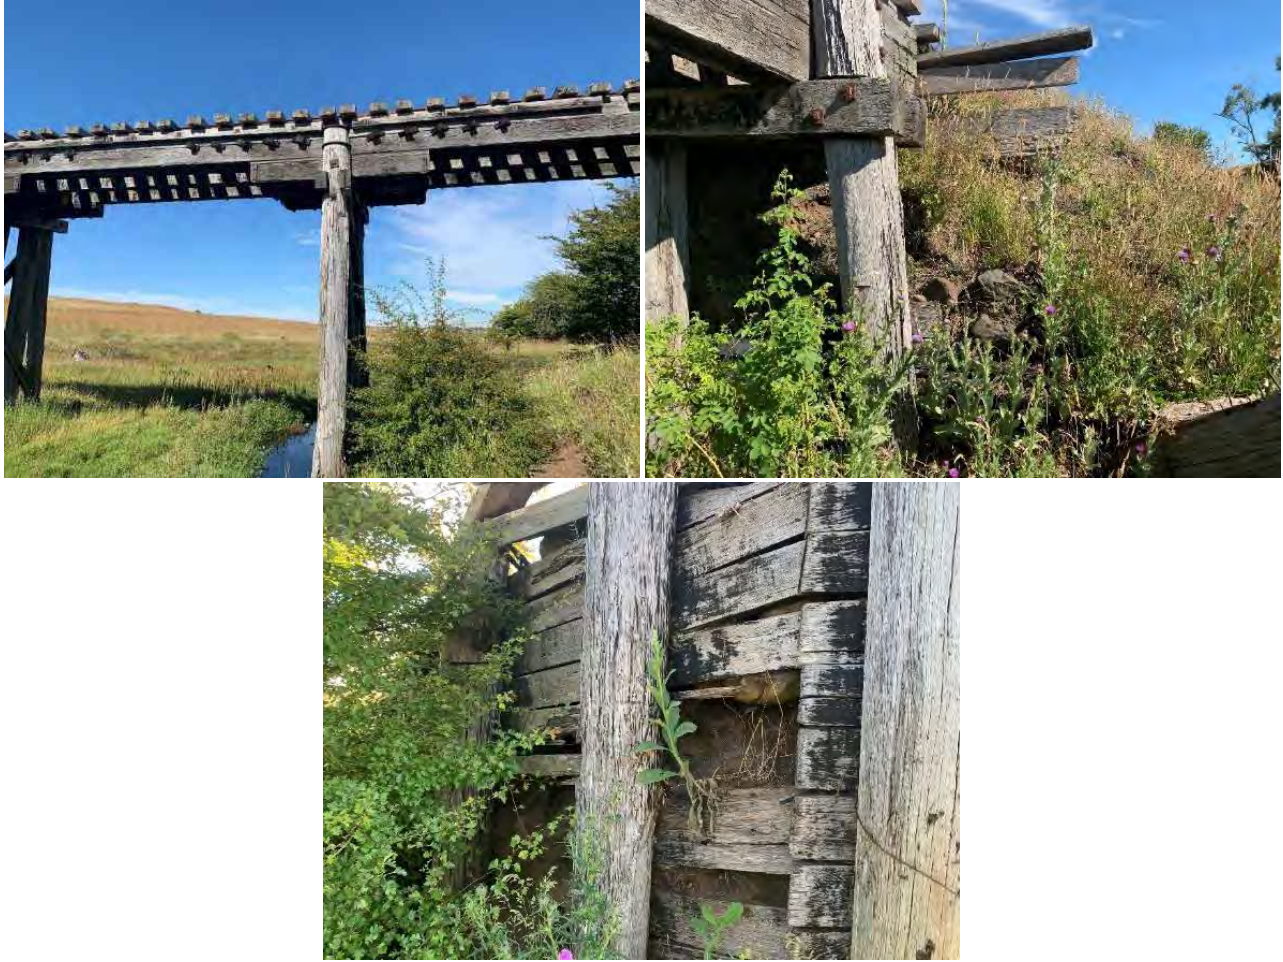
Figure 9-5: Large amounts of sapwood decay is present throughout the structure piles. It is recommended that this is monitored and removed appropriately.

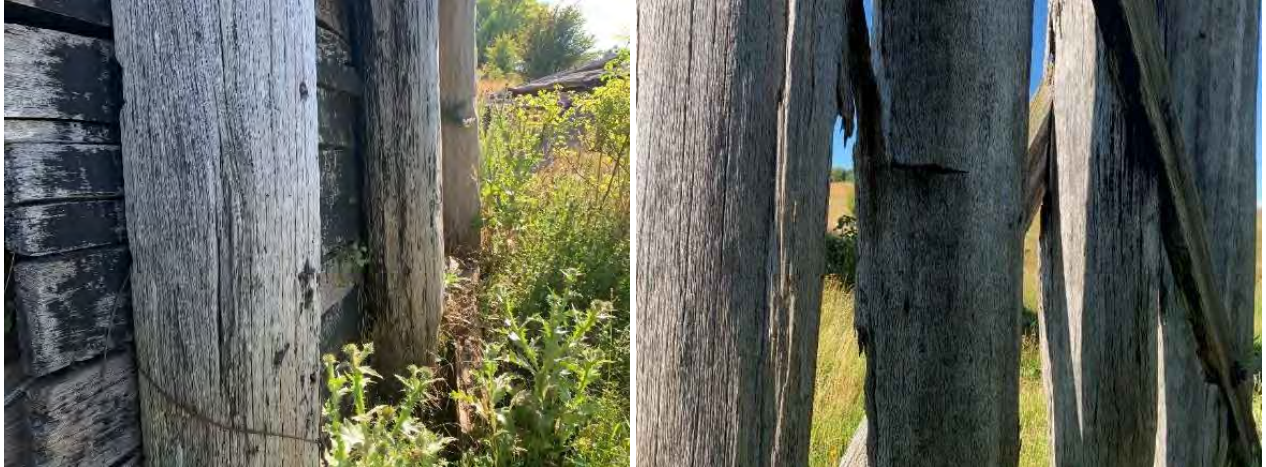
Figure 9-6: A view of two pile defects located at AB1 and PB2. The left image shows decay of sapwood forming a vertical cavity. The right image shows significant deterioration of sapwood (Peeling off).

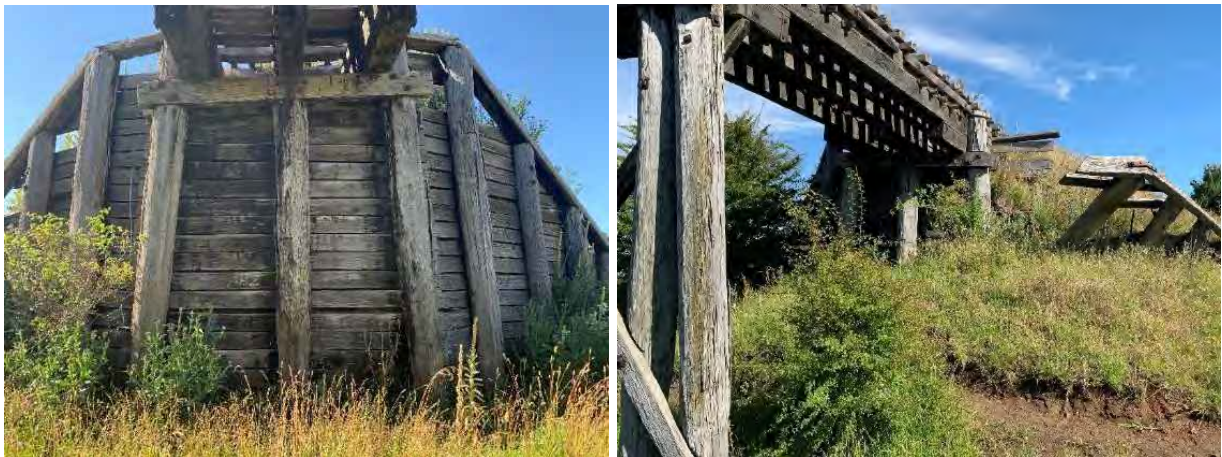
Figure 9-7: View of Abutment 1 and 2 and respective wingwalls. Abutment 1 breast/wingwall was found to be in poor condition due to the missing members and gaps between planks causing erosion of backfill. Abutment 2 was found to be in very poor condition with missing elements throughout and the right side wingwall had failed (collapsed).

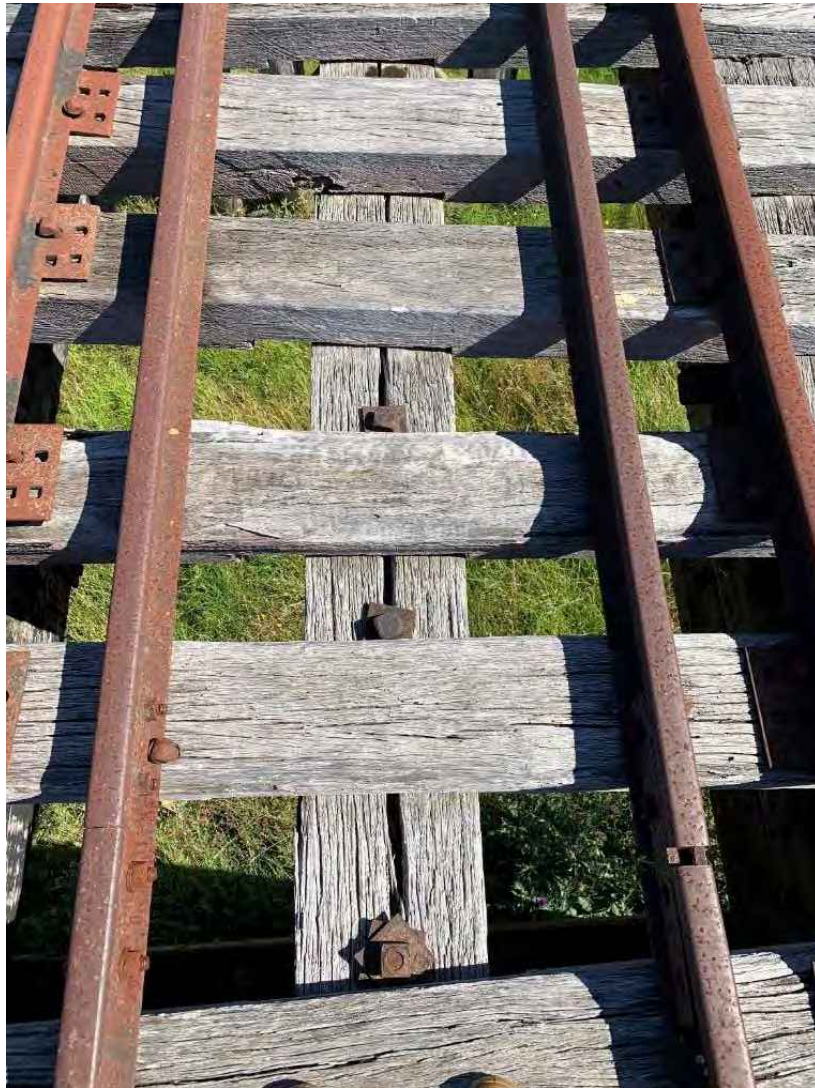
Figure 9-8: Top view of bridge surface, found to be in poor to very poor condition due to major vertical crack through the middle girder and major decay present in all other girder lengths. Vertical connections expose the bright wood to weathering and funnel watering, this leads to accelerated decay and higher moisture content. Transoms appear to be in fair to poor condition with no major decay or defects present. Note the smaller guard inner guard rail on this open deck railway bridge

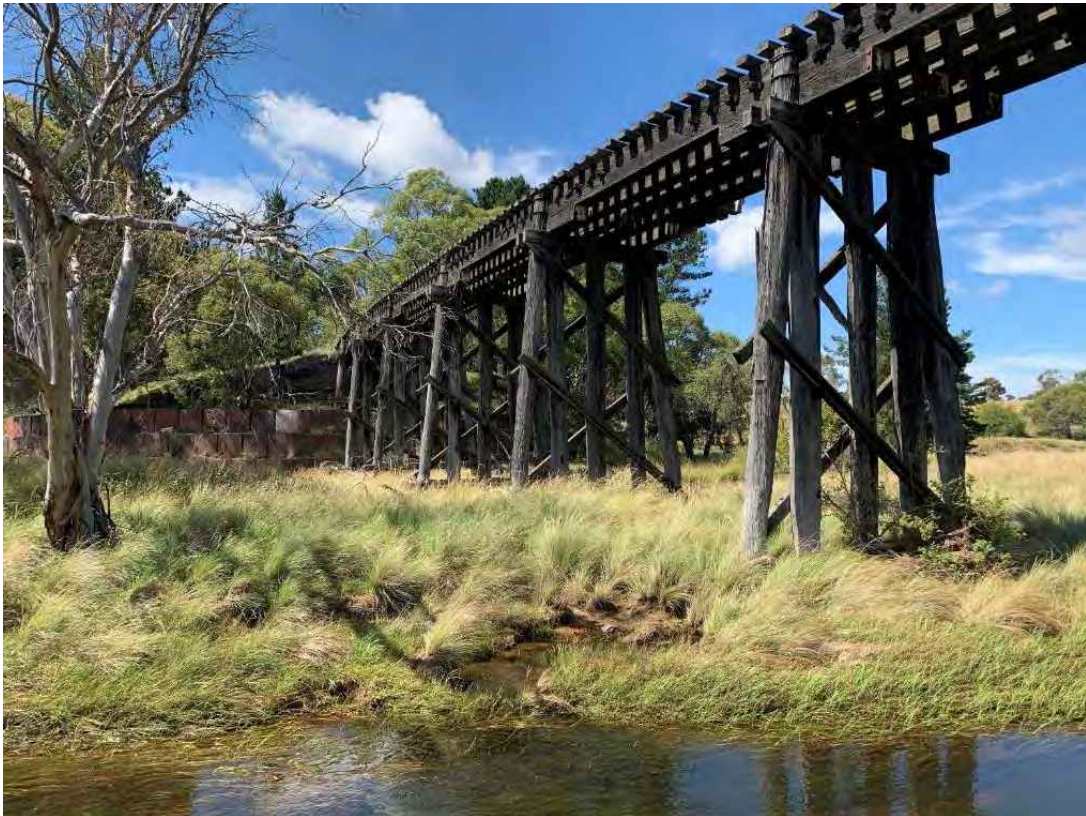
Figure 10-1: General view of MacLaughlin River Bridge from abutment 2 looking towards abutment 1. The timber bridge is 8 spans long and approximately 60 metres in length (7.5-8m spans). Note MacLaughlin River runs underneath span 3 and is approximately 3m wide and 0.7m deep. It was also noted that the bridge curved left and had appropriate camber. Note the double cross bracing on the bents as well the absence of a sash brace.

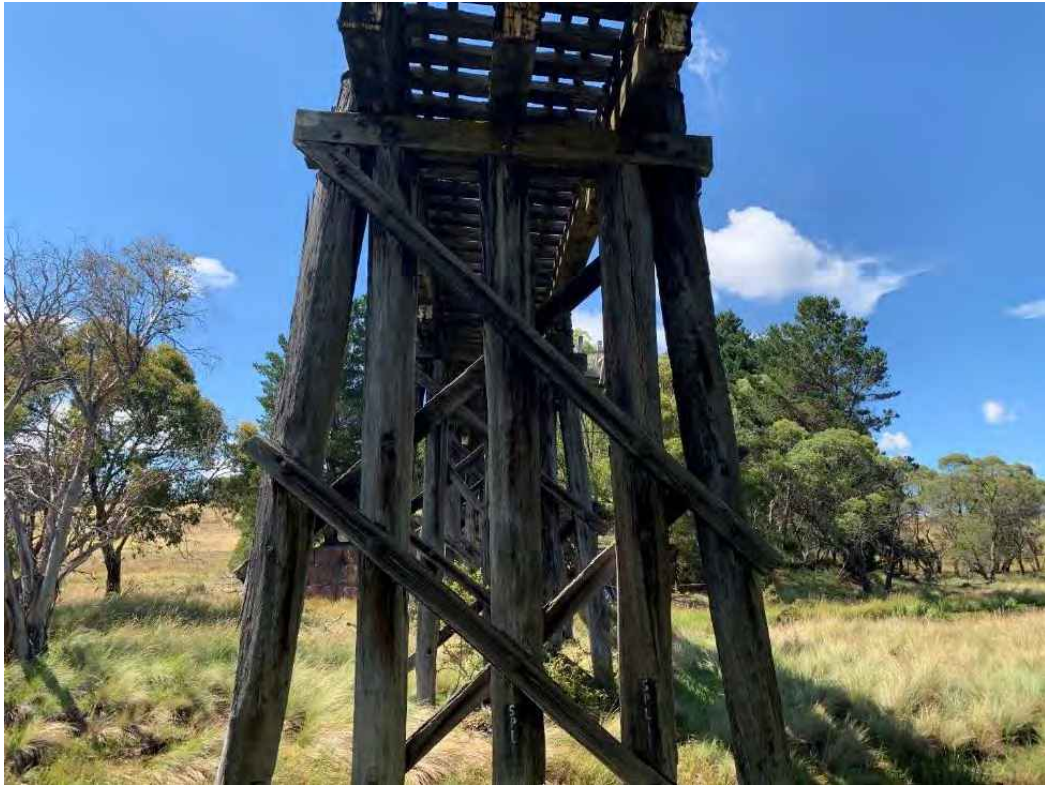
Figure 10-2: View of the timber pile bents configuration. Each pile bent comprises of 5 driven piles (3 Plum piles directly under the girders and 2 batter piles on either side) and are supported by double cross bracing (“X” at top and bottom of piles) and timber wales at the bottom. The two abutments do not contain the cross bracing and only exhibit 3 plum piles. It was noted that significant water stains were present on all timber members of each pile bent. This indicates a high moisture content, when timber elements reach 22%, decay causing fungi are activated and the decay process begins. Overall, the timber bents were found to range from fair to poor condition. Sapwood decay is present at on the piles within the image above. Note that the cross braces do not go all the way to the head stocks.

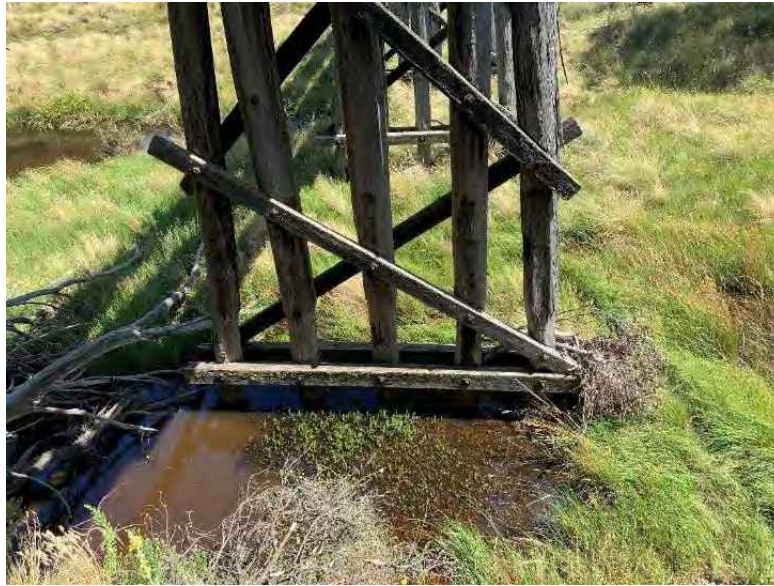
Figure 10-3: Significant decay is present on all piles in above image. Large decrease in pile cross-section on the bottom end of the piles located in the river (Body of water). Debris is caught up in the wales and surrounding areas of pile bents. It is recommended that deteriorated sapwood be removed appropriately.

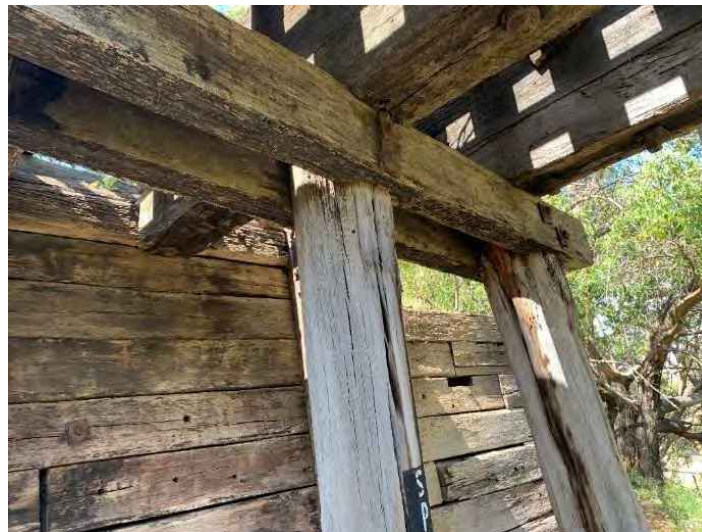
Figure 10-4: The images above show the condition of the split headstocks and the abutment breast wall. The headstocks were found to be in poor to very poor condition, exhibiting significant decay. The breast wall is in poor condition with missing members and weathered elements with splits and cracking throughout. Note: major vertical crack down middle pile exposing bright wood and accelerating decay. Typically, these decay cracks are initiated by fastener systems

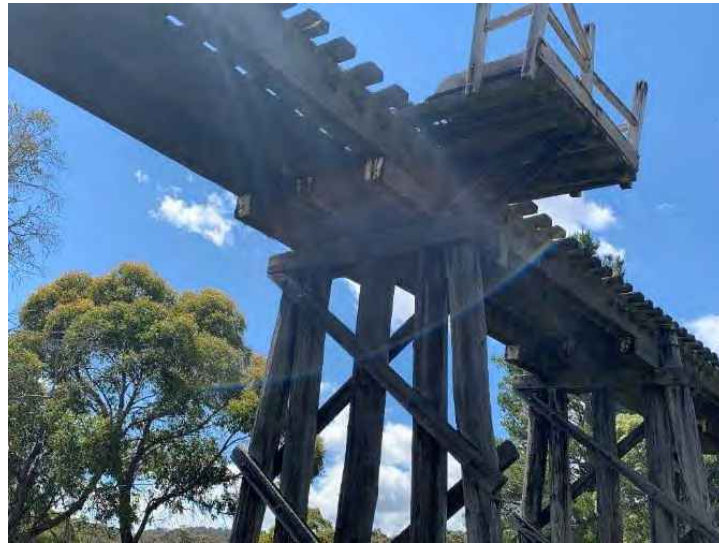
Figure 10-5: View of the walk out standing platform. Platform appears to be in poor to very poor condition with missing/failed members. This would not be safe to stand on. All timber appears to exhibit significant decay.
