Ordinary Meeting of Council

12 February 2025

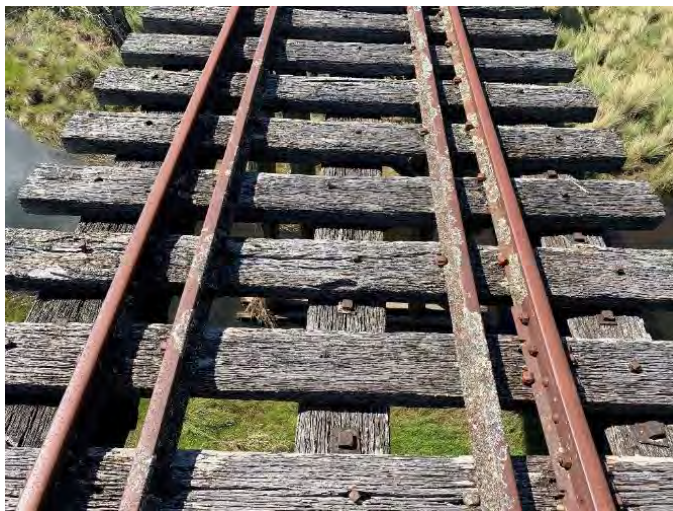
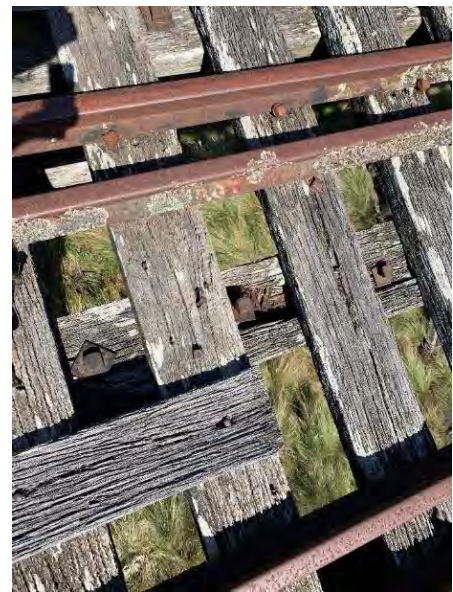
Figure 10-6: Top view of bridge open deck. Transoms and girders can be seen to be in poor to very poor condition, with significant deterioration present in all elements. This is seen to be caused by the vertical connections used in construction. If not sealed appropriately they are seen to funnel water and become moisture traps, when moisture content within timber exceeds 22%, decay causing fungi are activated and the decay process begins. Note: Large cavity around vertical connection in right side photo.

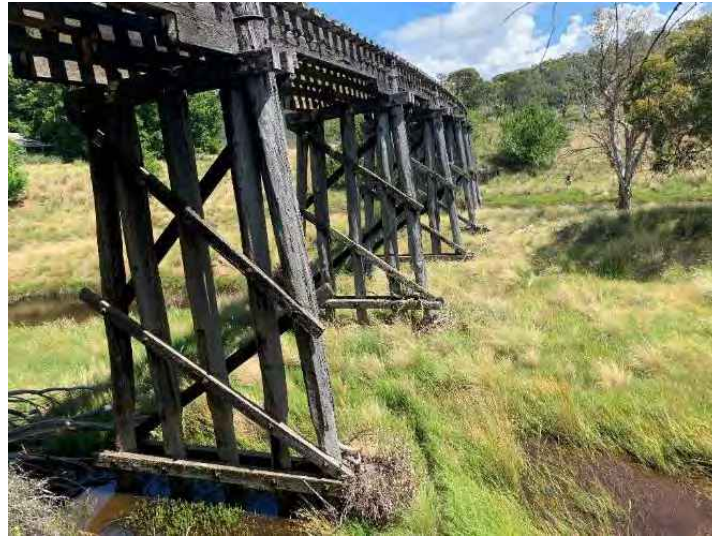
Figure 10-7: Above image shows the left curve and camber in the bridge. The bent configuration is also highlighted, it was noted that significant overgrown vegetation and debris build up was present at the base of all bents. This increases moisture retention leading to accelerated decay of the lower timber elements.

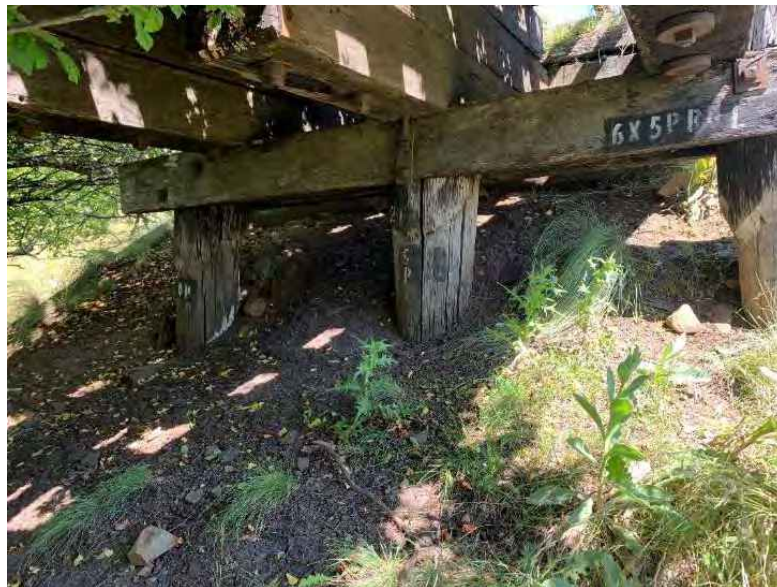
Figure 10-8: View of abutment 2 configuration, the abutment was found to be in poor condition with significant decay present. It was noted that the left two piles had large vertical splits in them, whilst the right pile had significant decay of sapwood.

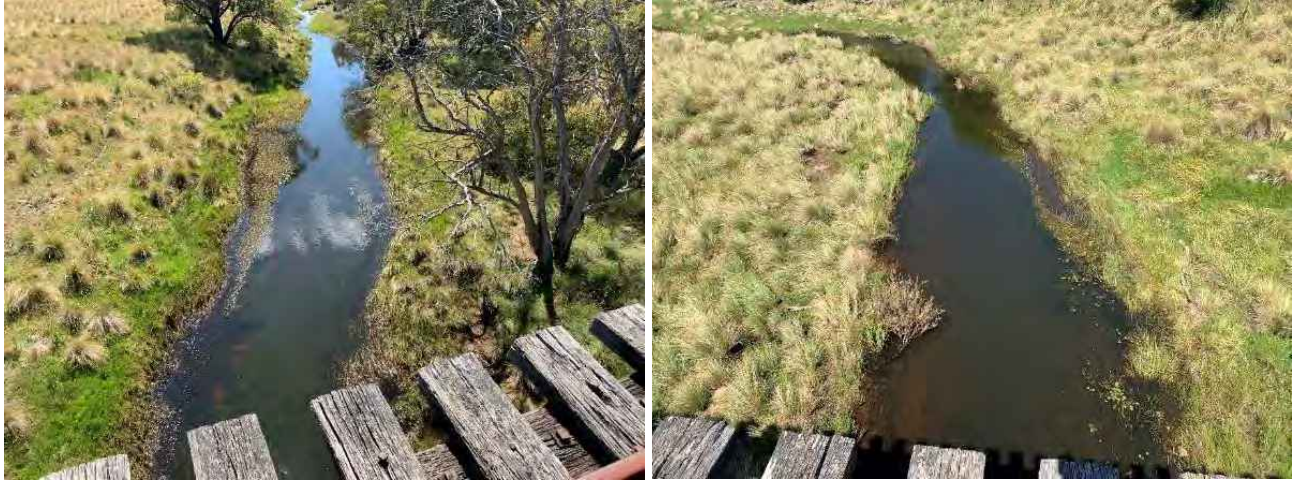
Figure 10-9: Left side image shows the view looking upstream and the right-side image shows the view downstream of the bridge of the edge of the open deck bridge.

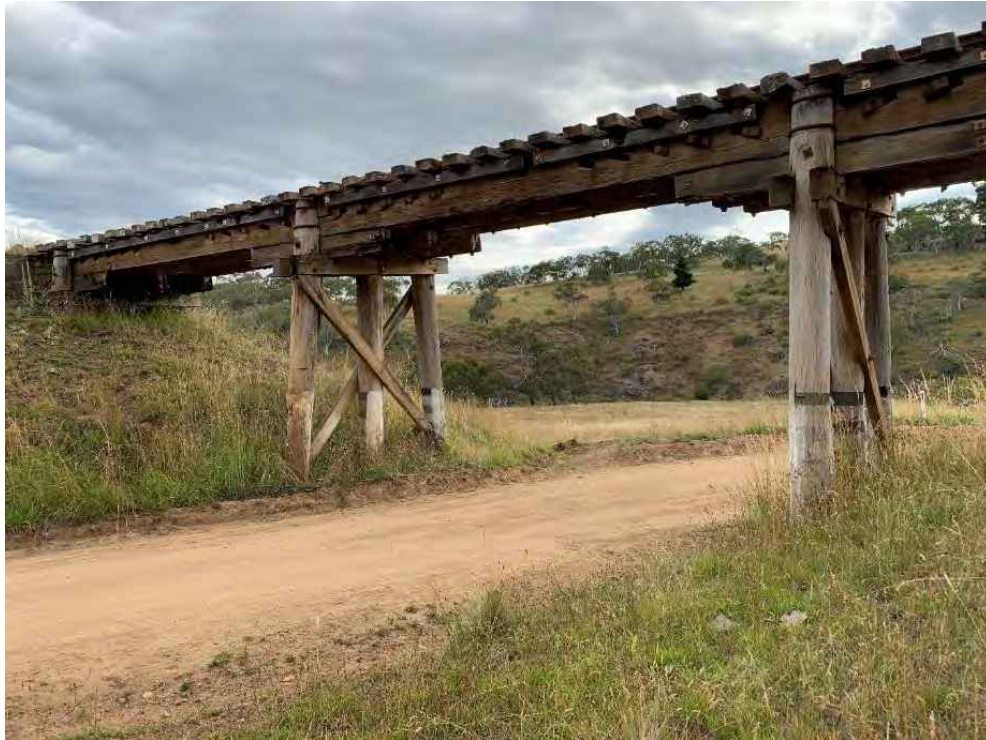
Figure 11-1: General view of Old Bombala Rd Bridge from abutment 1 looking towards abutment 2. The timber bridge is 3 spans long and approximately 22 metres in length (Sp1=7.8m, SP2=6.8m & SP3=6.6m). Note span 2 passes over the road (4.1m Clearance).

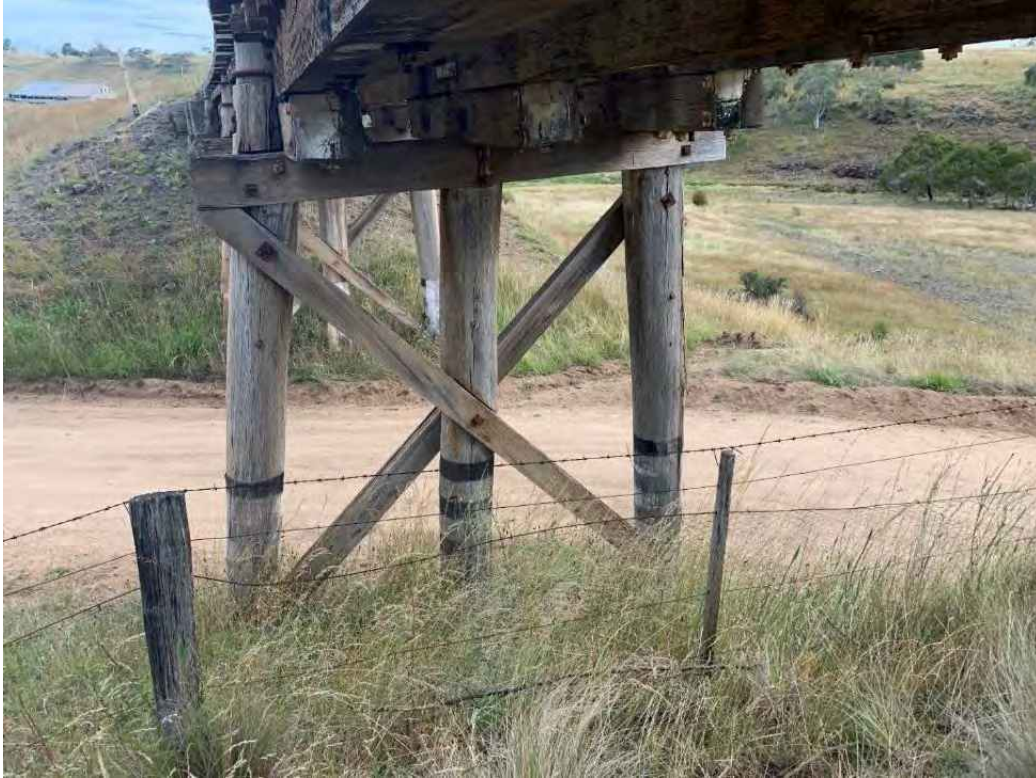
Figure 11-2: View of pile bent 1 configuration. The bents comprise of 3 driven piles. Pile bent 2 and 3 are supported by cross bracing. The two abutments do not contain the cross bracing but are supported by sheeting planks to retain backfill. It was noted that several piles and headstocks have started to undergo decay. It can be seen on pile 3 significant sapwood decay occurring.

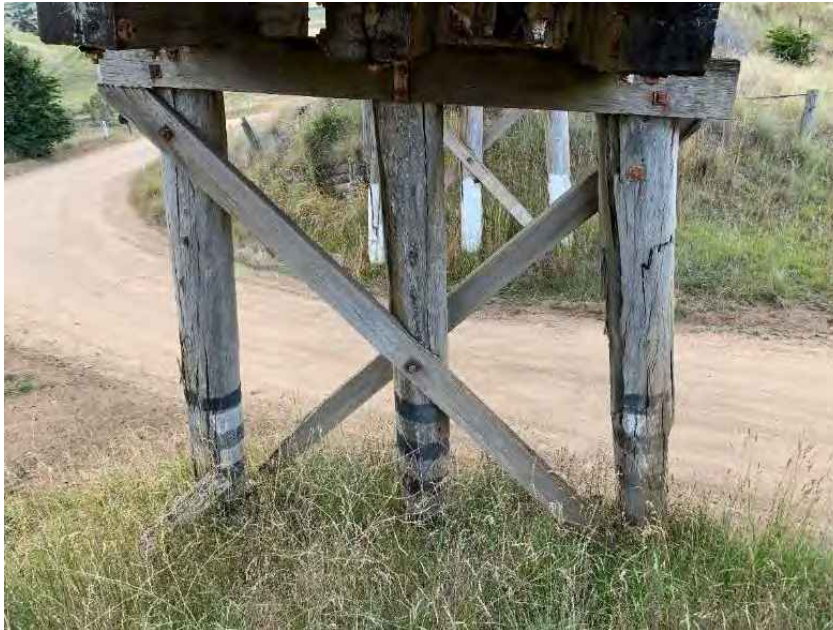
Figure 11-3: General view of pile bent 2. piles were found to be in poor condition. With significant sapwood decay present in all piles, it was noted that all piles have large vertical splits through the horizontal connections. The bottom sections of the timber piles were determined to be a ‘hotspot’ for decay due to increased moisture retained by the overgrown vegetation.

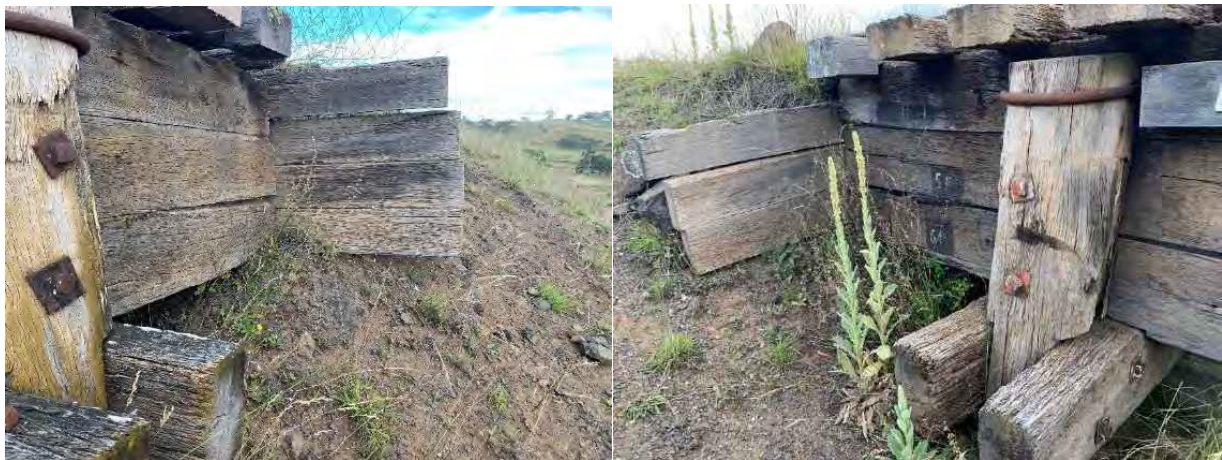
Figure 11-4: The images above show the condition of the breast wall at AB2. The abutment sheeting was found to be in fair condition with minor decay of the sapwood present. The headstock ends were in poor condition with decay and cracking present.

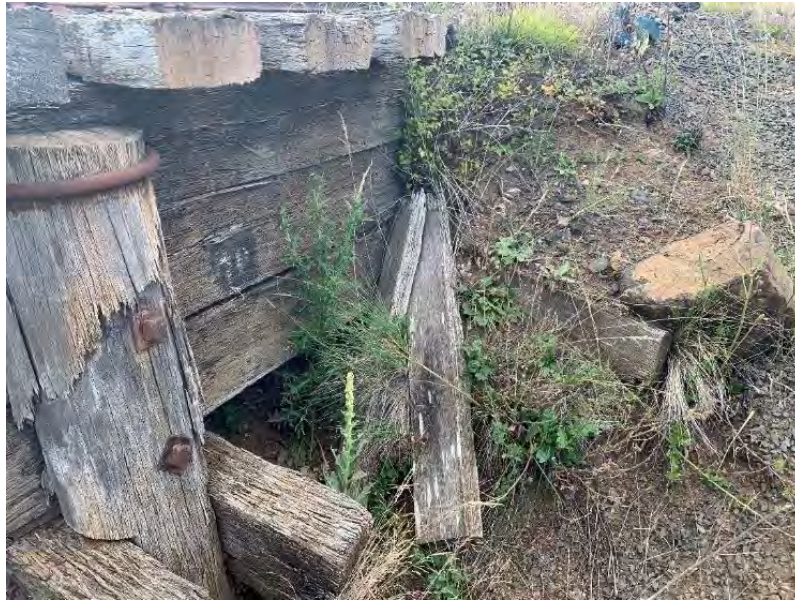
Figure 11-5: View of abutment 1, found to be in poor condition with major decay of sapwood present in piles and broken/missing elements in abutment sheeting.

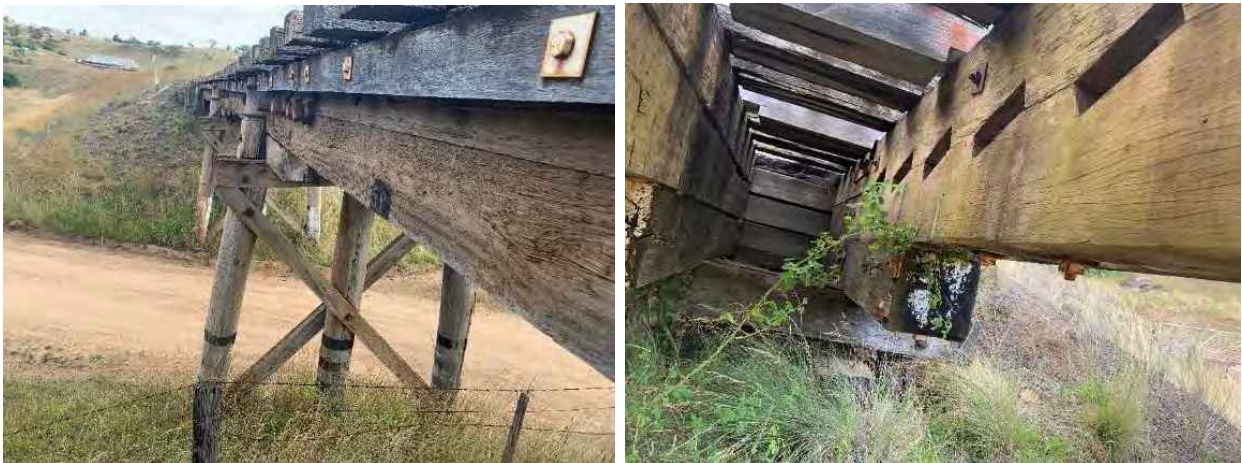
Figure 11-6: A view of girders formation and condition. Girders were found to be in fair to poor condition, the left photo shows a horizontal crack that is seen to be progressively increasing in size. The right photo shows sapwood decay of the internal girders.

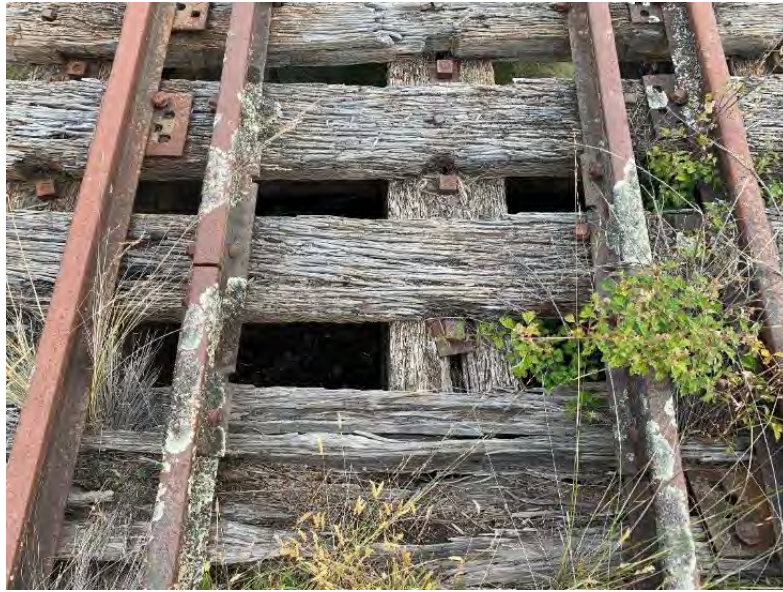
Figure 11-7: View of the bridge open deck, transverse sleepers were found to be in poor to very poor condition with significant decay, cavities and severely damaged members present throughout. It was noted that the vertical connections to the top girders were seen to funnel moisture and increase the moisture content present in both elements causes significant decay. When the moisture content exceeds 22%, timber consuming fungi are activated, and the decay process begins. Top girders were found to be in poor to very poor condition.

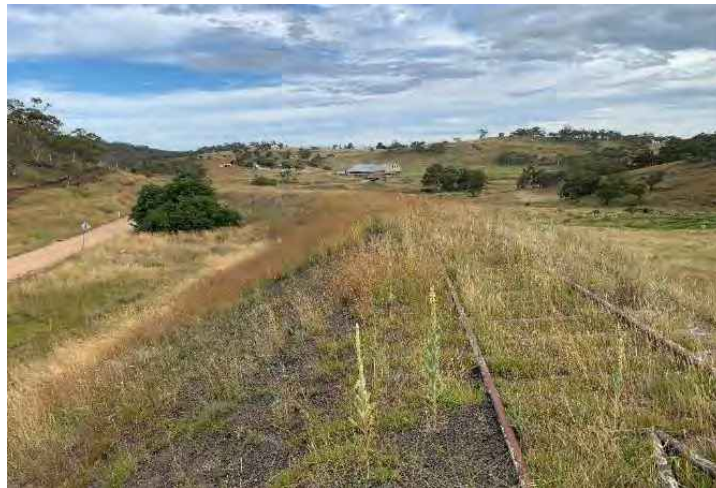
Figure 11-8: View of overgrown approach.

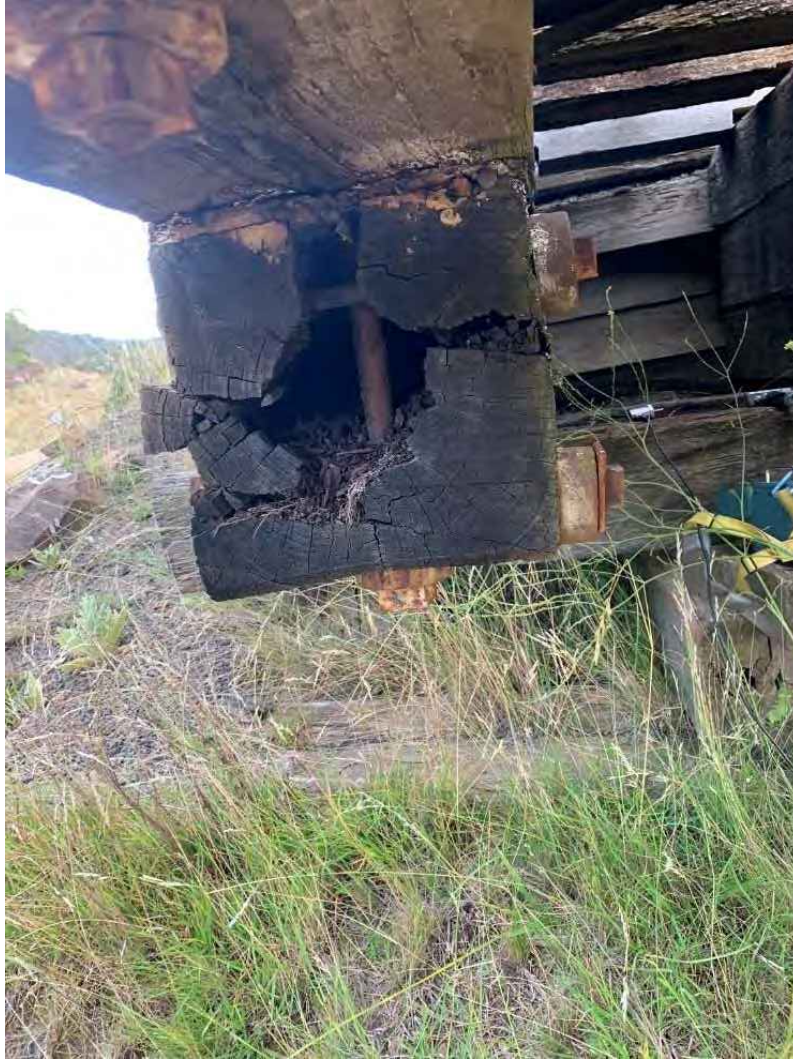
Figure 11-9: View of corbel 3 at abutment 1, Corbel was found to be in very poor condition with a large cavity present in the end. The vertical connection is visible highlighting the depth. The corbel needs replacement due to multiple failure points. Note the vertical fastener has split the corbel and the anti-splitter bolts have done the same thing. So many of these old details contributed to higher maintenance costs and reduced longevity.

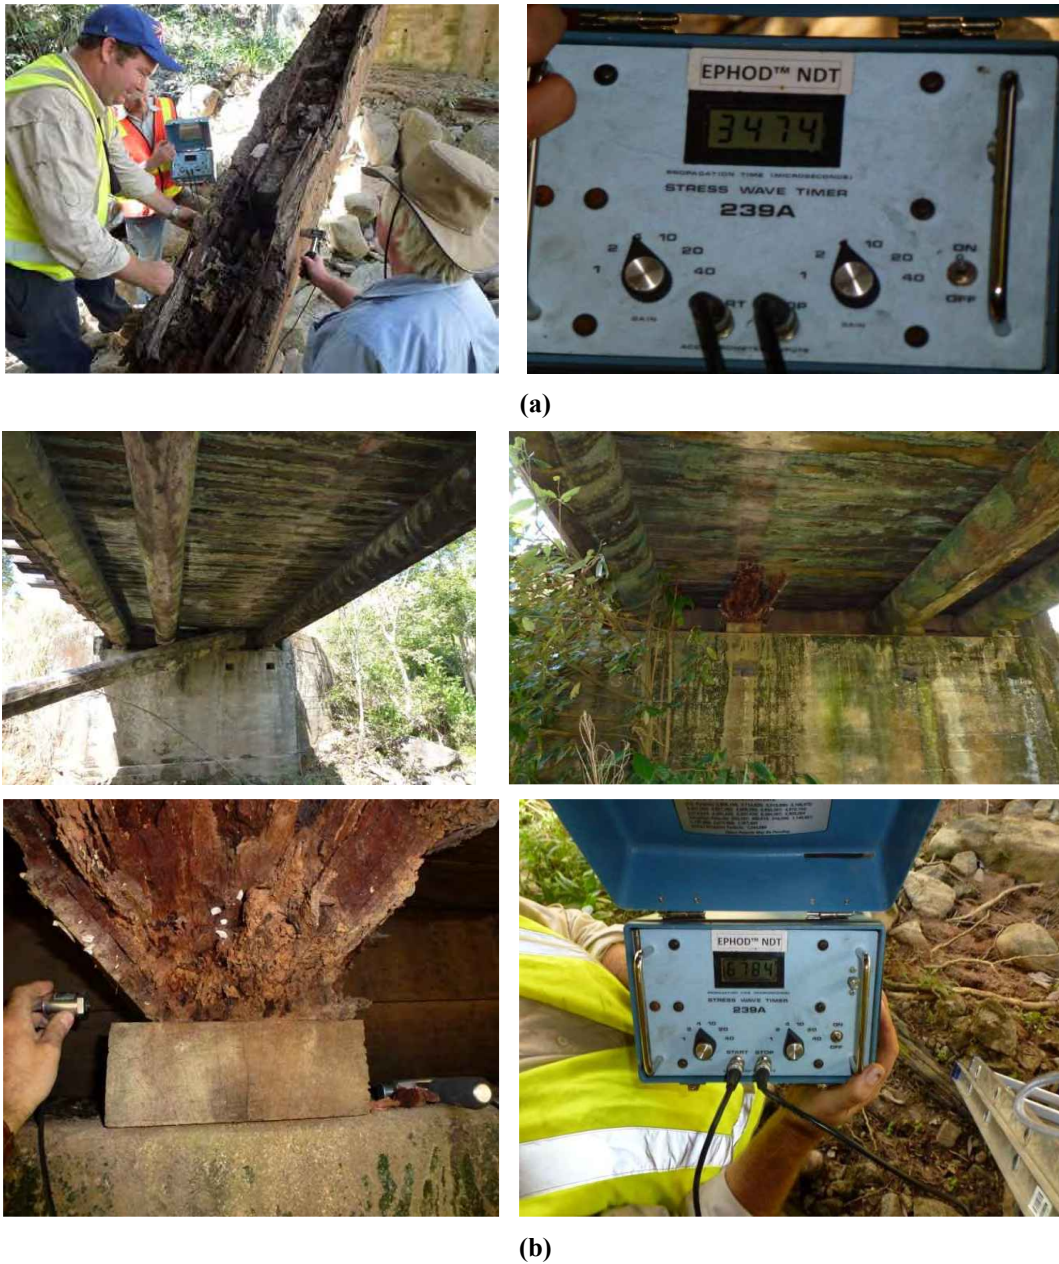
Figure 12-1: Photos showing global failure of a timber log girders. Both failures were caused by advanced decay in the ends of the girders and transverse shear failures. The primary cause of this decay was due to vertical fasteners. These failures were found in elements with SWT values in the 3k μ s (photos a. above) to 6k μ s range (photos b. below). Typically, similar bending extreme tensile fibre failures in log girders occur in zones of decay where there are over 2k μ s SWT values. Similarly, if vast portions of the log girder have SWT values over 3k μ s the failures may occur.

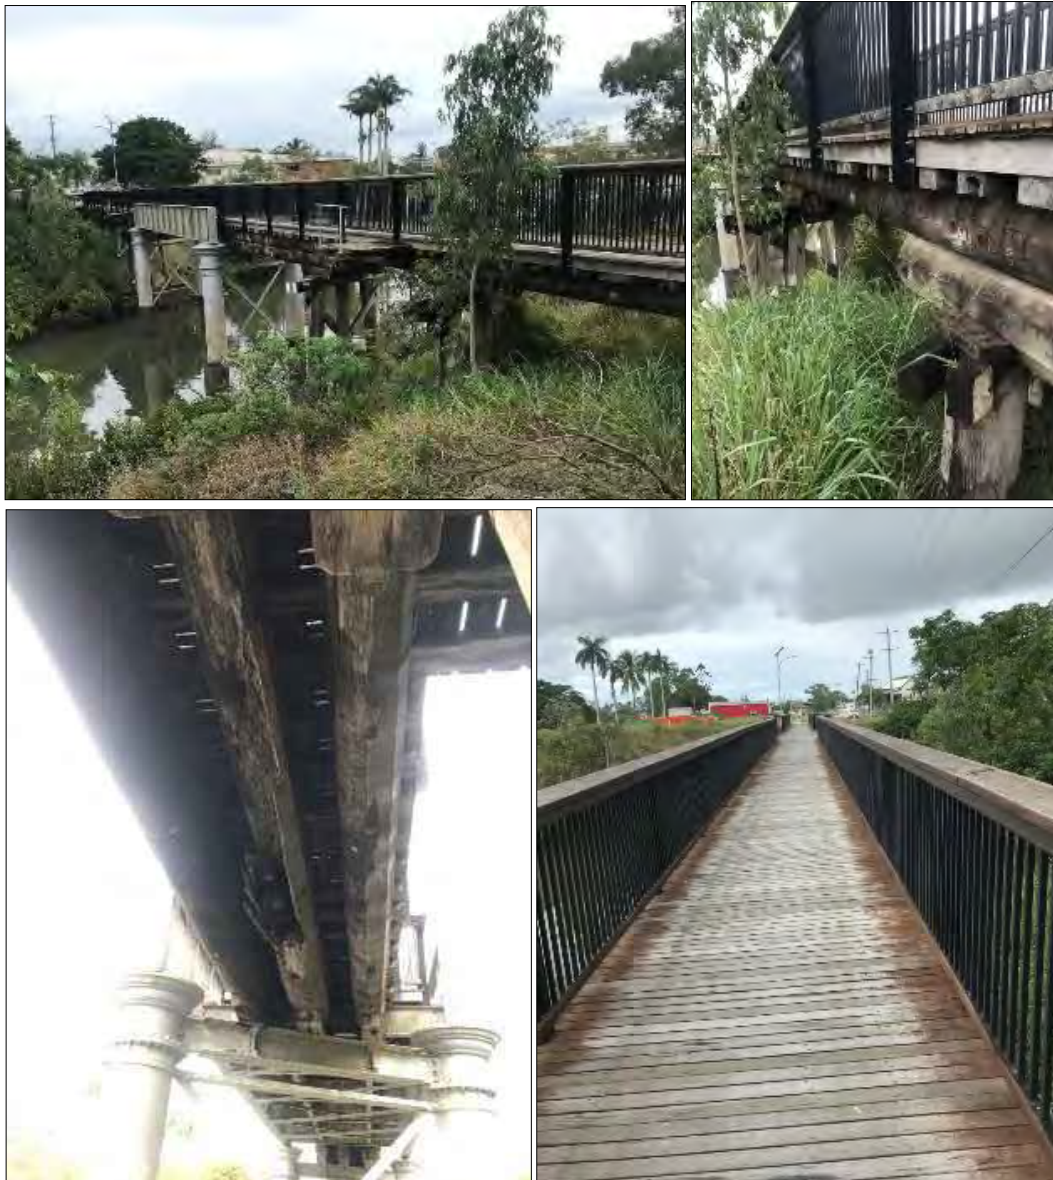
Figure 12-2: The above photo series demonstrates a similar repair to Option 1 type of refurbishment (build off existing railway bridge) used for the construction of a pedestrian bridge in Bundaberg CDB. The existing railway bridge was left un-touched and a new hardwood deck system with handrails was installed. Six 100mm x 250mm timber joists were placed on top of the existing transoms (rail ties) with a 38-50mm thick hardwood deck installed on top. This option will likely be the lowest cost but also carries the shortest expected lifespan. As seen in the bottom left photo above, one of the girders has failed and fallen out creating a 'weak' point along the bridge. Due to a high residual capacity of timber and the continuous joists, a complete failure of the bridge (span) hasn't occurred yet but is only a matter of time unless extensive maintenance is undertaken.

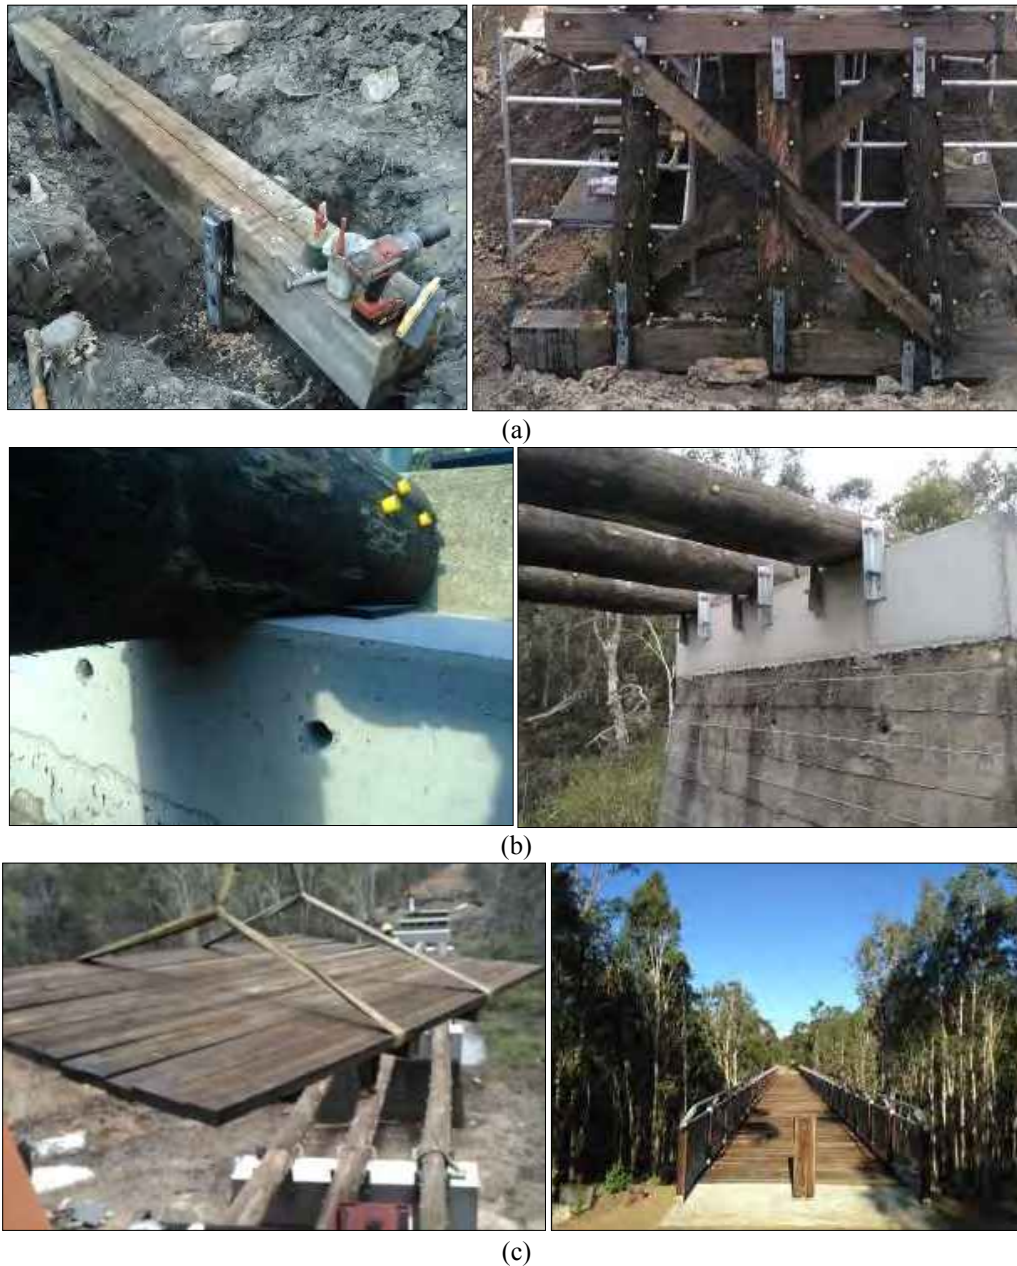
Figure 12-3: The above photo series demonstrates Option 2 type of fix (hardwood) used for the construction of two Mary to Bay Rail Trail Bridges. Seen above in photo (a) is the construction of a frame bent using an intermediate cap which was installed on top of the existing pile stubs. This allowed the hardwood posts, cross bracing, and cap to be installed at the correct reference height. Also note the yellow plugs that indicate that Decaystop® rods have been installed. Photo (b) shows the girders being installed using a horizontal connection system and a rubber liner between the timber girder and concrete pier. In photo (c) the pre-panelised deck is installed along with the modulus handrail and cycle rail system.

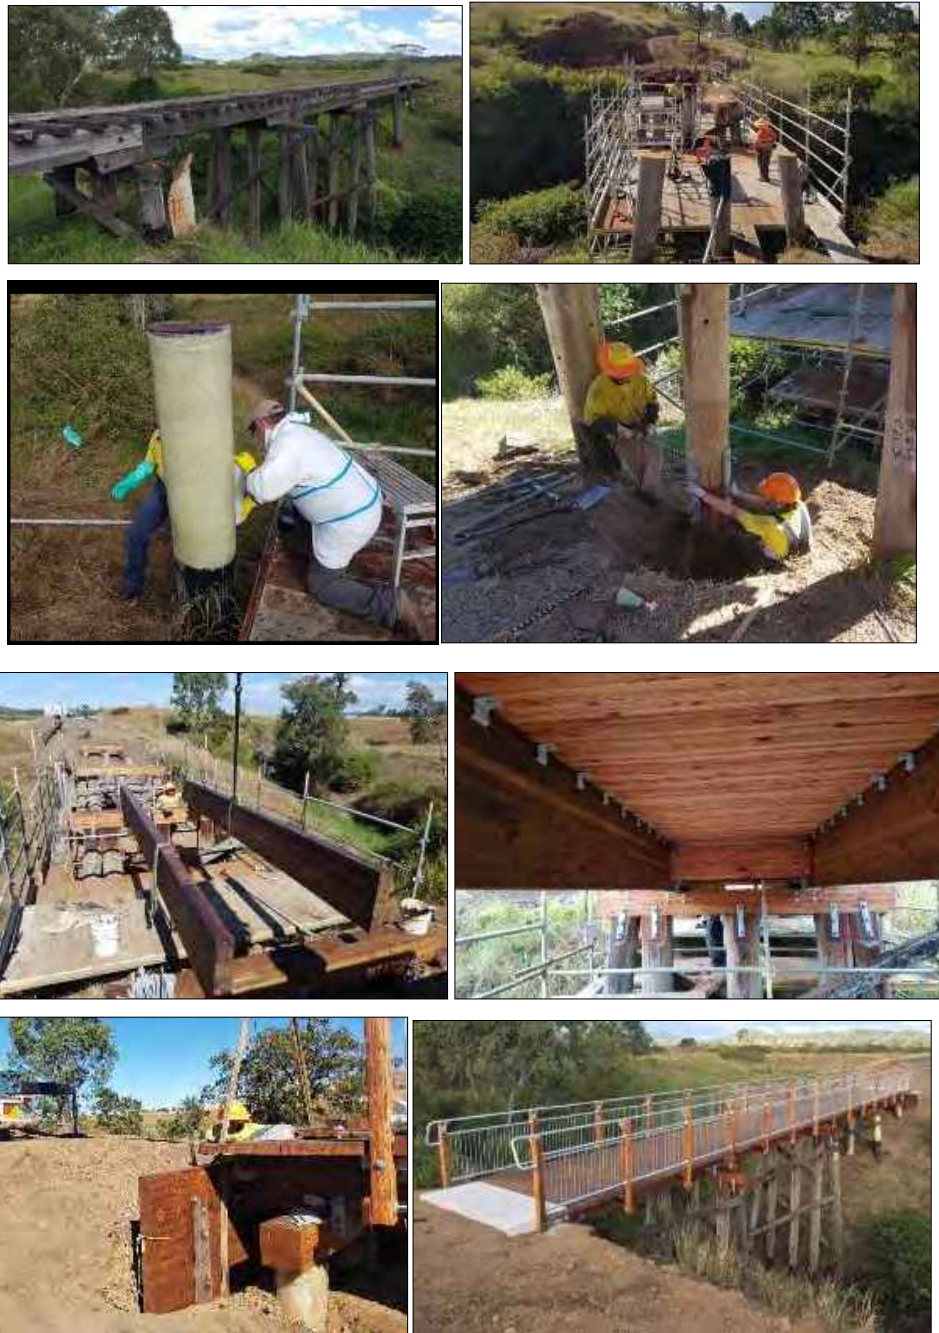
Figure 12-4: The photo series above demonstrates Option 3 type of fix that was completed on Jimmy Gully Bridge along the BVRT. The existing poor condition superstructure was removed, and the piles were repaired with high strength fibre or posted with new section. New glulam back wall, caps, girders and deck system were installed utilising a horizontal connection detail.

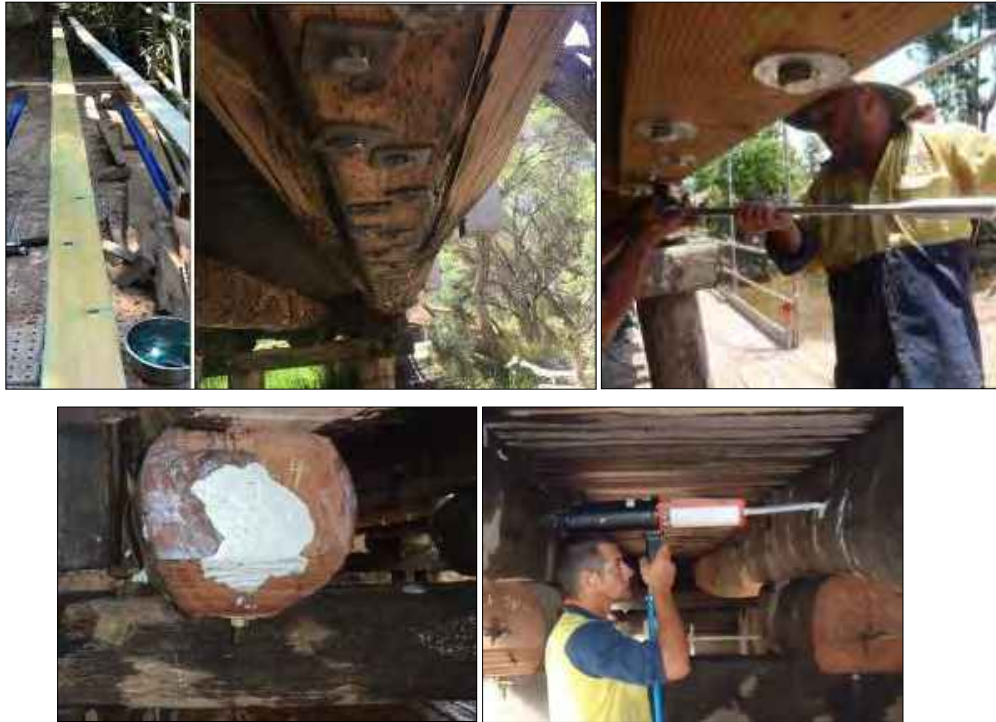
Figure 12-5: The repair of Meachams Bridge in Cassowary Coast. The bridge was retrofitted with fibre reinforcement on the bottom of the girders, some corbels and girders were injected with a high strength epoxy. Some piles were also wrapped with high strength fibre and injected with epoxy, then the entire bridge was diffused with borate salt rods to neutralize decay growth.

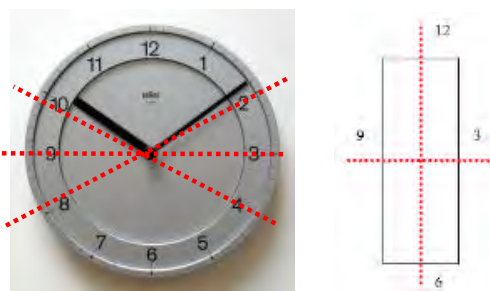
Figure 12-6: SWT configurations for round and rectangular timber

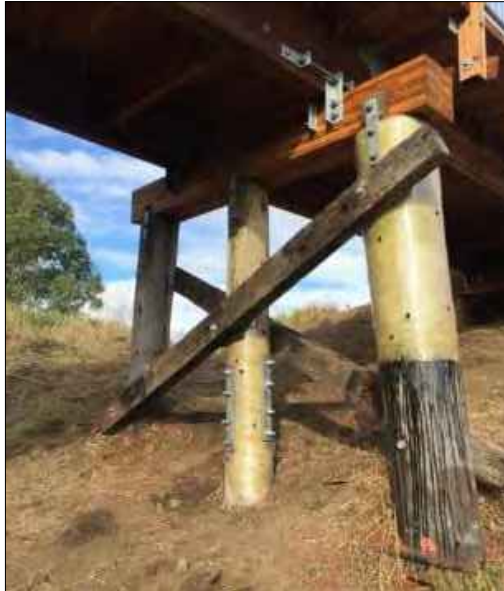
Figure 12-8: Diffuser (Borate Salt) rods are installed in the remaining hardwood elements to resist further deterioration of the timber caused by fungi growth. Note the red bungs are the decay ‘hotspots’ where the timber is prone to have a higher moisture content. These holes are required to be checked for rod depletion as per the issued maintenance manual (typically every 2-5 years depending on environmental conditions).

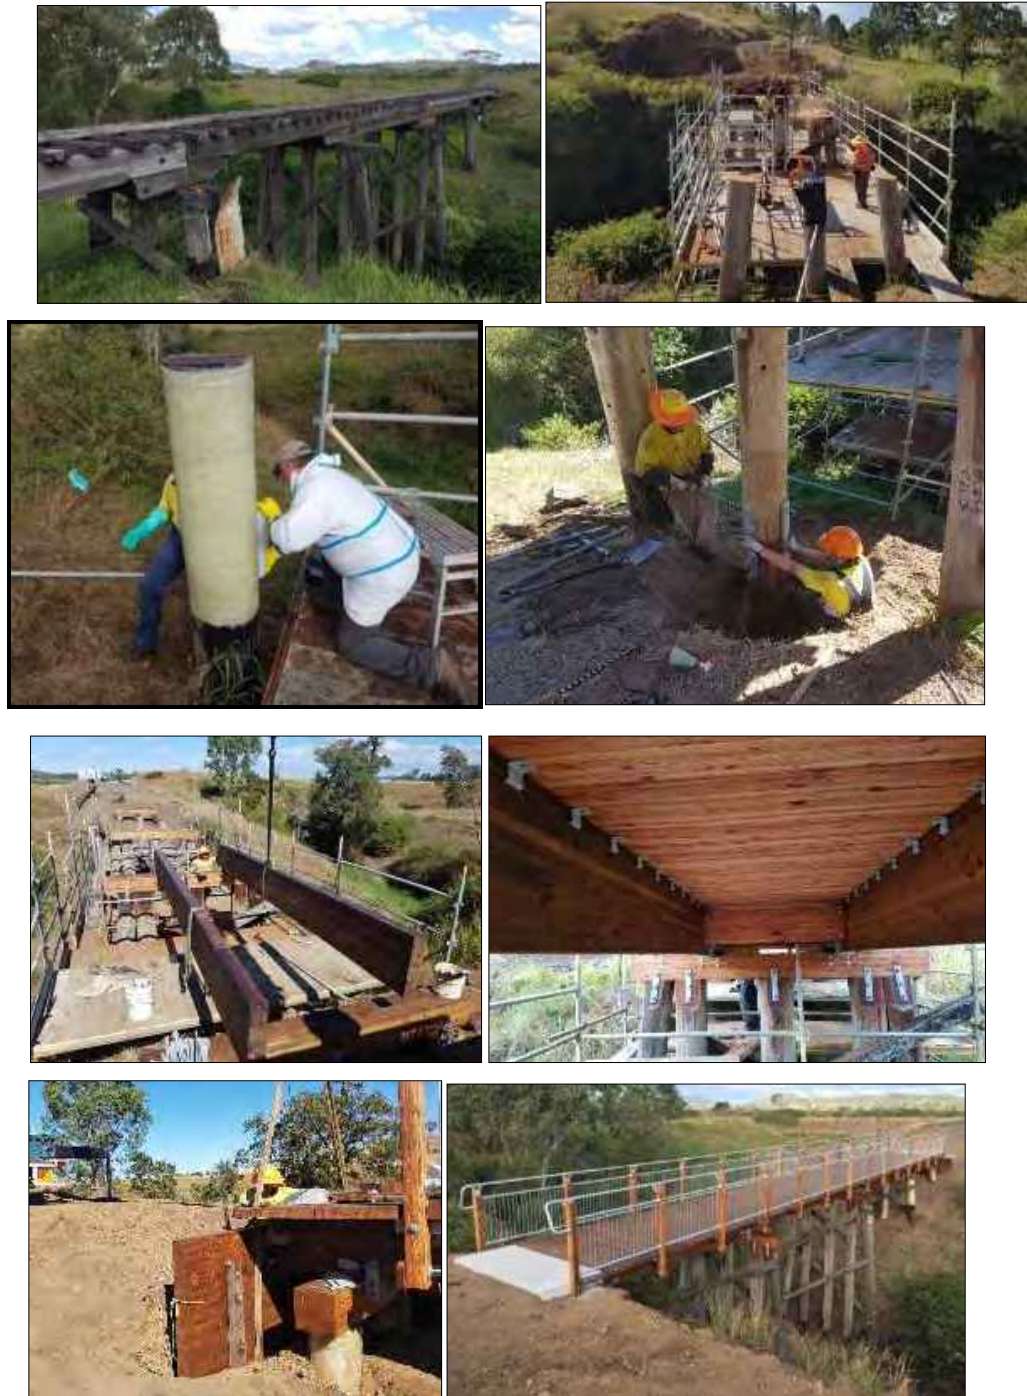
Figure 12-9: The photo series above demonstrates an Option 2 type of fix that was done for Jimmy Gully Bridge along the BVRT. The existing poor condition superstructure was removed, and the piles were repaired or posted with new section. New glulam back wall, caps, girders, and deck system were installed utilising a horizontal connection detail.

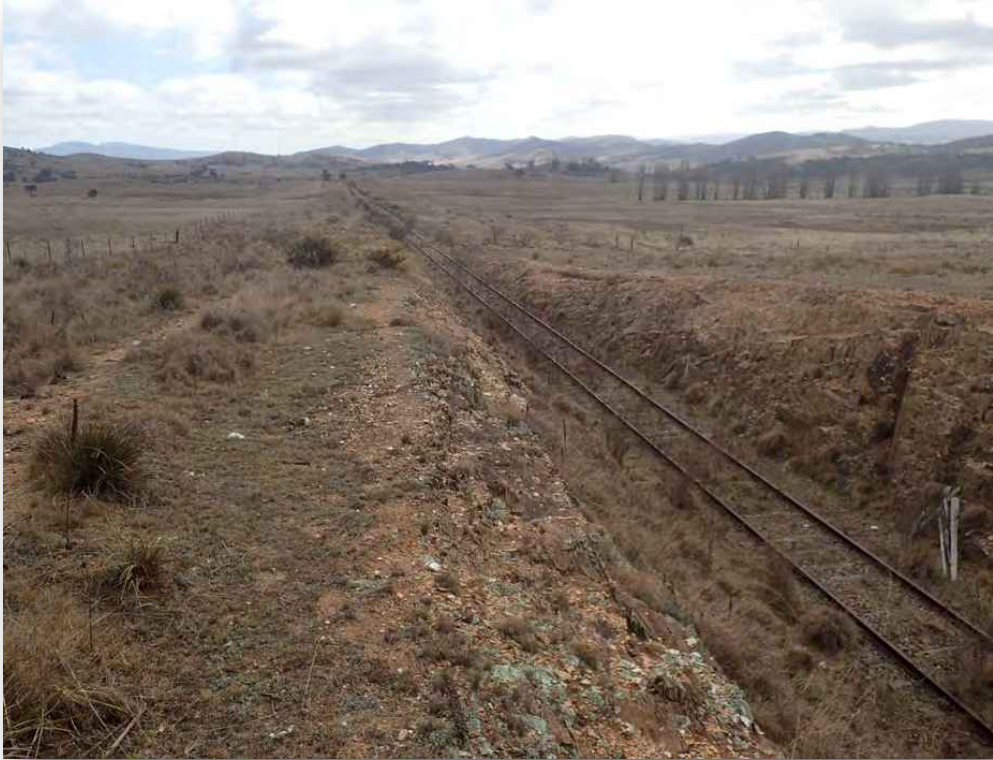
Monaro Rail Trail Development Plans Stage 2 (draft)

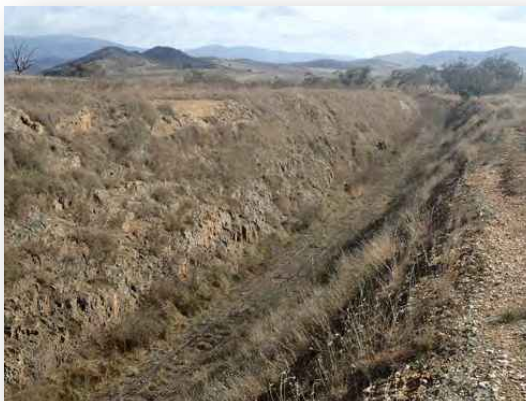
The old drains of the many cuttings along the proposed rail trail will require attention to ensure they still perform the task of clearing water from the cuttings

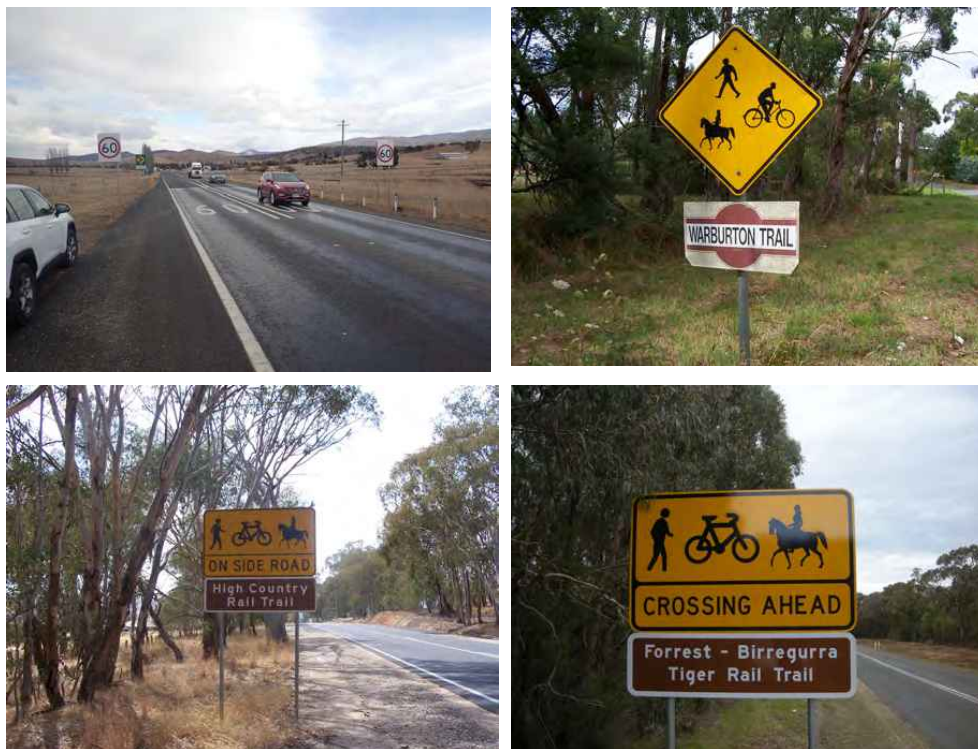
Road crossings often present a challenge. Crossing the Monaro Highway at Bredbo presents a particular challenge (top left). The suggested solution is to include a large trail name sign at the bottom of the standard trail crossing sign (as shown above on three Victorian rail trails – top right, bottom left, bottom right).

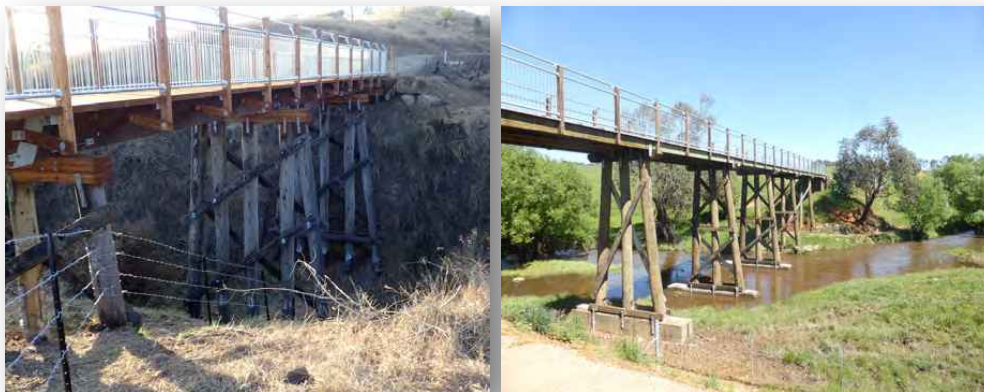
Renovating original railway bridges adds significantly to the trail user's experience. The bridge on the left is on the Brisbane Valley Rail Trail while the bridge on the right is on Tumbarumba-Rosewood Rail Trail. Both are good examples of restored railway bridges. Both use a combination of old (existing) and new timbers.

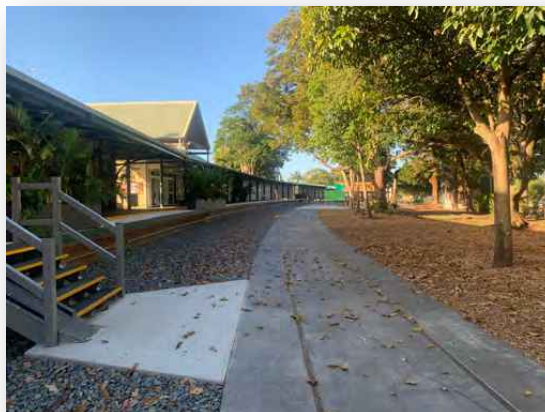
Trailheads present a unique opportunity to provide high quality starting/finishing and intervening attractions on a rail trail. On the newly opened Northern Rivers Rail Trail, Murwillumbah Railway Station has been turned into a very attractive trailhead. Usually these shelters may contain two information panels (front and back, with general information, a map with the trail route and key features and important safety information for trail users.

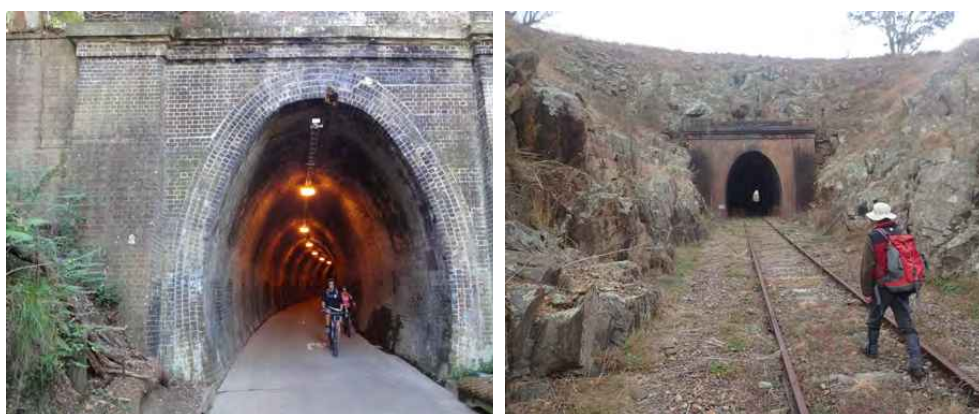
3.15 EMERGENCY SHELTERS

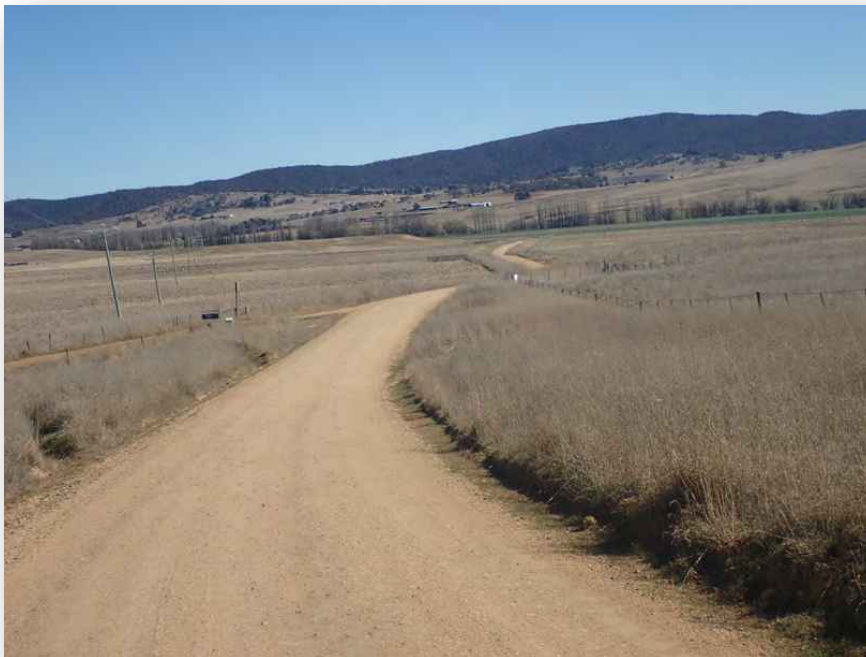
Monaro Rail Trail Development Plans Stage 2 (draft)

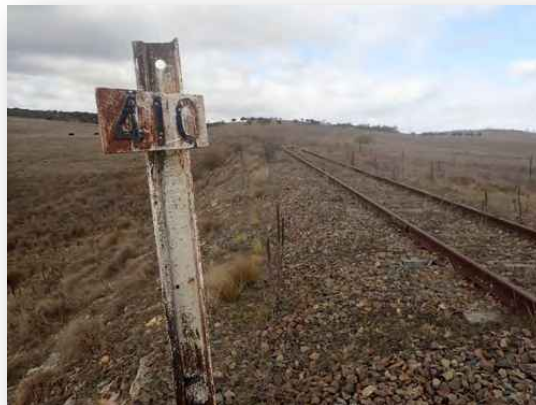
Retention of all old distance pegs, and other signage, is strongly recommended.

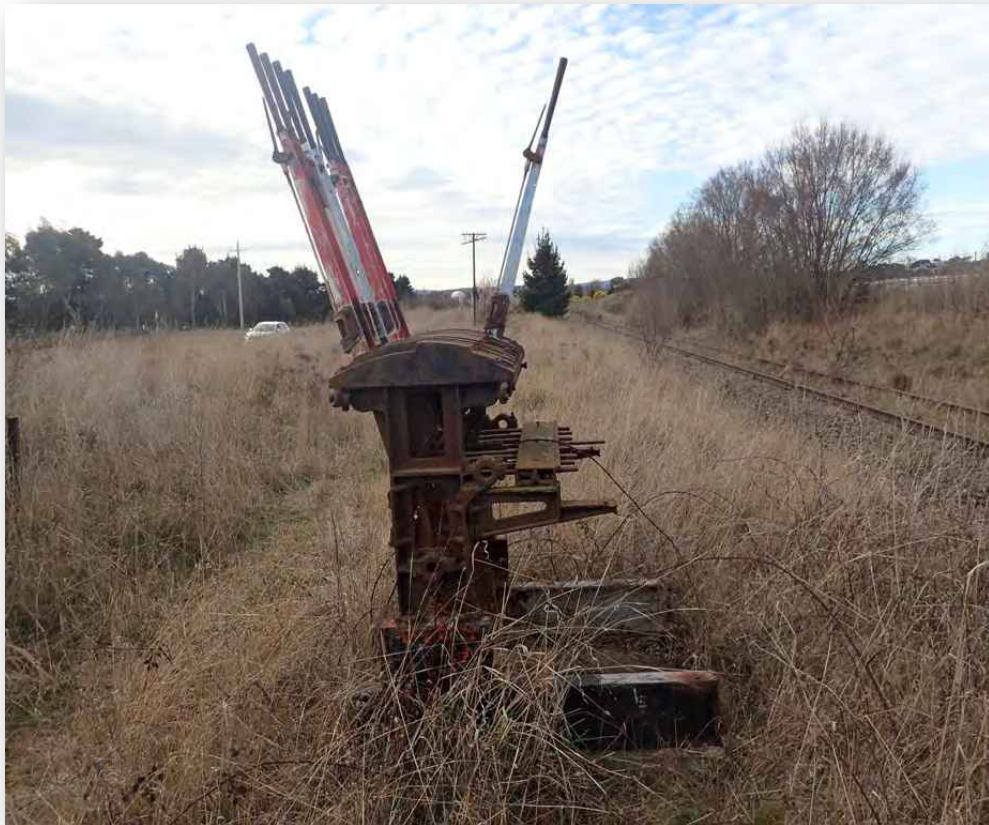
Monaro Rail Trail Development Plans Stage 2 (draft)

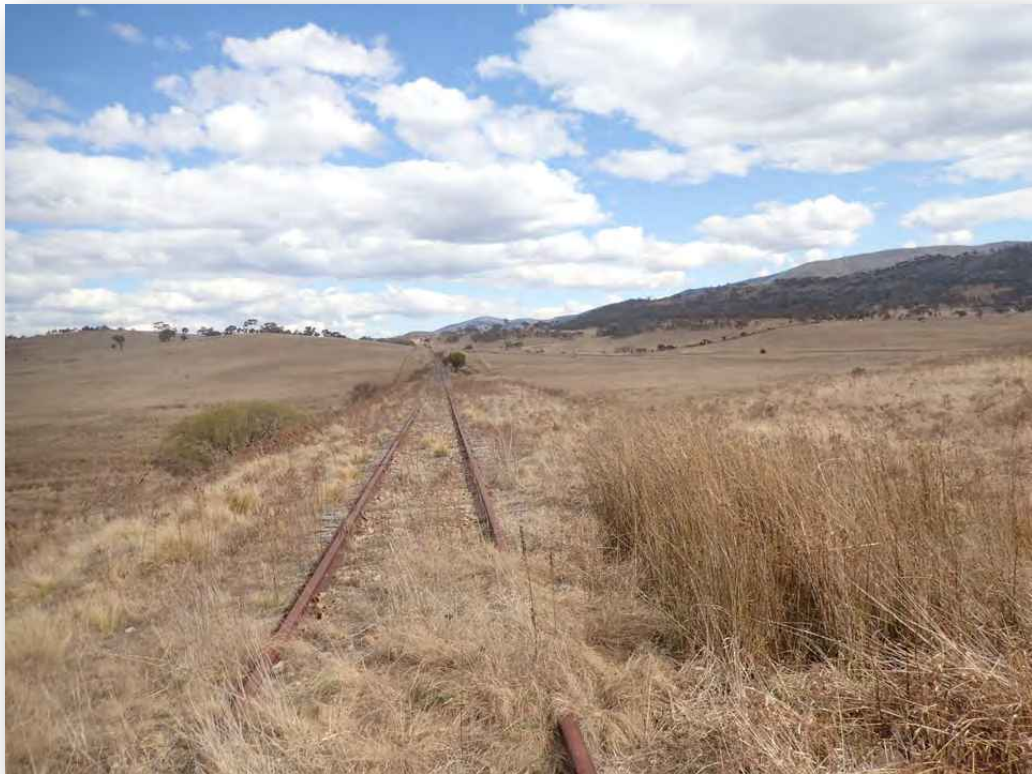
Monaro Rail Trail Development Plans Stage 2
