Ordinary Meeting of Council

12 February 2025

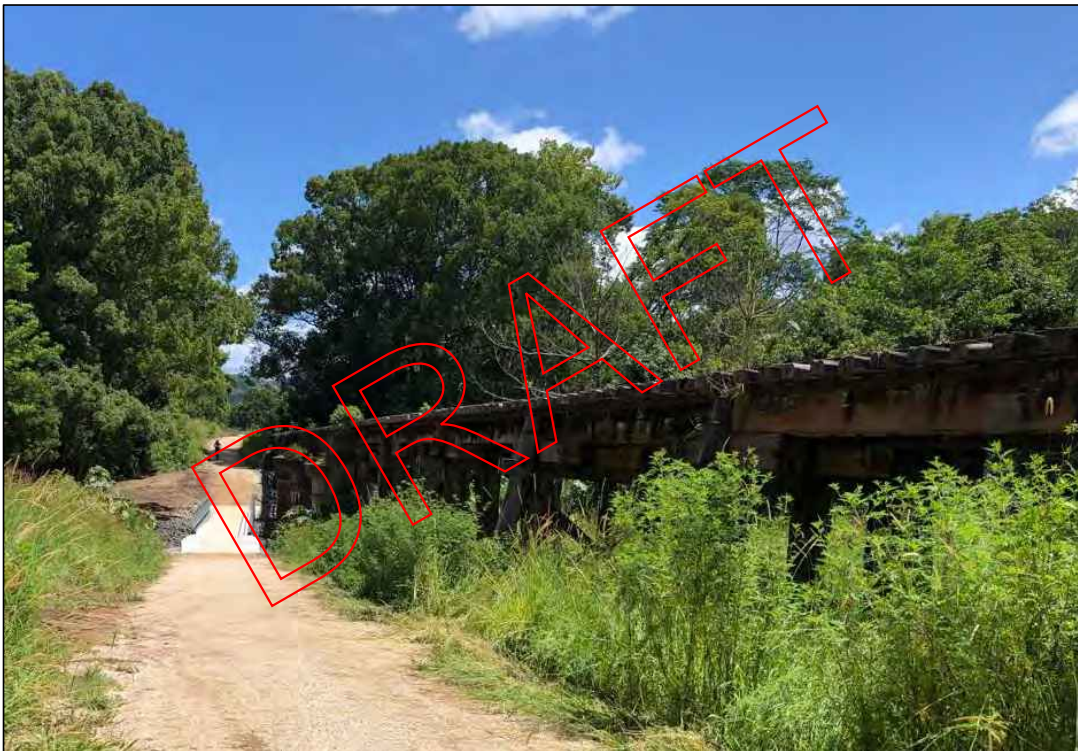
Figure 4.1 Low-Level Bypass at Burringbar Creek on the Northern Rivers Rail Trail

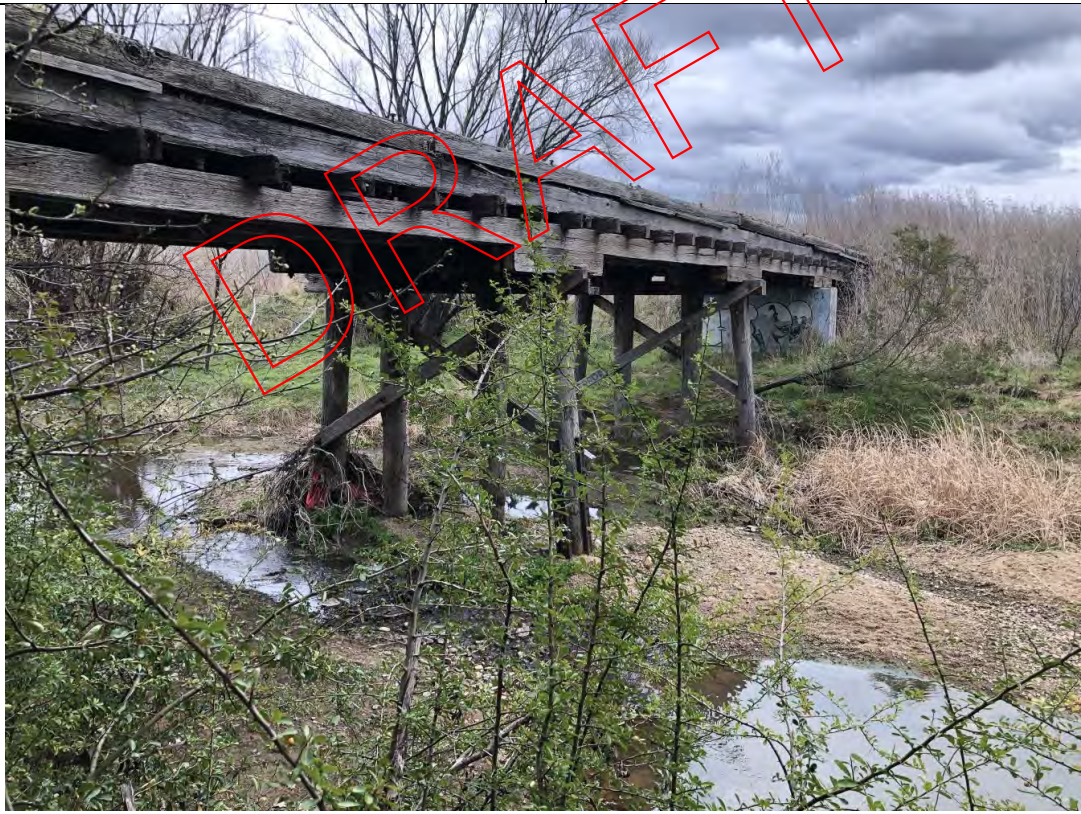
Coote Burchills Engineering Pty Ltd
 T/A Burchills Engineering Solutions
 ABN: 76 166 942 365
 admin@burchills.com.au
 www.burchills.com.au
 PO Box 3766, Australia Fair,
 Southport, Qld 4215

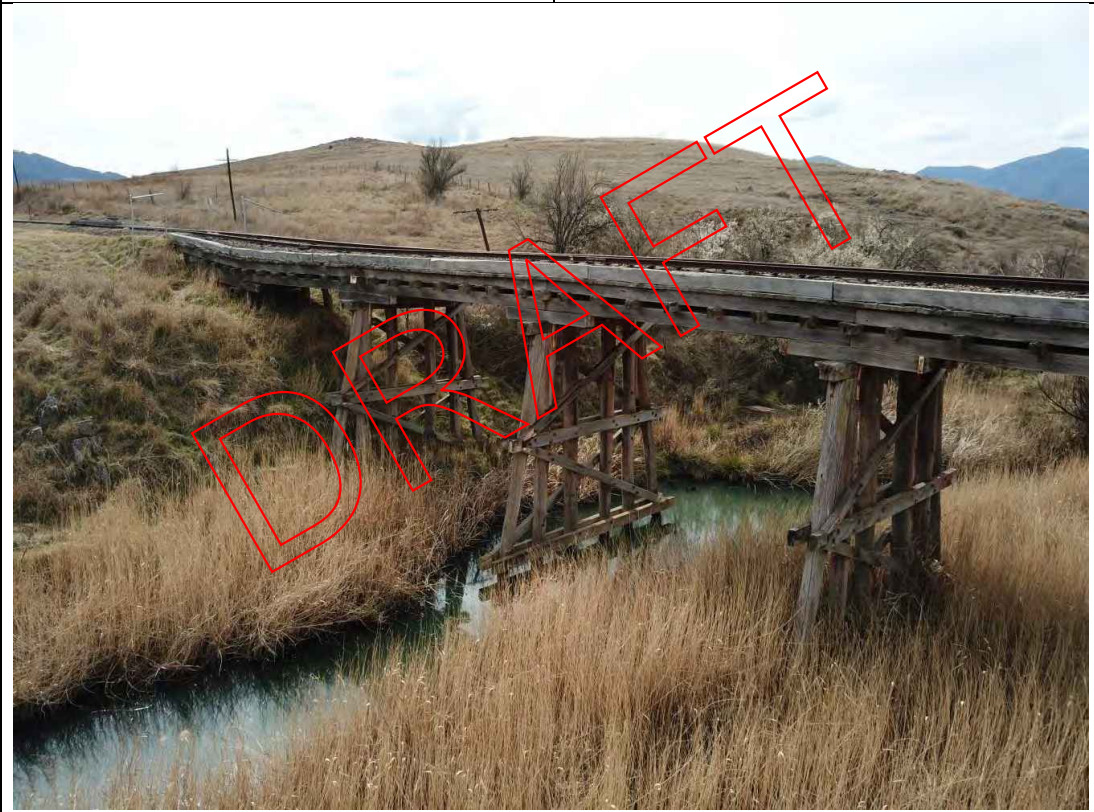
The experience **you deserve**

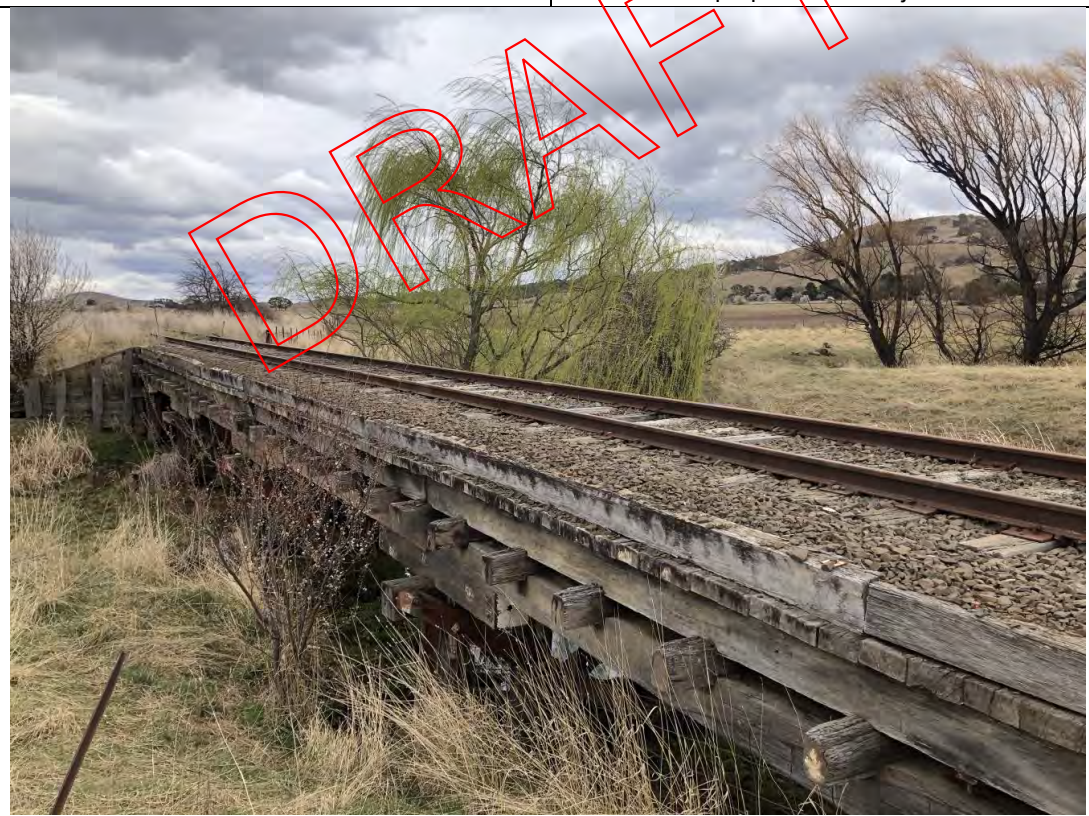
The experience you deserve

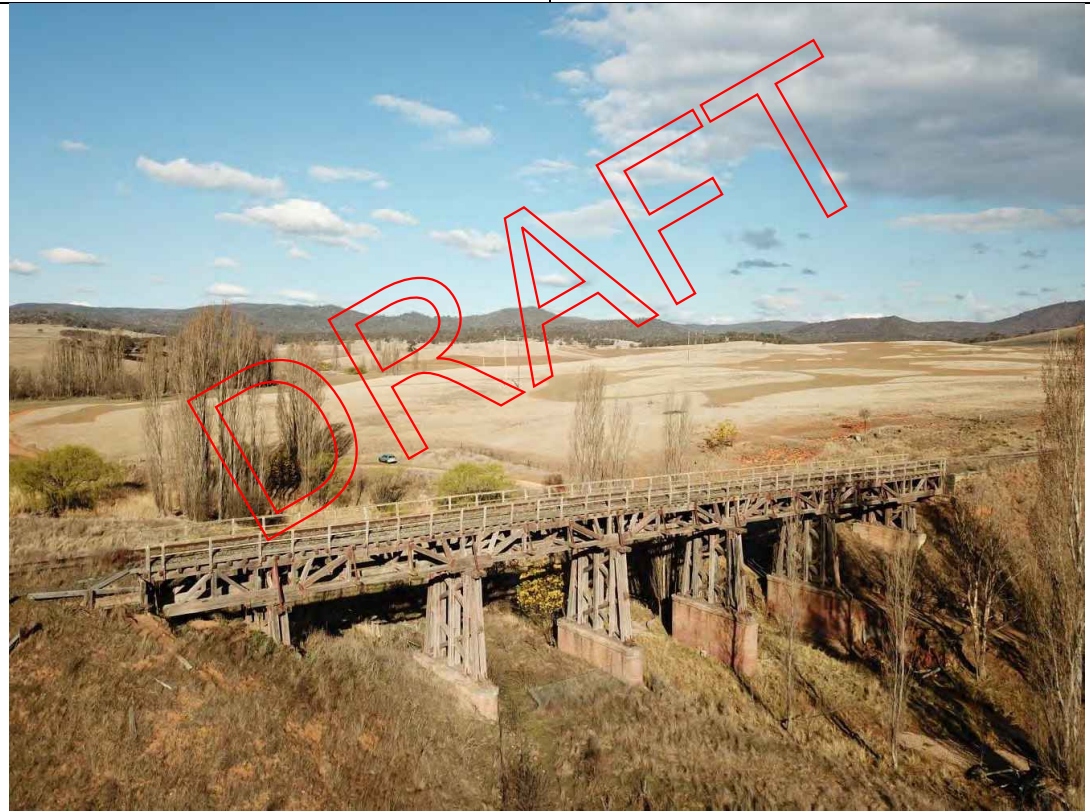
The experience you deserve

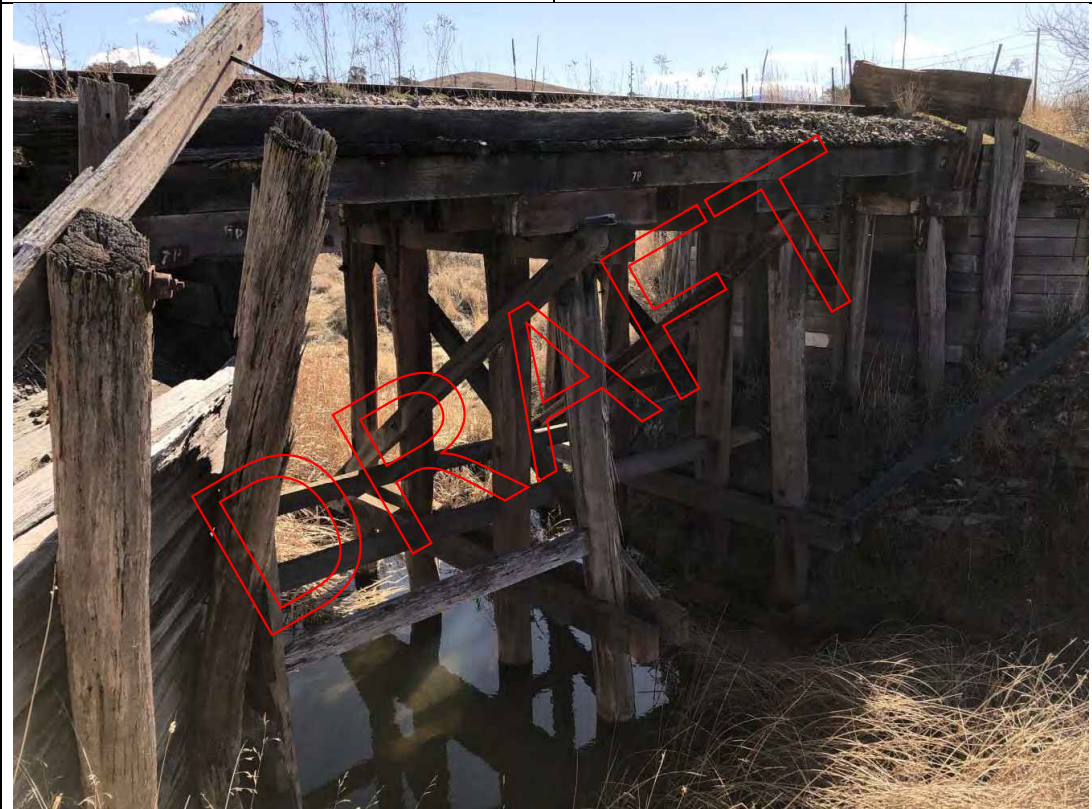
The experience **you deserve**

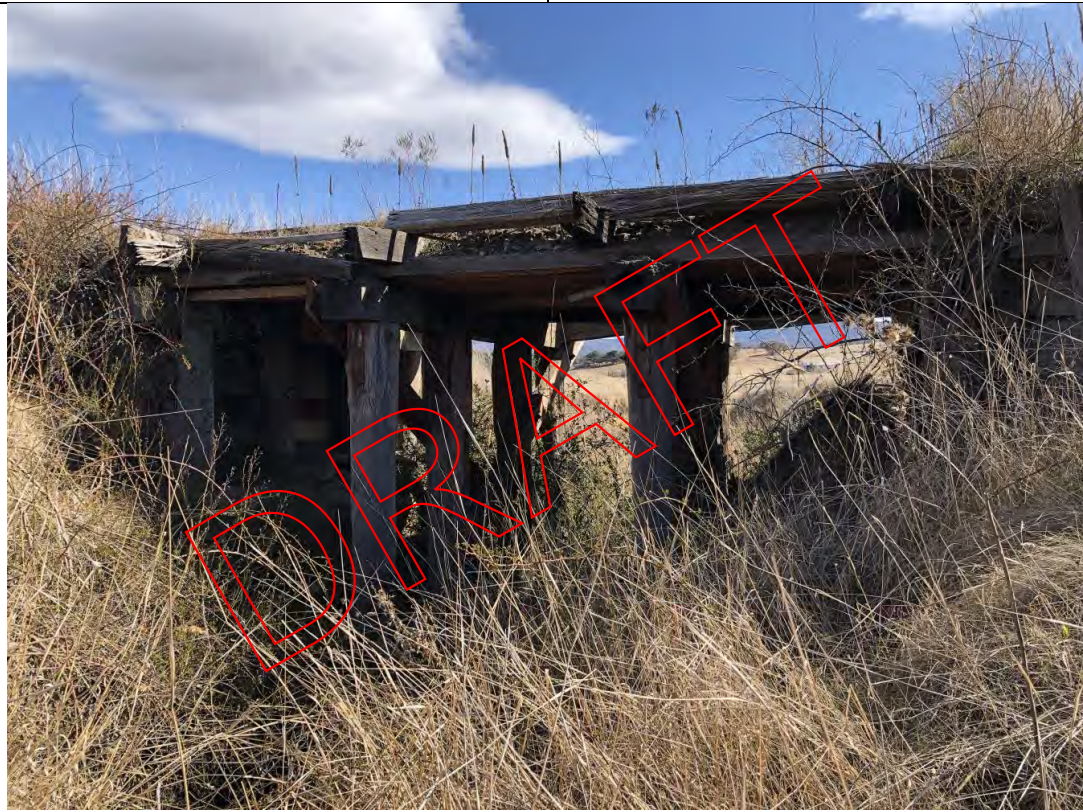
The experience **you deserve**

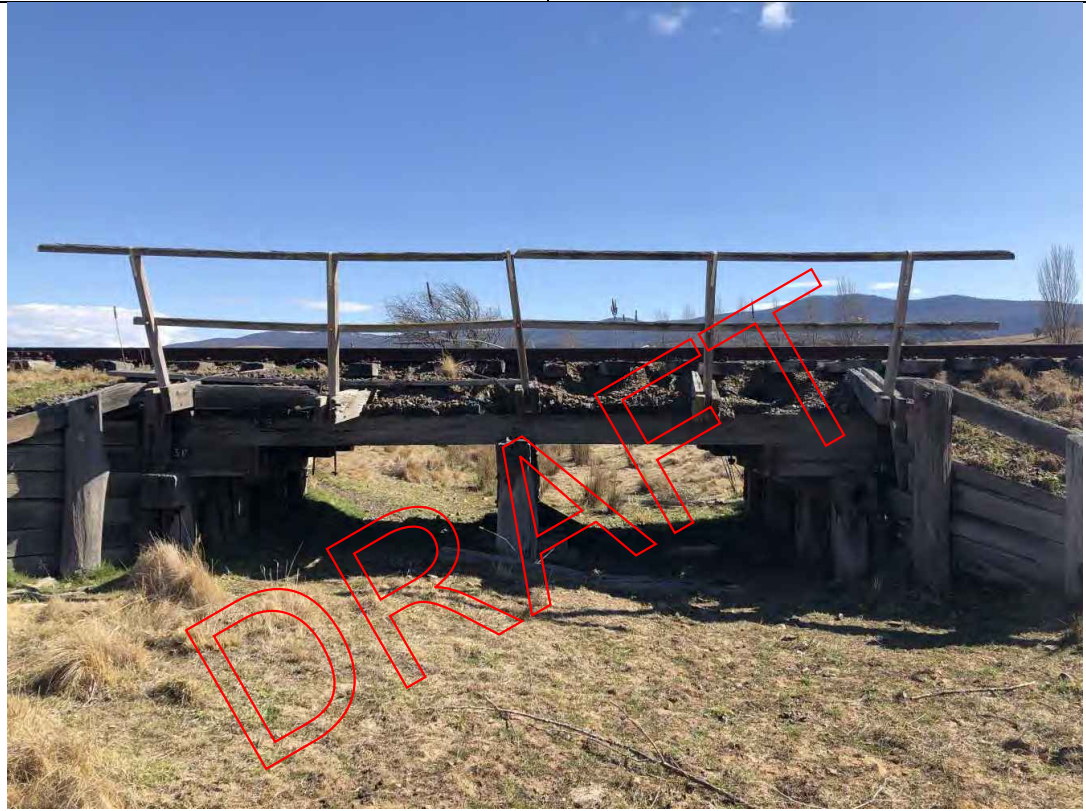
The experience you deserve

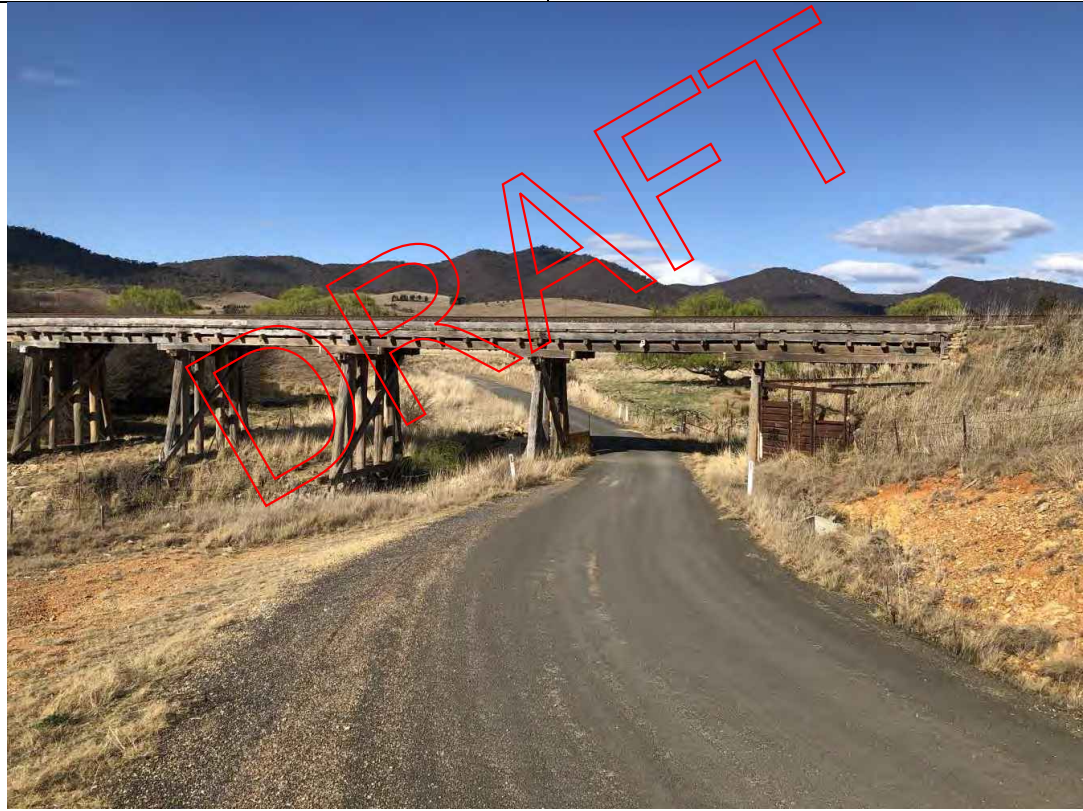
The experience you deserve

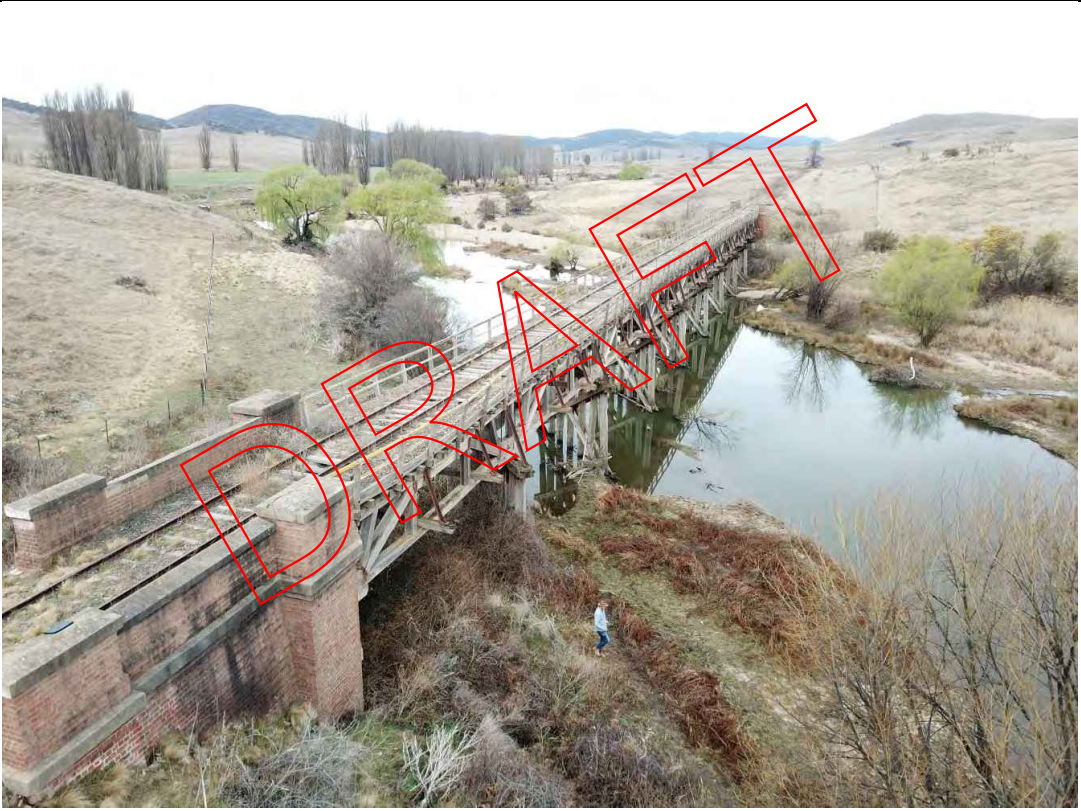
9. BREDBO RIVER	
General Conditions & Bypass Options	Existing Structure Observations
<ul style="list-style-type: none"> • Bypass a real challenge given height and span of river • Best bypass would be on east side • To reduce span of bypass follow river edge east back still significant bridge, at least 60-80m. Existing bridge is 150m • Bypass could start straight out of cutting • Heritage requirements TBC. Rebuild on existing abutments likely preferred option 	<ul style="list-style-type: none"> • 148m long • Concrete / many abutments • Drone capture of all accessible components

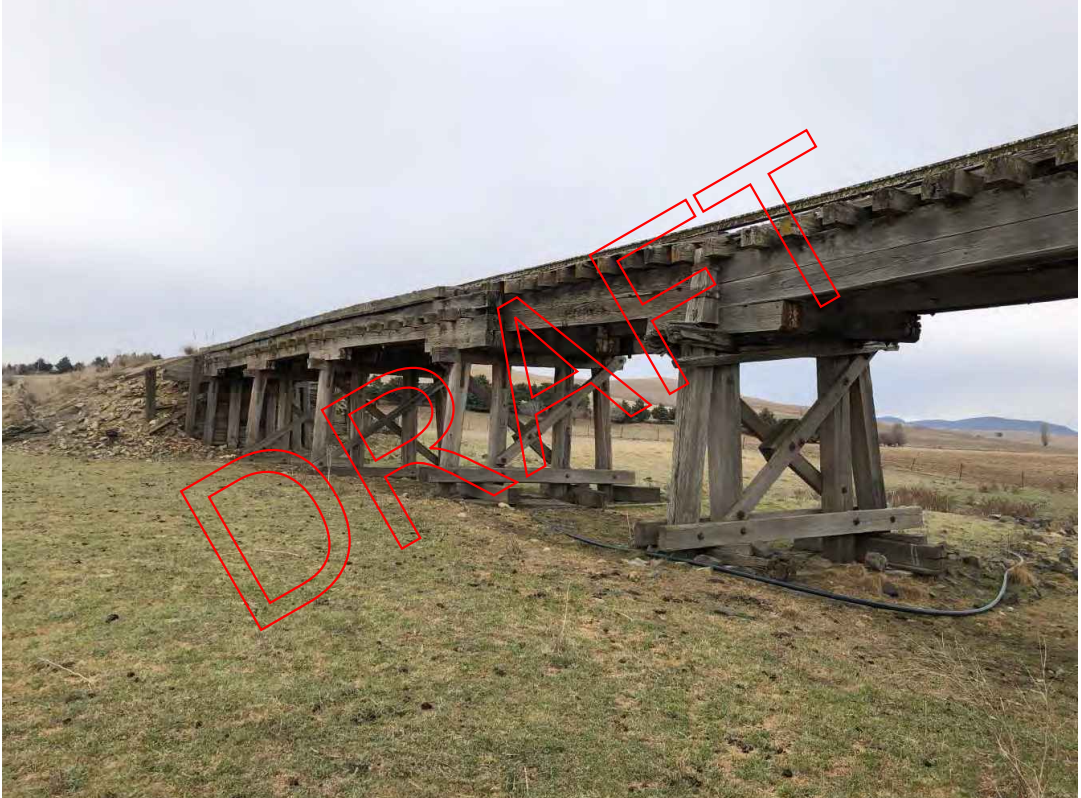
11. NUMERALLA NO.2	
General Conditions & Bypass Options	Existing Structure Observations
<ul style="list-style-type: none"> • 50m span • Bypass best option 60 to 70m length • Transitions needed, back up to formation • Minor culvert needed at low point perhaps 2 of • Bypass on grade, rocky subgrade • 4-5m high transitions • West side for bypass 	<ul style="list-style-type: none"> • 6 spans timber trestle • SP 4-6 ballast topped • Timber abutments • 48m long

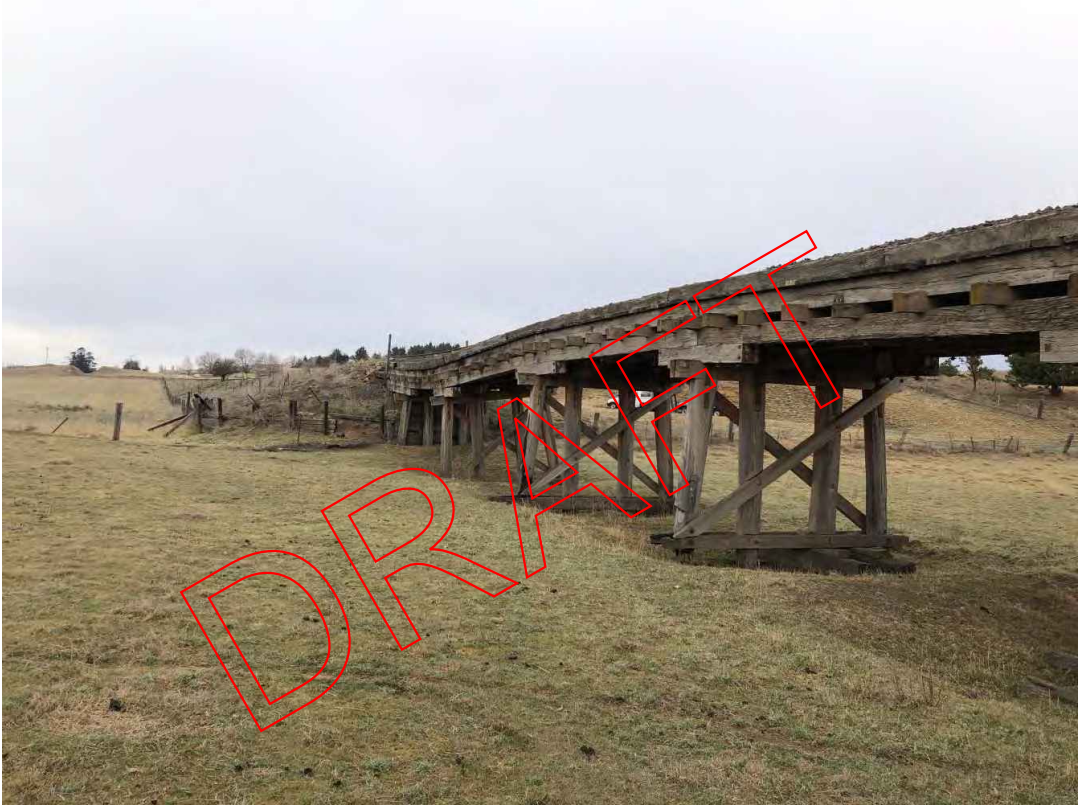
12. NUMERALLA NO.3	
General Conditions & Bypass Options	Existing Structure Observations
<ul style="list-style-type: none"> • Same as No.2 • West side (but on land owners side) • 65m span • Minor culverts only for local drainage 2 of 	<ul style="list-style-type: none"> • 6 spans and 2 abt spans • 59m long • SP1 – Rotten griders • P2,3,6,7 settled P4 missing P5 fire damage • SP1,2,3,4 major failure

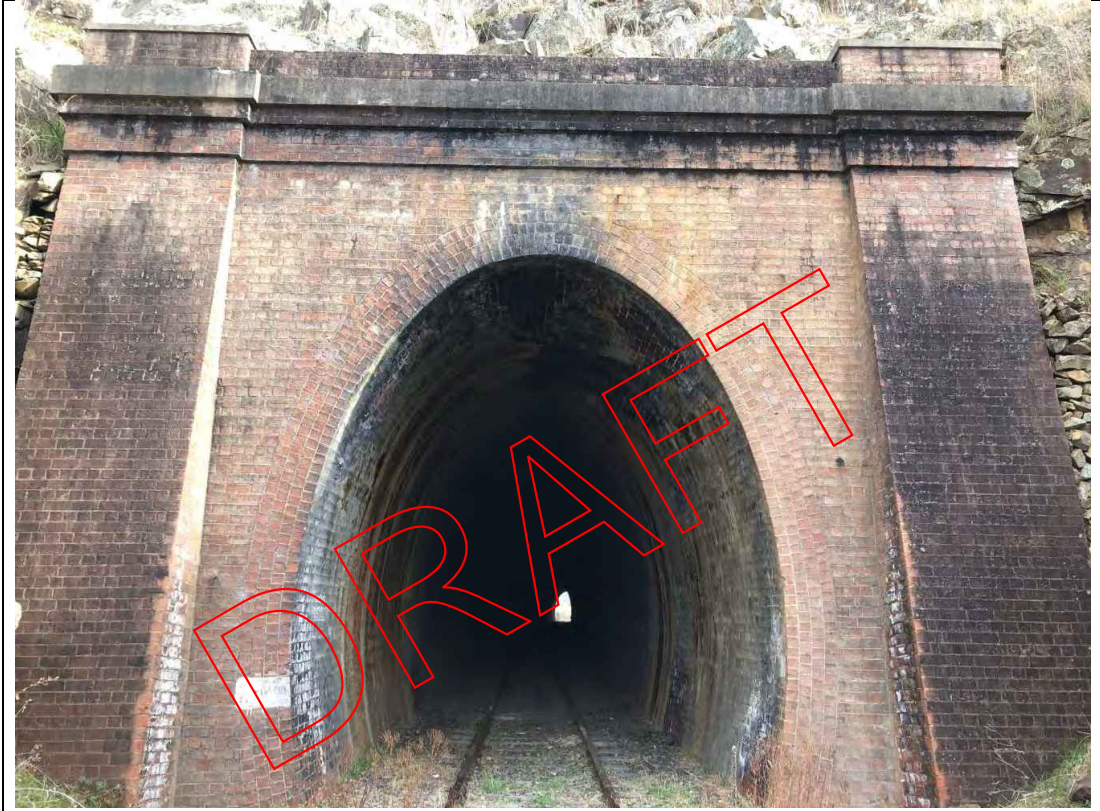
Monaro Rail Trail Development Plans Stage 2
